# Coal Bumps in an Eastern Kentucky USA Longwall Coal Mine 1989 to 1997

J. Hoelle

This conference paper was originally published as Hoelle, J, Coal Bumps in an Eastern Kentucky USA Longwall Coal Mine 1989 to 1997, in Aziz, N (ed), Coal 2009: Coal Operators' Conference, University of Wollongong & the Australasian Institute of Mining and Metallurgy, 2009, 236-245.

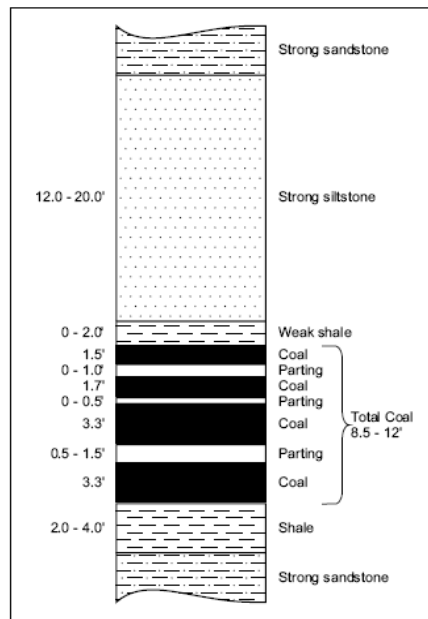
Figure No 1 - Typical stratigraphical section

2.5 to 3.7 m in economical mining thickness. The seam occurred in four benches and in some areas, the parting between the upper bench and the three lower coal benches or the parting between the lower bench and the three upper benches became too thick to mine. A typical section is shown in Figure 1. The seam dipped 2 to 3 degrees to the south. The access portals were drift portals with four additional sets of intake and return portals – all drifts were located at the north-end of the reserve. The overburden gradually increased as mining advanced to the south with overburden thicknesses up to 670 m.

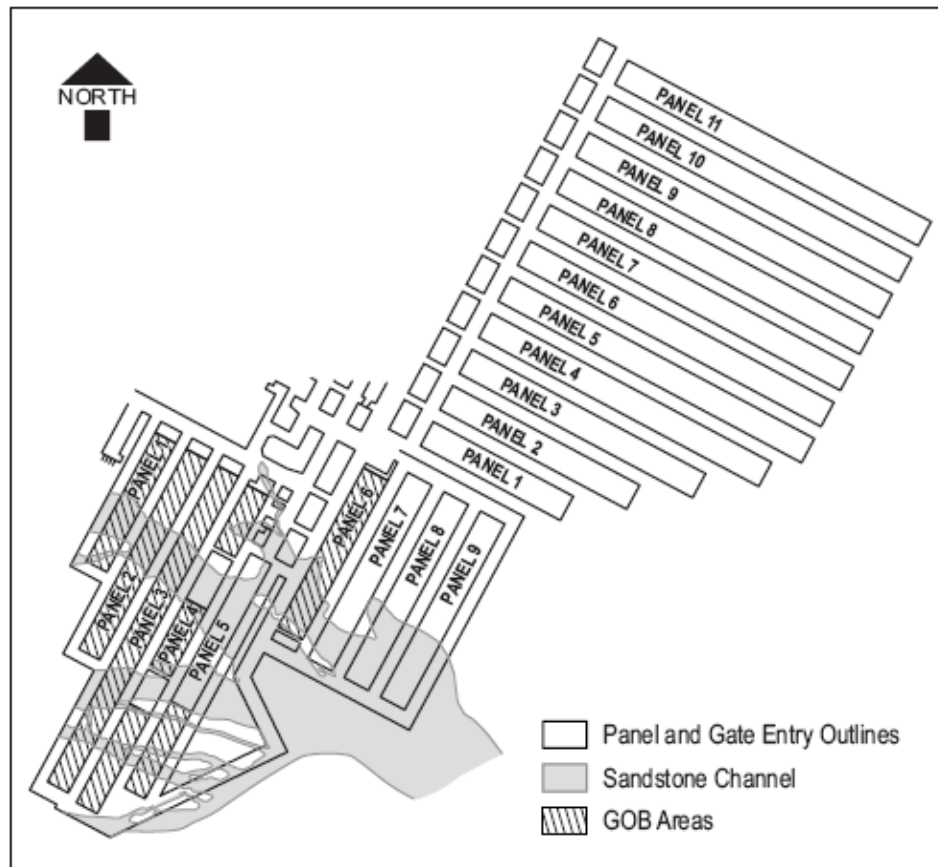
Figure No 2 - Mine plan for Groups 3, 4 and 5

Based on movement of the coal pillars along coal bench-parting contacts and information from nearby mines, there was a regional stress field to the north-east, which trended approximately N55E. Three in-situ stress tests were conducted at the mine. There were five groups of panels with the last three shown in Figure 2. Group 3 is shown with five panels (numbered 1 through 5) and Group 4 had four panels (numbered 6 through 9 in Figure 2). Group 5 is shown with 11 panels. The panel widths were 152 m for Group 3 and 4 shown in Figure 2. Panels 1 through 11 in the last group were 183 m wide.

Mining started in April 1990 in Group 4 and the first panel (panel 6 in Figure 2) was mined without major incident but there were two minor bumps near the beginning of the panel. The second panel (panel 7 in Figure 2) had 2 minor bumps and then a large bump after mining a short distance into the panel, with the bump damaging the shearer. Since this bump was under the same sandstone channel feature that was affiliated with the bumps in Group 3, the decision was made to move the longwall around the sandstone channel. Seven more minor bumps occurred before two large bumps occurred on the 8<sup>th</sup> October 1990 when the face was under a high mountain peak as well as under a barrier pillar that was in the overlying adverse mine. At about the same time, an abutment pillar in the headgate bumped, totally destroying the integrity of the pillar. No additional bumps occurred during mining of the rest of the panel. The bumps that occurred in the longwall panel were within 46 m of the tailgate

The third panel (panel 8 in Figure 2) was started inbye the sandstone channel. There were no bumps until the panel was under a barrier pillar in the overlying adverse mine when a minor bump followed by a major bump approximately 46 m from the tailgate. The decision was made to conduct an in-panel move around the high cover area that caused the bumps in the second panel. This also avoided the area of the previously destroyed abutment pillar in the tailgate. There were no further bumps in the rest of panel 8 or in panel 9.

The Group 5 set of 11 panels was started in October 1991. These panels were oriented at 90° to the orientation of the first four set of panels, as shown in Figure 2. Since a large number of bumps occurred in Group 4, the size and configuration of the gate road pillars were evaluated and major changes were made. The abutment pillars were designed as a 4-entry yield-abutment-yield arrangement. In the initial two panels, the gate road pillars were designed with the length at 47.5 m and the width at 12 and 47.5 and 12 m respectively. As part of this re-design, the smaller pillars were designed as true yield pillars. The length of the pillars was shortened to 46 m in the third panel and the 4<sup>th</sup> through the 11<sup>th</sup> abutment pillars were 45 m long by 46 m wide. The yield pillars remained 12 m wide. The pillar configurations are summarised in Table 2. The memory cut capabilities of the shearer continued to be used in the Group 5 panels.

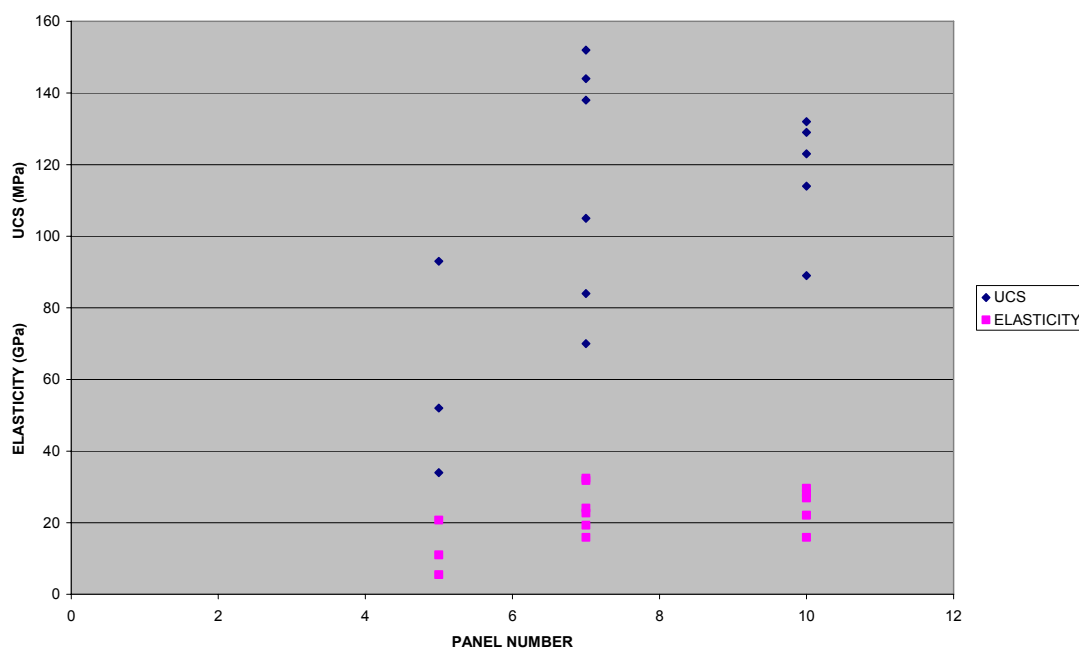
Figure 4 - Roof rock strengths

Starting with the panel 3 headgate, core holes were drilled 2.5 to 3.0 m into the floor and 12 to 15 m into the roof from the gate roads. The purpose of this was to determine if thick sandstone roof strata was present. A strong sandstone on or near the coal was not encountered; however a strong siltstone did occur within 0.6 m of the coal seam. A typical profile from the drilling is shown in Figure 3. Along with strata identification, RQD's were recorded and starting with the fifth panel, samples were tested for UCS and Young's modulus strength characteristics. The test results are illustrated in Table 3. The UCS strengths and the Young's modulus increased from south to north and from west to east. Figure 4 illustrates the increase in UCS and Young's modulus. The first five panels were bump-free even though the overburden thicknesses were up to 670 m. Because the first five panels were bump free, it was decided that the abutment pillars were properly designed to prevent bumps from occurring.

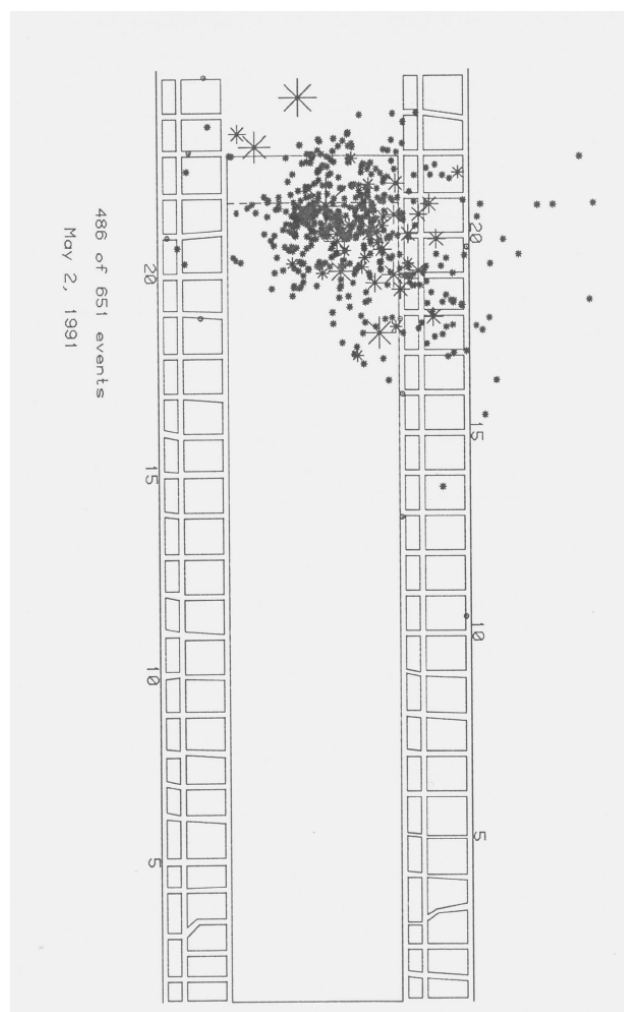
**Figure 5 - Microseismic activity, Group 4, Panel 4**

- The US Bureau of Mines installed geophones in the head and tail gates starting in Panel 4 of Group 3 with the objective of determining if precursors of events could be obtained. An example of the number of events that were recorded in one of the panels (Group 4, panel 4) is shown in Figure 5. However, a definitive precursor was never determined (Coughlin and Rowell, 1993). Microseismics were recorded from mid 1989 until mid 1993.
