# Coal Bumps in an Eastern Kentucky USA Longwall Coal Mine 1989 to 1997

J. Hoelle

This conference paper was originally published as Hoelle, J, Coal Bumps in an Eastern Kentucky USA Longwall Coal Mine 1989 to 1997, in Aziz, N (ed), Coal 2009: Coal Operators' Conference, University of Wollongong & the Australasian Institute of Mining and Metallurgy, 2009, 236-245.

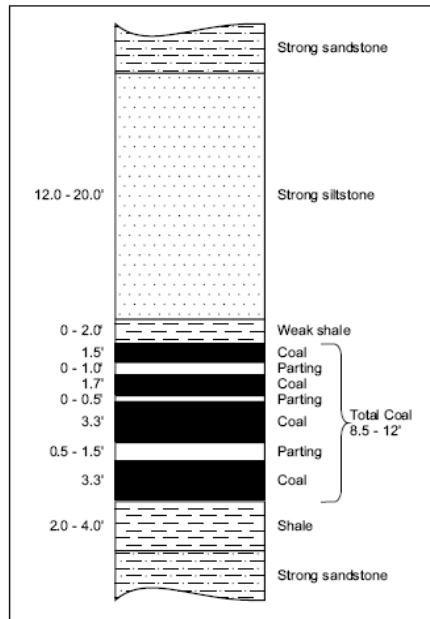
Figure No 1 - Typical stratigraphical section

2.5 to 3.7 m in economical mining thickness. The seam occurred in four benches and in some areas, the parting between the upper bench and the three lower coal benches or the parting between the lower bench and the three upper benches became too thick to mine. A typical section is shown in Figure 1. The seam dipped 2 to 3 degrees to the south. The access portals were drift portals with four additional sets of intake and return portals – all drifts were located at the north-end of the reserve. The overburden gradually increased as mining advanced to the south with overburden thicknesses up to 670 m.

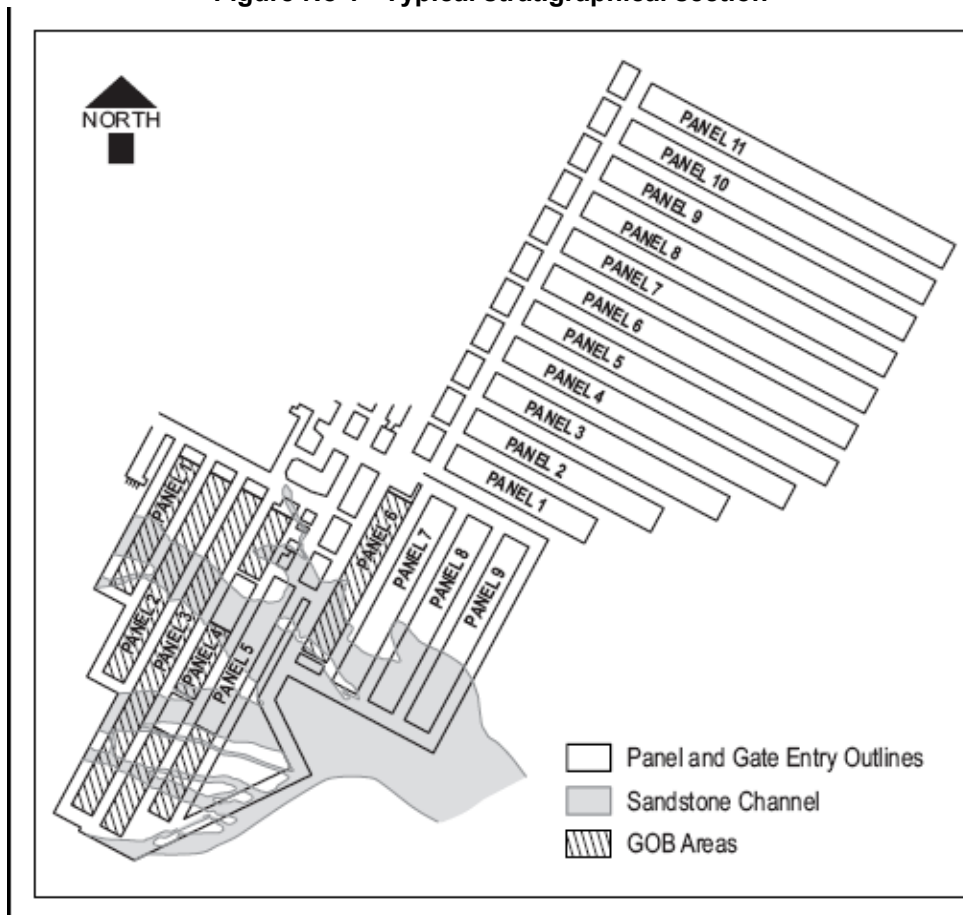
Figure No 2 - Mine plan for Groups 3, 4 and 5

Mining started in April 1990 in Group 4 and the first panel (panel 6 in Figure 2) was mined without major incident but there were two minor bumps near the beginning of the panel. The second panel (panel 7 in Figure 2) had 2 minor bumps and then a large bump after mining a short distance into the panel, with the bump damaging the shearer. Since this bump was under the same sandstone channel feature that was affiliated with the bumps in Group 3, the decision was made to move the longwall around the sandstone channel. Seven more minor bumps occurred before two large bumps occurred on the 8<sup>th</sup> October 1990 when the face was under a high mountain peak as well as under a barrier pillar that was in the overlying adverse mine. At about the same time, an abutment pillar in the headgate bumped, totally destroying the integrity of the pillar. No additional bumps occurred during mining of the rest of the panel. The bumps that occurred in the longwall panel were within 46 m of the tailgate

The third panel (panel 8 in Figure 2) was started inbye the sandstone channel. There were no bumps until the panel was under a barrier pillar in the overlying adverse mine when a minor bump followed by a major bump approximately 46 m from the tailgate. The decision was made to conduct an in-panel move around the high cover area that caused the bumps in the second panel. This also avoided the area of the previously destroyed abutment pillar in the tailgate. There were no further bumps in the rest of panel 8 or in panel 9.

The Group 5 set of 11 panels was started in October 1991. These panels were oriented at 90° to the orientation of the first four set of panels, as shown in Figure 2. Since a large number of bumps occurred in Group 4, the size and configuration of the gate road pillars were evaluated and major changes were made. The abutment pillars were designed as a 4-entry yield-abutment-yield arrangement. In the initial two panels, the gate road pillars were designed with the length at 47.5 m and the width at 12 and 47.5 and 12 m respectively. As part of this re-design, the smaller pillars were designed as true yield pillars. The length of the pillars was shortened to 46 m in the third panel and the 4<sup>th</sup> through the 11<sup>th</sup> abutment pillars were 45 m long by 46 m wide. The yield pillars remained 12 m wide. The pillar configurations are summarised in Table 2. The memory cut capabilities of the shearer continued to be used in the Group 5 panels.

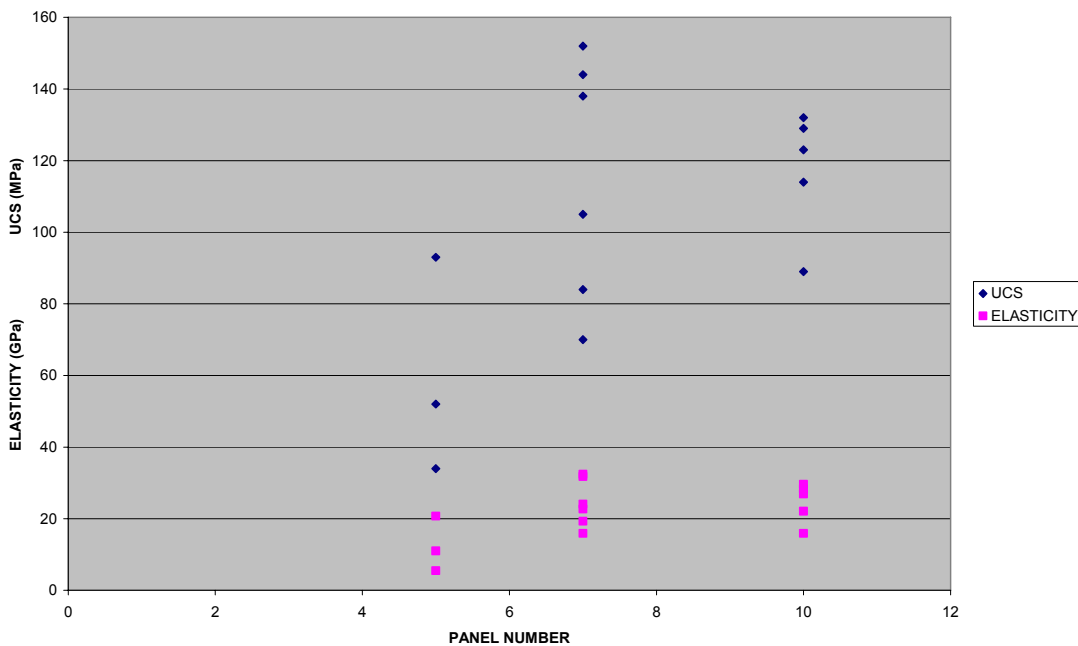
Figure 4 - Roof rock strengths

Starting with the panel 3 headgate, core holes were drilled 2.5 to 3.0 m into the floor and 12 to 15 m into the roof from the gate roads. The purpose of this was to determine if thick sandstone roof strata was present. A strong sandstone on or near the coal was not encountered; however a strong siltstone did occur within 0.6 m of the coal seam. A typical profile from the drilling is shown in Figure 3. Along with strata identification, RQD's were recorded and starting with the fifth panel, samples were tested for UCS and Young's modulus strength characteristics. The test results are illustrated in Table 3. The UCS strengths and the Young's modulus increased from south to north and from west to east. Figure 4 illustrates the increase in UCS and Young's modulus. The first five panels were bump-free even though the overburden thicknesses were up to 670 m. Because the first five panels were bump free, it was decided that the abutment pillars were properly designed to prevent bumps from occurring.

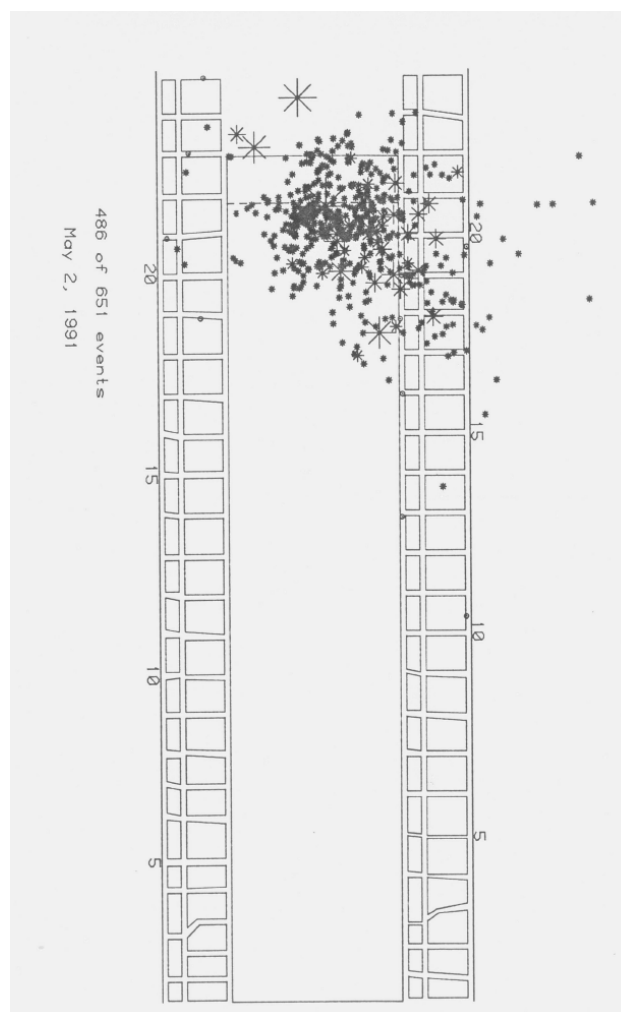
**Figure 5 - Microseismic activity, Group 4, Panel 4**

- The US Bureau of Mines installed geophones in the head and tail gates starting in Panel 4 of Group 3 with the objective of determining if precursors of events could be obtained. An example of the number of events that were recorded in one of the panels (Group 4, panel 4) is shown in Figure 5. However, a definitive precursor was never determined (Coughlin and Rowell, 1993). Microseismics were recorded from mid 1989 until mid 1993.
