Assessment of an Underground Coal Mine Fire: A Case Study From Zonguldak, Turkey

ASSESSMENT OF AN UNDERGROUND COAL MINE FIRE: A CASE STUDY FROM ZONGULDAK, TURKEY

Alaaddin Cakir¹ and Kemal Baris¹

ABSTRACT: This paper aims to evaluate an underground coal-mine fire detected on November, 11th 2007 in Gelik Mine of Karadon Colliery of Turkish Hardcoal Enterprise (TTK), Zonguldak, Turkey. Several techniques were employed by TTK to fight the fire including sealing, filling the mine with water and pumping nitrogen. The mine atmosphere was continuously monitored and gas samples were collected for analysis using a gas chromatograph. In this study, following a description of the fire fighting efforts, the interpretations of well-known fire indices applied to the different stages of the incident were given and attempts were made to compare and to test the reliability of these indices.

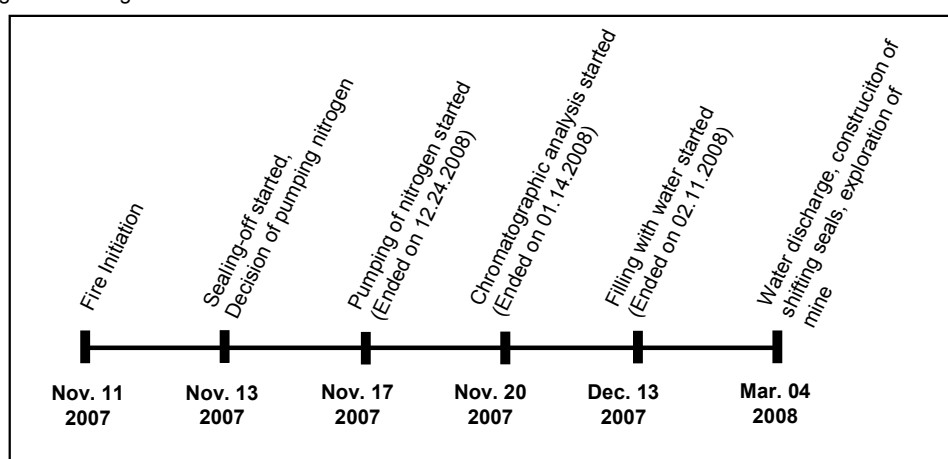
Figure 2 - Timeline of events in Gelik mine fire

While these events had been taking place the second team working at No.41303 drift (-260) was advancing up to the place where there was once a transformer station, 20 m away from No.41307 drift (-260). However, there was also a roof collapse in this area. Due to intense smoke and CO concentration, up to 2,000 ppm it became impossible to advance further, and a decision was made to pull out of the drift at 06:00 on 13th November, 2007 and seal the mine. The timeline showing the dates of the actions during the fire is presented in Figure 2.

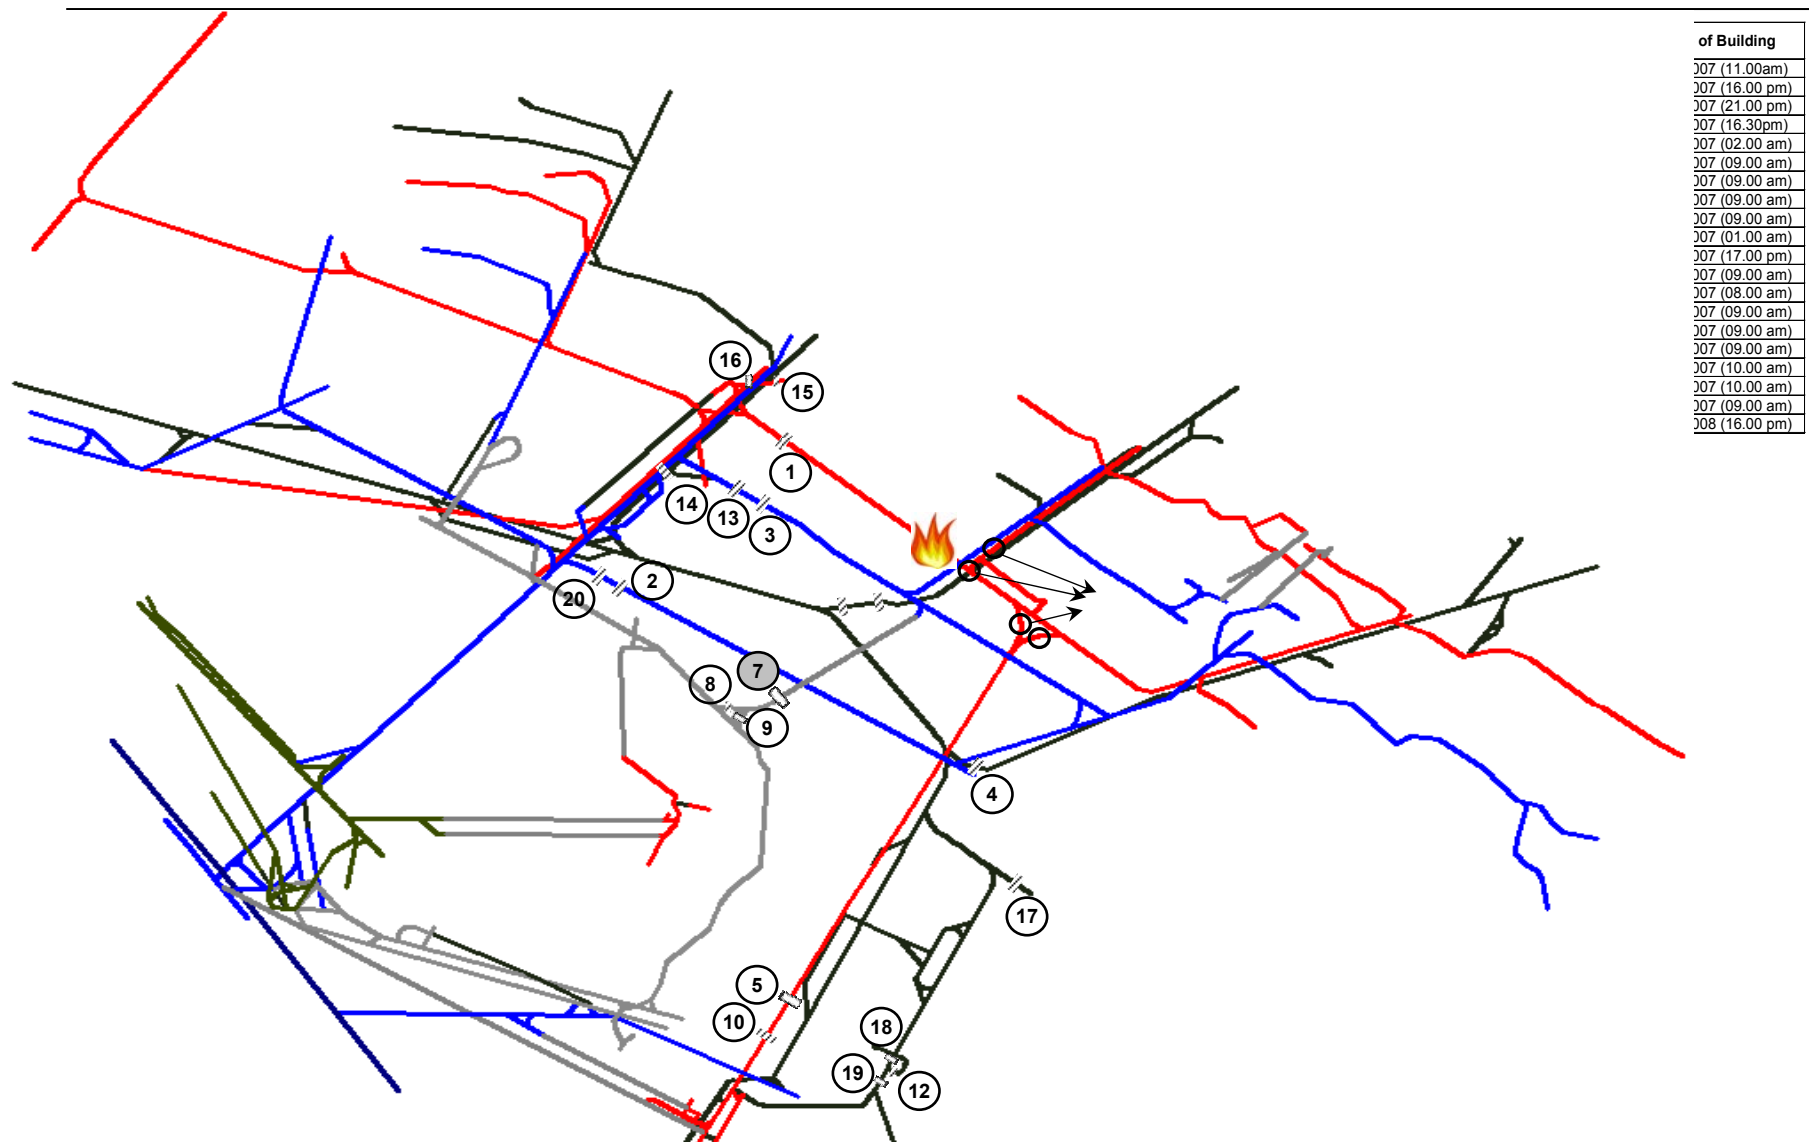
Figure 3 - Mine plan showing the location of the seals

The decision was made to erect the first seal at No. 41300 drift (-260) at approximately 11.00 am on Tuesday, 13th November, 2007. A further 19 seals were erected during the period to 05th January, 2008. The location and the details of the 20 seals are illustrated in Figure 3.

The mine management held a meeting to discuss the fire situation on 13th December, 2007. Although 16 seals had been constructed (3 in -55, 4 in -150, 5 in -260 and 4 in -360 levels, as shown in Figure 3) gas samples taken from the mine since 20th November, 2007 indicated that oxygen concentration were not decreasing (CO: 34ppm, CH₄: 4.3%, CO₂: 2.36%, O₂: 12.62), prompting the mine management to conclude the possibility of air leakage to the fire area. Air leakage was thought to have come from a number of old and abandoned workings close to the fire zone, and affected most of the -55, -160, -260 and -360 levels. Therefore, the mine management decided to fill the mine with water to prevent fresh air entrance to the mine and thus extinguish the fire.

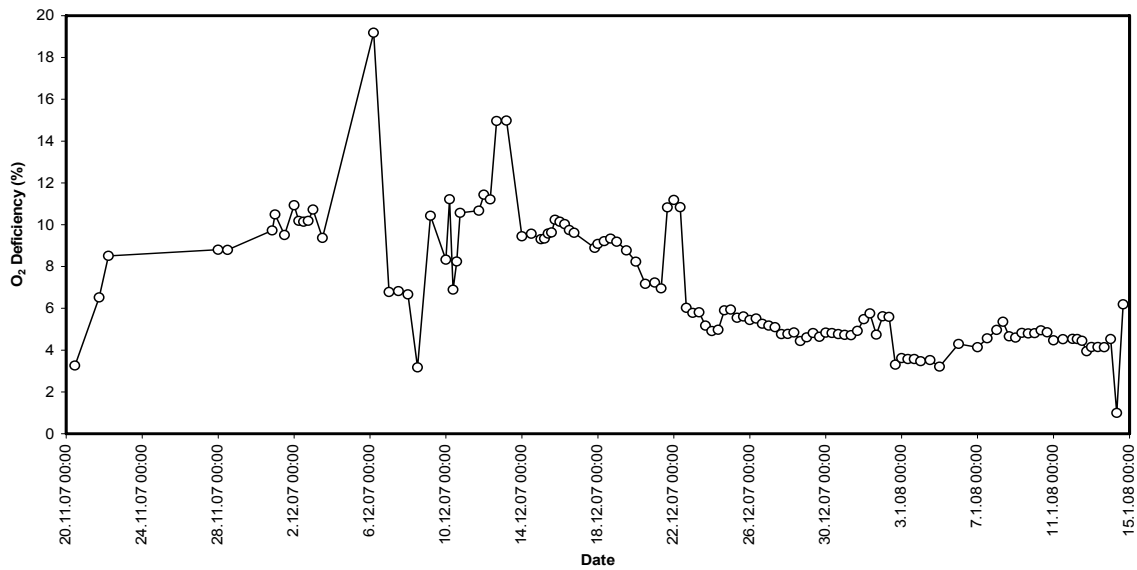
Figure 5 - The variation in O₂ deficiency values for Gelik mine fire incident

Figure 5 and 6 presents the graphical illustration of the variation in O₂ deficiency and Graham's ratio for Gelik mine fire.

Although there was some observed decrease at the beginning of the fire, the oxygen concentration showed an increase in general. It can be considered that the precautions taken to combat the fire were effective at early stages, thus causing a decrease in the oxygen concentration but since there was air leakage into the fire zone it was not possible to reduce the oxygen concentration below 15-16%. It is considered that the air leakage is the result of either unfavourable geological conditions (faults, cracks etc.) or workings of adjacent private mines.
