# Assessment of an Underground Coal Mine Fire: A Case Study From Zonguldak, Turkey

# ASSESSMENT OF AN UNDERGROUND COAL MINE FIRE: A CASE STUDY FROM ZONGULDAK, TURKEY

Alaaddin Cakir<sup>1</sup> and Kemal Baris<sup>1</sup>

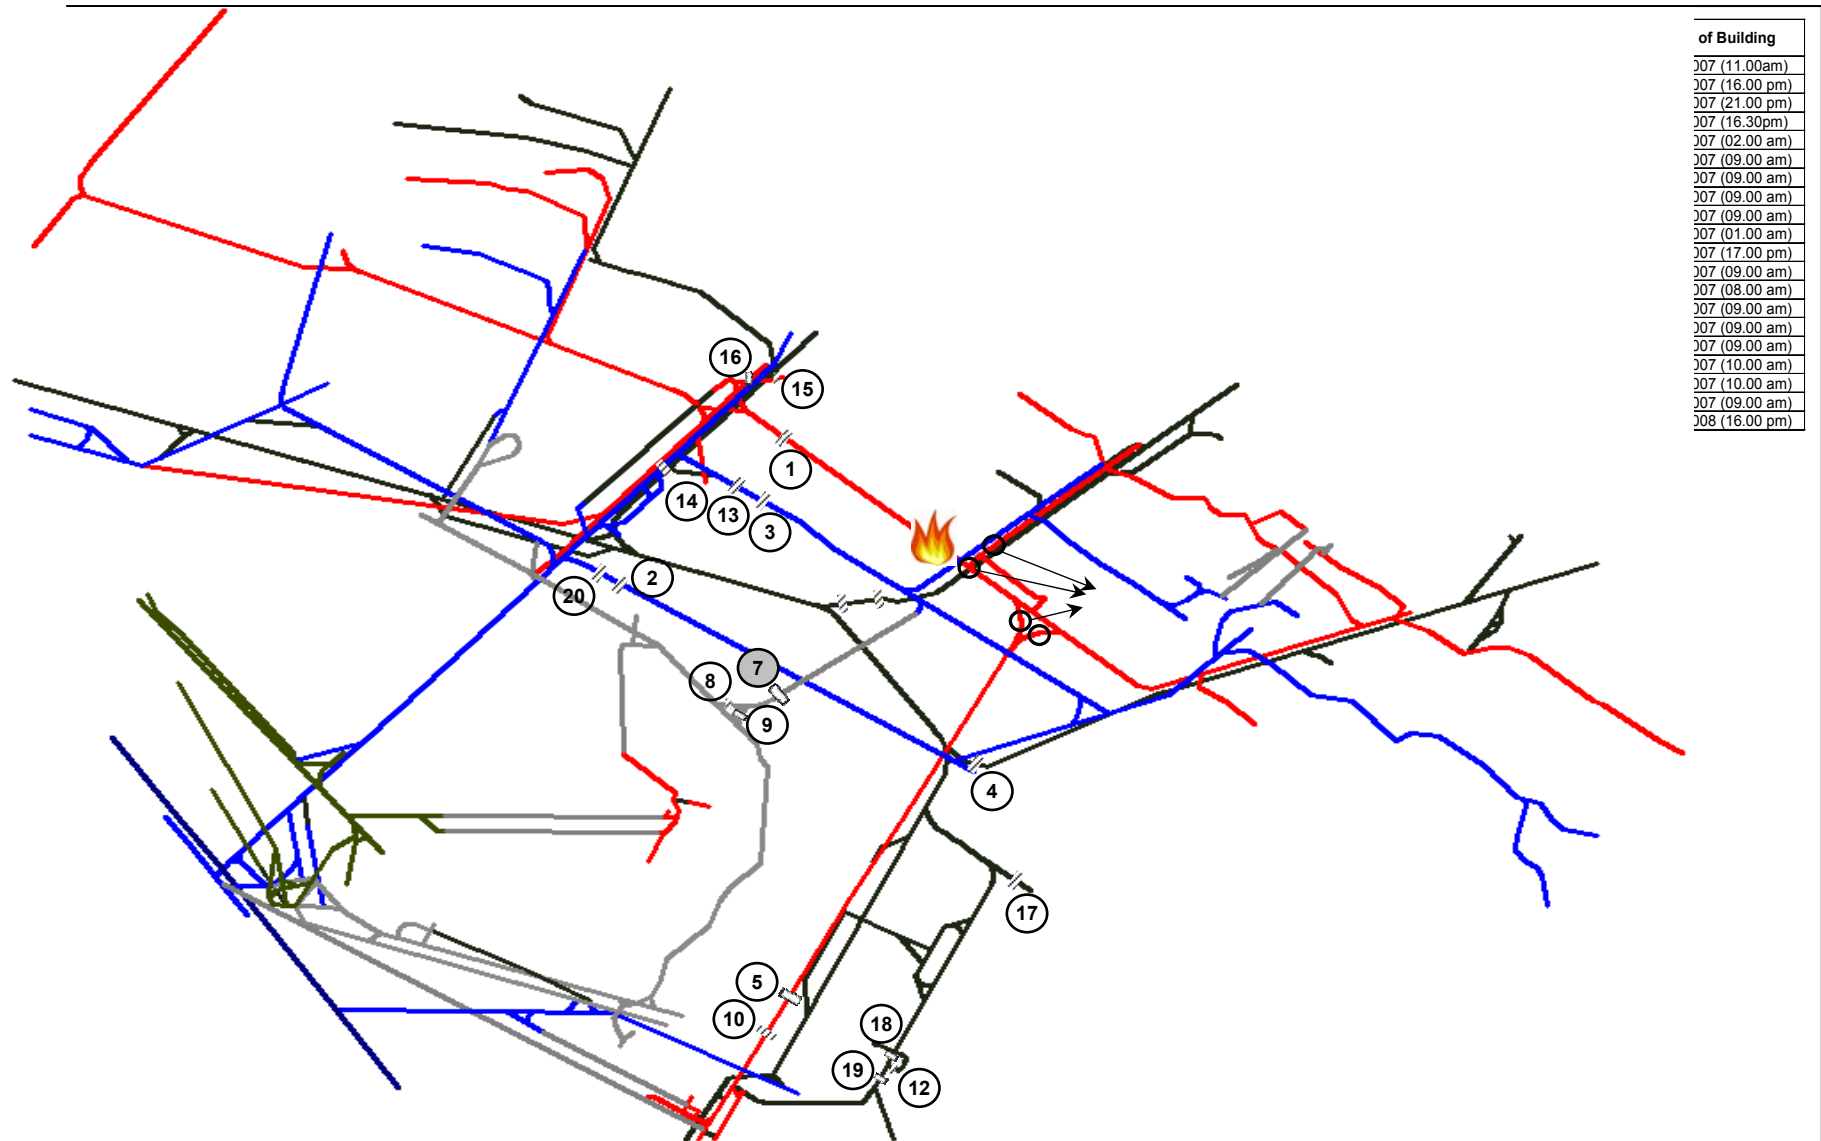
Figure 3 - Mine plan showing the location of the seals

The decision was made to erect the first seal at No. 41300 drift (-260) at approximately 11.00 am on Tuesday, 13<sup>th</sup> November, 2007. A further 19 seals were erected during the period to 05<sup>th</sup> January, 2008. The location and the details of the 20 seals are illustrated in Figure 3.

The mine management held a meeting to discuss the fire situation on 13<sup>th</sup> December, 2007. Although 16 seals had been constructed (3 in -55, 4 in -150, 5 in -260 and 4 in -360 levels, as shown in Figure 3) gas samples taken from the mine since 20<sup>th</sup> November, 2007 indicated that oxygen concentration were not decreasing (CO: 34ppm, CH<sub>4</sub>: 4.3%, CO<sub>2</sub>: 2.36%, O<sub>2</sub>: 12.62), prompting the mine management to conclude the possibility of air leakage to the fire area. Air leakage was thought to have come from a number of old and abandoned workings close to the fire zone, and affected most of the -55, -160, -260 and -360 levels. Therefore, the mine management decided to fill the mine with water to prevent fresh air entrance to the mine and thus extinguish the fire.

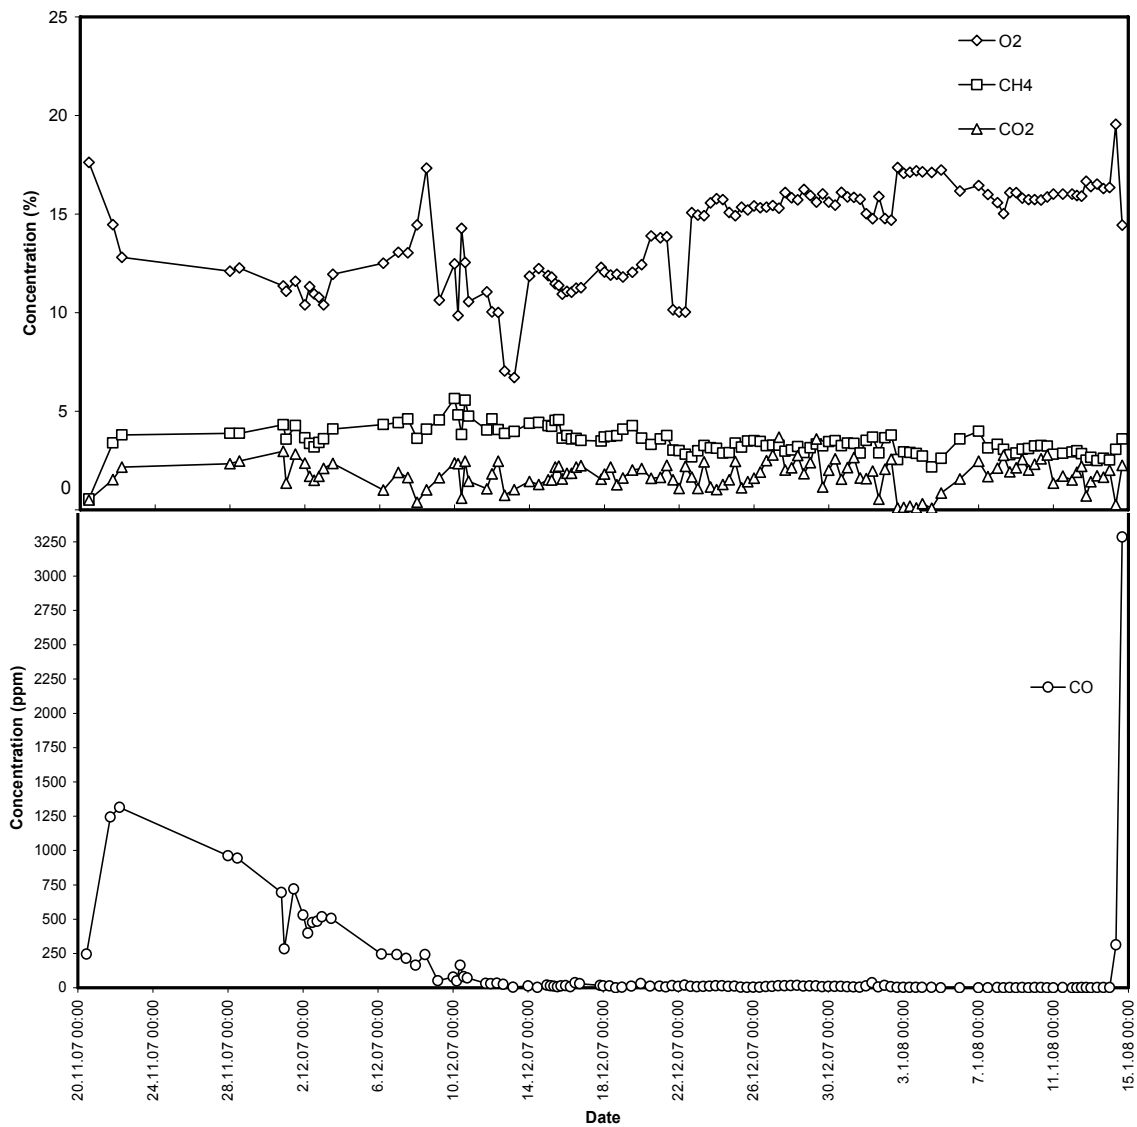
Figure 4b - Variation in the concentrations of CO, CO<sub>2</sub>, O<sub>2</sub> and CH<sub>4</sub>

In the Gelik mine case, CO concentration at the beginning of the fire was measured as 1,250 ppm and decreased to normal levels (below 50 ppm for Turkish coal mines) after control actions (sealing-off, filling with water and pumping nitrogen) were implemented. However, CO concentration climbed to 3,250 ppm following the opening of the No.1 seal on drift No. 41300 (-260) in 1<sup>st</sup> January, 2008. As soon as the seal was opened the CO concentration started to increase dramatically and the area was resealed.

Although there was some observed decrease at the beginning of the fire, the oxygen concentration showed an increase in general. It can be considered that the precautions taken to combat the fire were effective at early stages, thus causing a decrease in the oxygen concentration but since there was air leakage into the fire zone it was not possible to reduce the oxygen concentration below 15-16%. It is considered that the air leakage is the result of either unfavourable geological conditions (faults, cracks etc.) or workings of adjacent private mines.

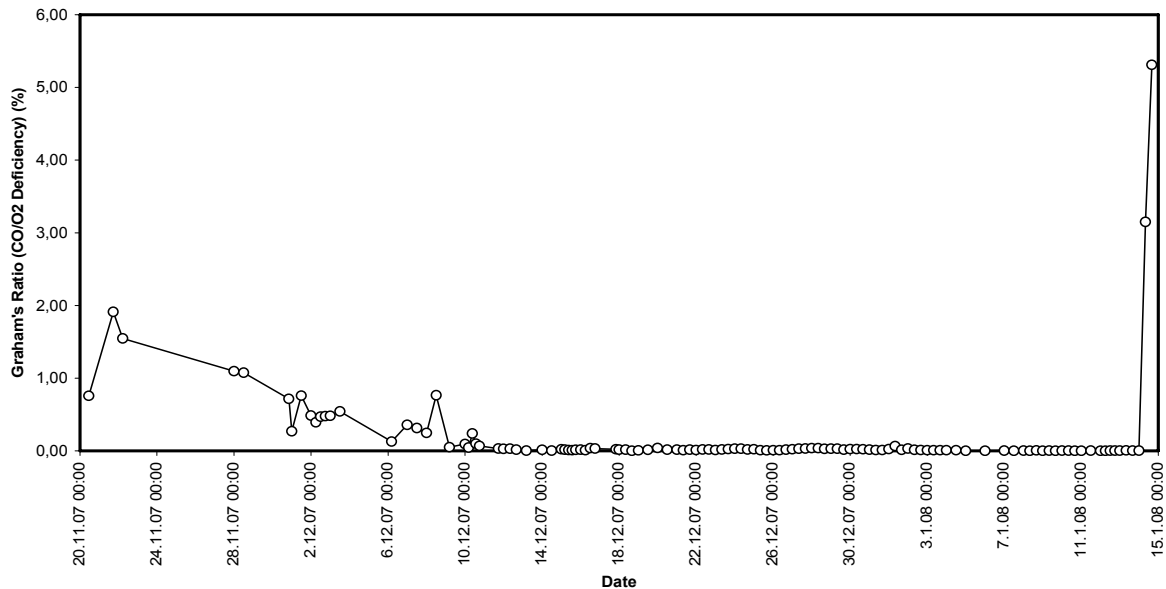
Figure 6 - The variation in Graham's ratio for Gelik mine fire

A sharp increase (from normal value to two) in Graham's ratio implied that there was an advanced heating which may turn into an extensive fire. After sealing, filling the fire zone with water and pumping nitrogen Graham's ratio reduced to its normal value indicating heating had cooled down. Nevertheless, after No.1 seal on drift No. 41300 (-260) was opened, there occurred a dramatic increase in Graham's ratio since CO concentration reached to 3,200 ppm on 14<sup>th</sup> January, 2008.

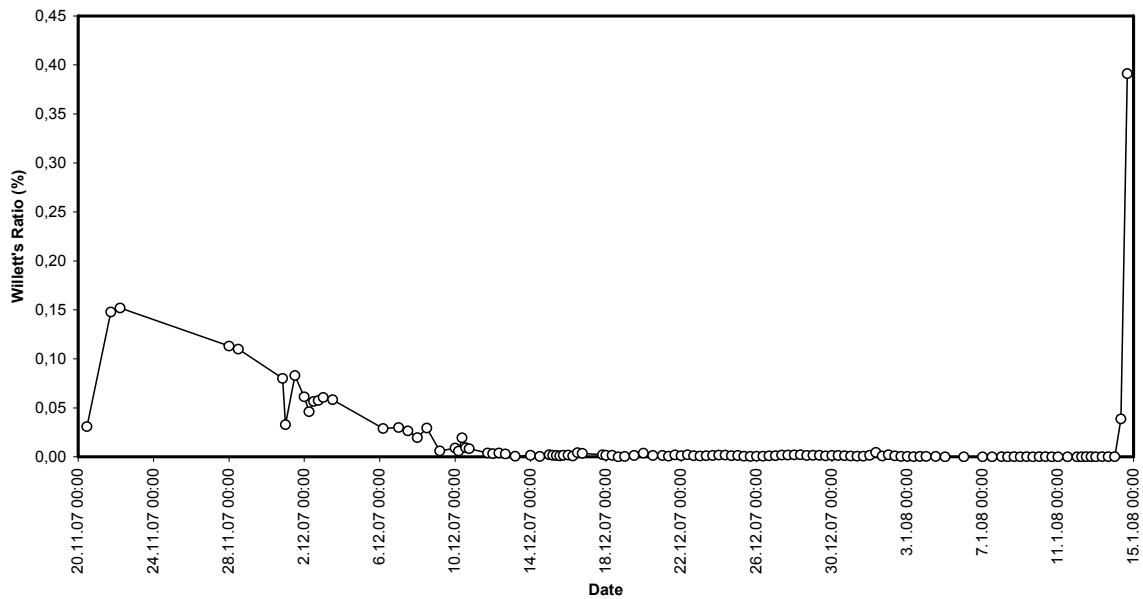
Figure 7 - Variation in Willett's ratio for Gelik mine fire

Willet's ratio followed the same trend as Graham's index showing an increase at the beginning and then reducing, implying that the fire was extinguished but then increasing sharply on 14<sup>th</sup> January, 2008, as result of the sharp increase in CO concentration.

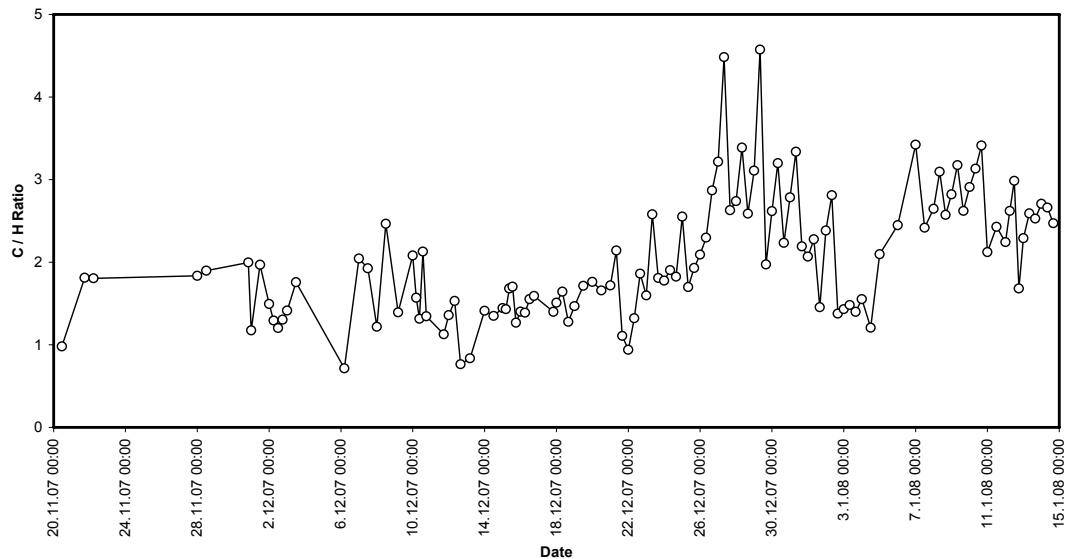
Figure 8 - The variation in C/H ratio for Gelik mine fire

While the indicators above implied that the fire seemed to be extinguished, the C/H ratio value approaching five suggested that there was possibly a localised, superficial fire behind the seals. This was proved after measuring high CO concentrations as soon as the seal was opened.

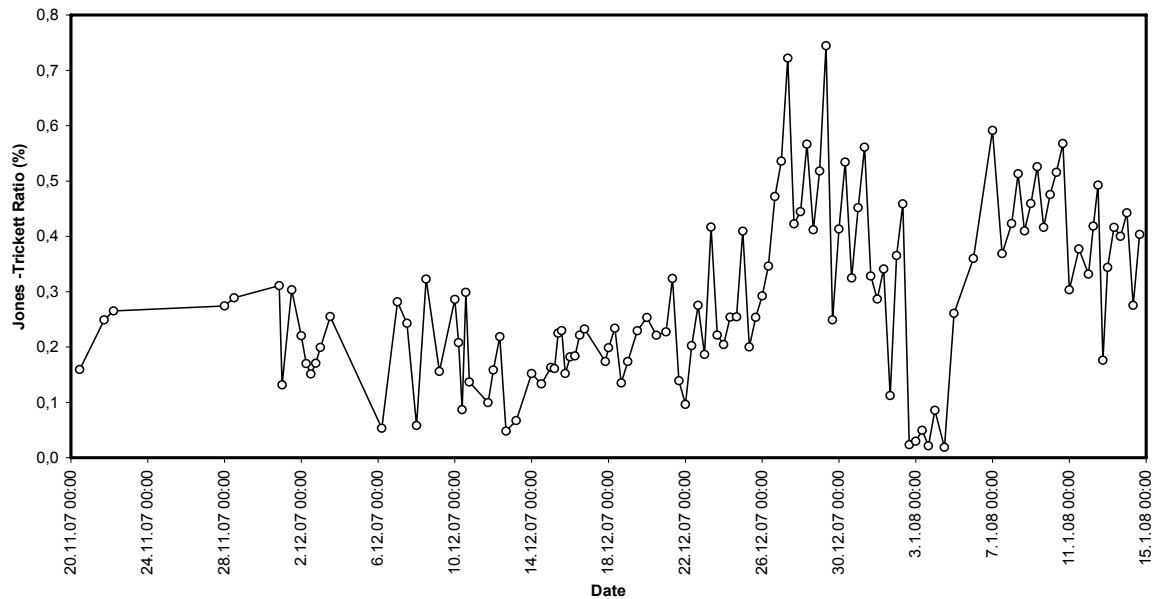
**Figure 9 - The variation in Jones-Trickett ratio during Gelik mine fire**

The Jones-Trickett ratio suggested that no combustion existed until the date 23<sup>rd</sup> December, 2007 when the ratio had a value of 0.42. After that time the ratio increased, ranging between 0.5 and 0.9, indicating there was a fire in which coal, oil, conveyor belts and insulation were the fuel. This suggestion proved to be true after a subsequent mine inspection confirmed that coal, conveyor belts and cables had burned.
