Assessment of an Underground Coal Mine Fire: A Case Study From Zonguldak, Turkey

ASSESSMENT OF AN UNDERGROUND COAL MINE FIRE: A CASE STUDY FROM ZONGULDAK, TURKEY

Alaaddin Cakir¹ and Kemal Baris¹

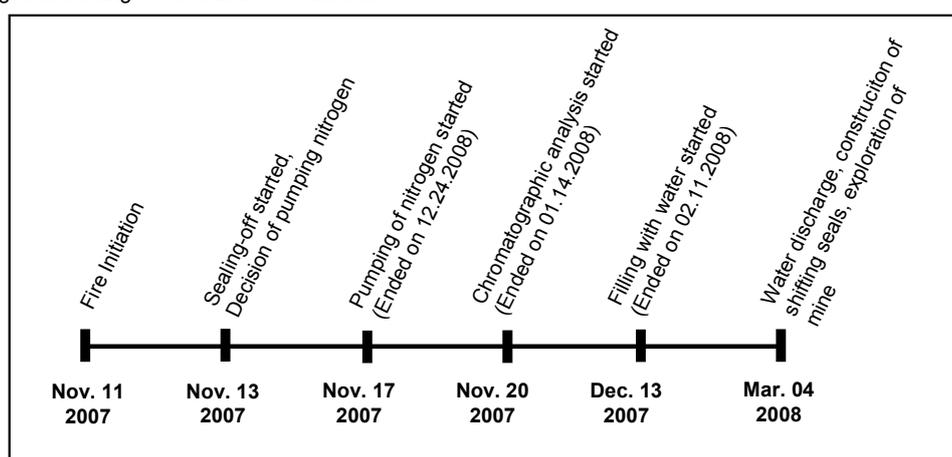
Figure 2 - Timeline of events in Gelik mine fire

While these events had been taking place the second team working at No.41303 drift (-260) was advancing up to the place where there was once a transformer station, 20 m away from No.41307 drift (-260). However, there was also a roof collapse in this area. Due to intense smoke and CO concentration, up to 2,000 ppm it became impossible to advance further, and a decision was made to pull out of the drift at 06:00 on 13th November, 2007 and seal the mine. The timeline showing the dates of the actions during the fire is presented in Figure 2.

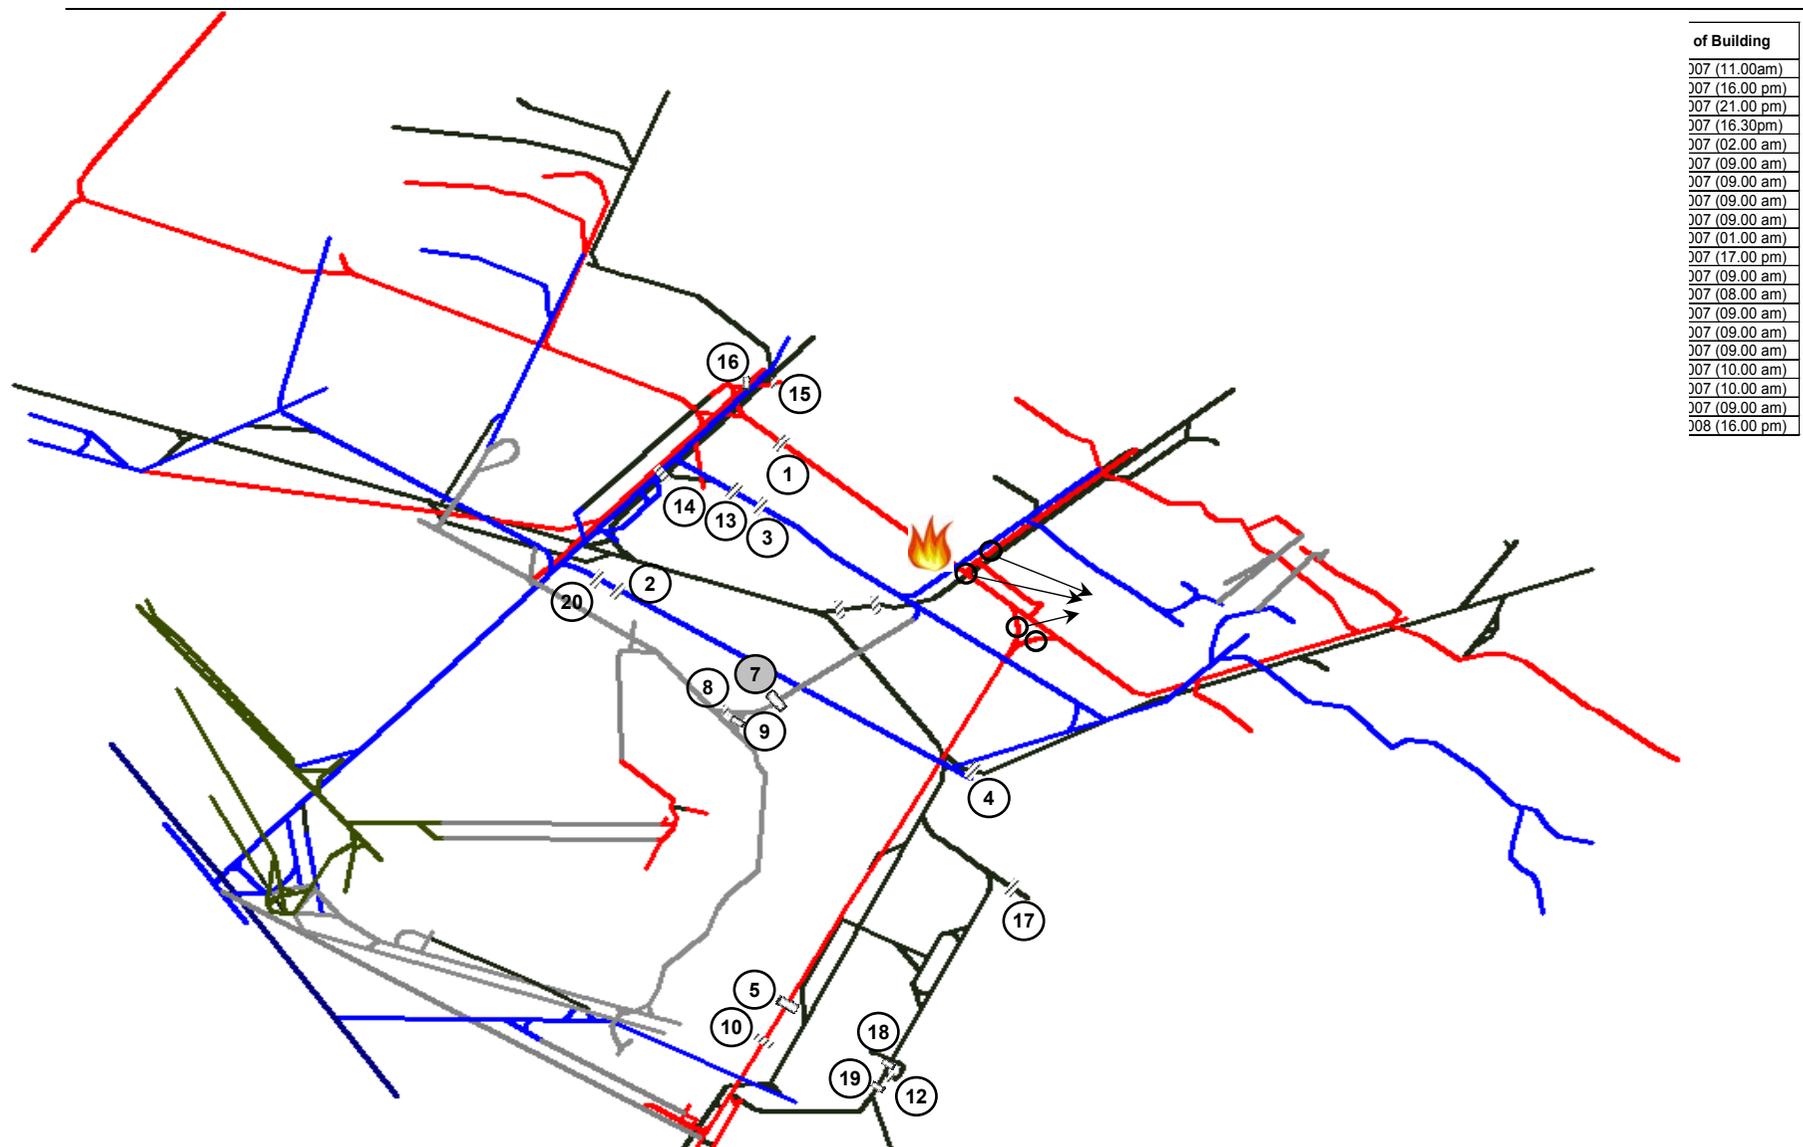
Figure 3 - Mine plan showing the location of the seals

The decision was made to erect the first seal at No. 41300 drift (-260) at approximately 11.00 am on Tuesday, 13th November, 2007. A further 19 seals were erected during the period to 05th January, 2008. The location and the details of the 20 seals are illustrated in Figure 3.

The mine management held a meeting to discuss the fire situation on 13th December, 2007. Although 16 seals had been constructed (3 in -55, 4 in -150, 5 in -260 and 4 in -360 levels, as shown in Figure 3) gas samples taken from the mine since 20th November, 2007 indicated that oxygen concentration were not decreasing (CO: 34ppm, CH₄: 4.3%, CO₂: 2.36%, O₂: 12.62), prompting the mine management to conclude the possibility of air leakage to the fire area. Air leakage was thought to have come from a number of old and abandoned workings close to the fire zone, and affected most of the -55, -160, -260 and -360 levels. Therefore, the mine management decided to fill the mine with water to prevent fresh air entrance to the mine and thus extinguish the fire.

- There had been two large roof falls in the junction of No.41300, No.41303 and No.41307 drifts. One of them was at the cut-through which connected No.41300 and No.41303 drifts and the other was between No.41300 and No.41307 drifts.
- There were two more collapses, with one at the junction connecting No.41300 and No.41306 drifts and the other 20 m Northeast of No.41306 drift entry.
- The fire had taken place in the region around 20m northwest, 200m northeast and 200m southeast of No.41306 drift. All timber supports, conveyor belts and cables were burnt out.
- No fire indication was observed in roadways connecting No.41303 drift to No.41300 and No.41307 drifts.

The water filling operation commenced at 20.00 on 13th December, 2007 from the No.1 seal constructed on No.41300 drift (-260) by a 100mm-diameter pipe and No.10 seal constructed on No.41303 drift (-260) by a 50 mm-diameter pipe. The piped water was provided by pumps from the water pools located on the on-setting station which was 220m away from No.1 seal and on the bottom of No.41222 (-150/-260) incline.

No. 20 and No.2 seals were opened and these places were ventilated on 7th March, 2008. No. 2 shifting seal was constructed on No.41230 drift and closed. Finally, on 9th March, 2008, No.10 and No.5 seals and on 10th March, 2008 No.1 seal were opened and ventilated.

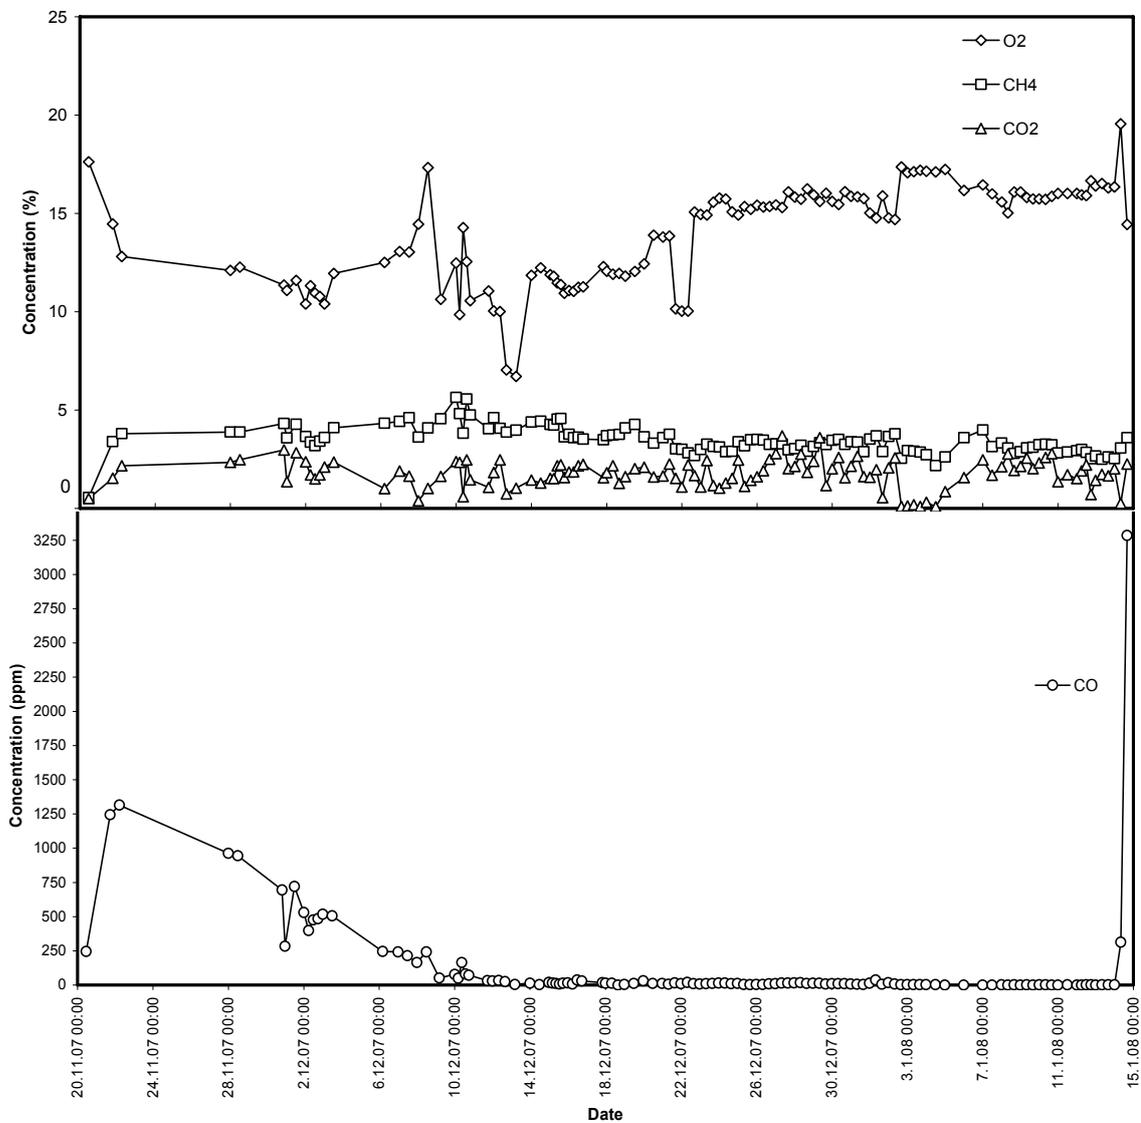
Figure 4b - Variation in the concentrations of CO, CO₂, O₂ and CH₄

Mine atmosphere was continuously monitored during the fire. The first gas samples were taken on 20th November, 2007 from No.7 seal which was the only seal where sampling was possible at that time. Gas sampling continued for 55 days until 14th January, 2008. During this period a total of 435 samples were taken. 118 samples were analysed by gas chromatograph at the Department of Safety and Education of TTK. The rest of the samples were roughly analysed in the laboratories of Gelik Mine. All data obtained from the gas chromatograph analysis were taken into account to validate the scientific approach. Figure 4 shows the trend in the concentrations of CO, CO₂, CH₄ and O₂ during the incident.

In the Gelik mine case, CO concentration at the beginning of the fire was measured as 1,250 ppm and decreased to normal levels (below 50 ppm for Turkish coal mines) after control actions (sealing-off, filling with water and pumping nitrogen) were implemented. However, CO concentration climbed to 3,250 ppm following the opening of the No.1 seal on drift No. 41300 (-260) in 1st January, 2008. As soon as the seal was opened the CO concentration started to increase dramatically and the area was resealed.

Although there was some observed decrease at the beginning of the fire, the oxygen concentration showed an increase in general. It can be considered that the precautions taken to combat the fire were effective at early stages, thus causing a decrease in the oxygen concentration but since there was air leakage into the fire zone it was not possible to reduce the oxygen concentration below 15-16%. It is considered that the air leakage is the result of either unfavourable geological conditions (faults, cracks etc.) or workings of adjacent private mines.

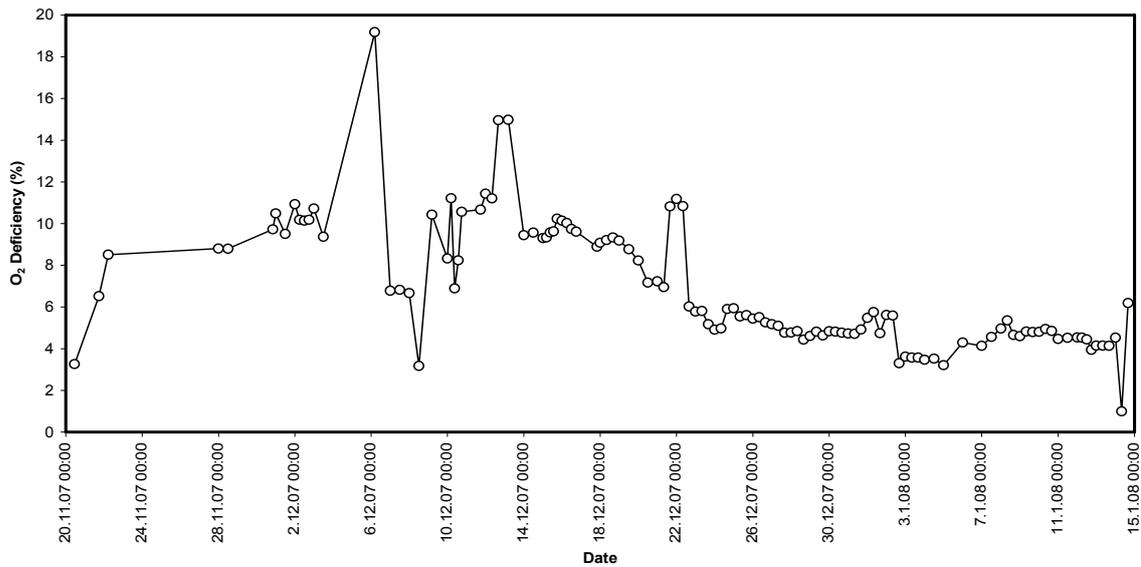
Figure 5 - The variation in O₂ deficiency values for Gelik mine fire incident

The flaming combustion in a fire is expected to cease when the oxygen concentration is below 12.4%. However, fire can be sustained for a long time even at 1-2% oxygen in the atmosphere. Successful extinguishing of a mine fire can occur if no re-ignition occurs with the introduction of sufficient amount of oxygen to fire zone. However, in most cases as in this present case study, it was extremely difficult to get an accurate oxygen consumption rate since there was some air leakage into the sealed area.

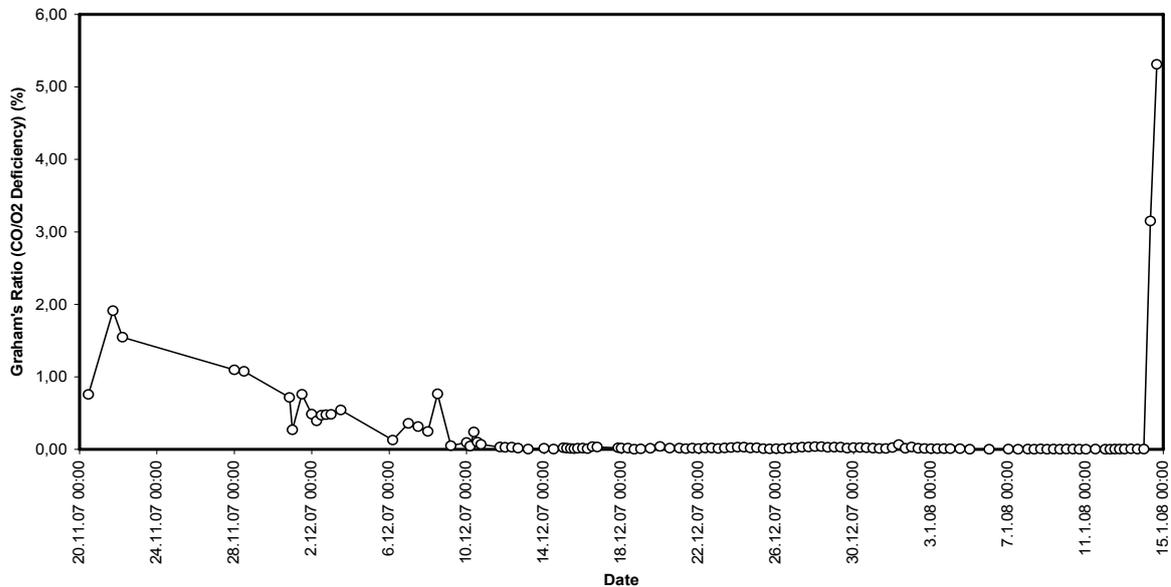
Figure 6 - The variation in Graham's ratio for Gelik mine fire

A sharp increase (from normal value to two) in Graham's ratio implied that there was an advanced heating which may turn into an extensive fire. After sealing, filling the fire zone with water and pumping nitrogen Graham's ratio reduced to its normal value indicating heating had cooled down. Nevertheless, after No.1 seal on drift No. 41300 (-260) was opened, there occurred a dramatic increase in Graham's ratio since CO concentration reached to 3,200 ppm on 14th January, 2008.

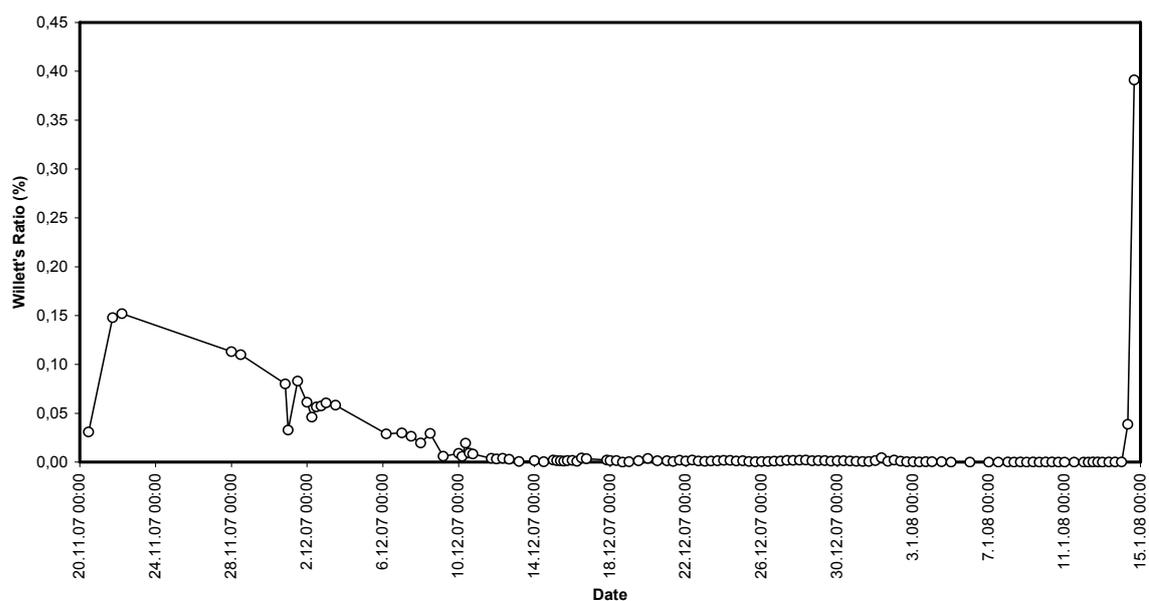
Figure 7 - Variation in Willett's ratio for Gelik mine fire

Willet's ratio followed the same trend as Graham's index showing an increase at the beginning and then reducing, implying that the fire was extinguished but then increasing sharply on 14th January, 2008, as result of the sharp increase in CO concentration.

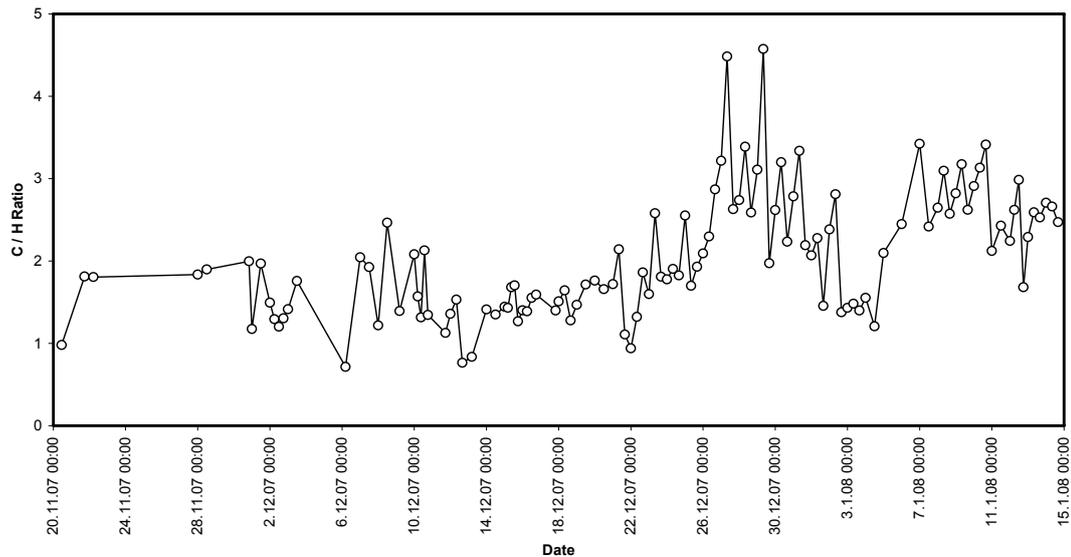
Figure 8 - The variation in C/H ratio for Gelik mine fire

While the indicators above implied that the fire seemed to be extinguished, the C/H ratio value approaching five suggested that there was possibly a localised, superficial fire behind the seals. This was proved after measuring high CO concentrations as soon as the seal was opened.

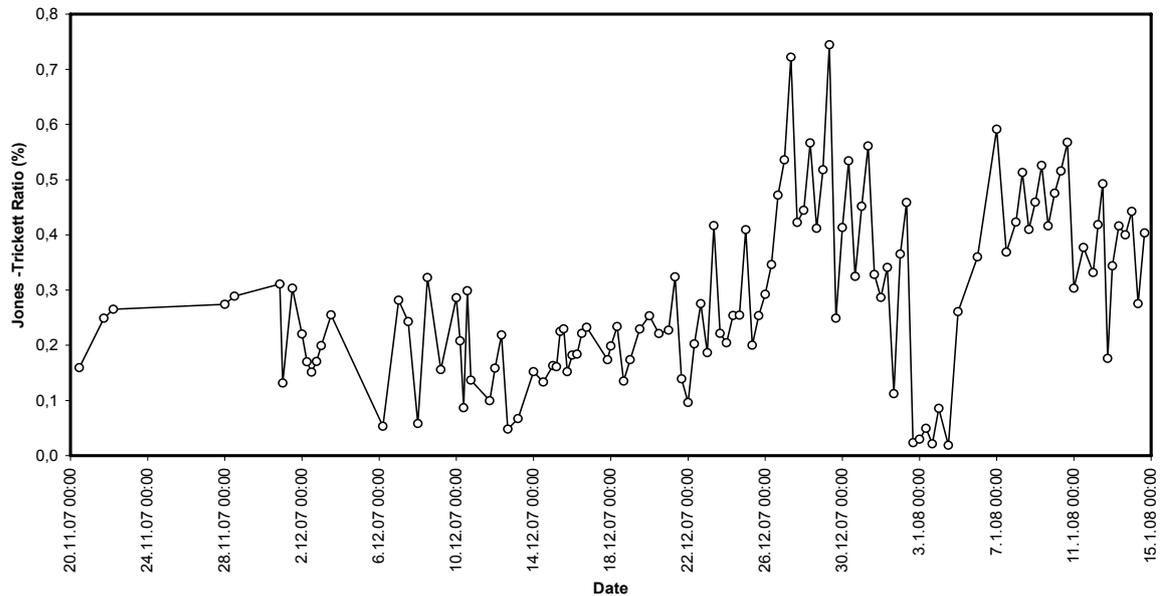
Figure 9 - The variation in Jones-Trickett ratio during Gelik mine fire

The Jones-Trickett ratio suggested that no combustion existed until the date 23rd December, 2007 when the ratio had a value of 0.42. After that time the ratio increased, ranging between 0.5 and 0.9, indicating there was a fire in which coal, oil, conveyor belts and insulation were the fuel. This suggestion proved to be true after a subsequent mine inspection confirmed that coal, conveyor belts and cables had burned.
