## Investigations Aimed to Improve Tailgate Serviceability at Dartbrook Mine

# INVESTIGATIONS AIMED TO IMPROVE TAILGATE SERVICEABILITY AT DARTBROOK MINE

*ABSTRACT:* Dartbrook Mine has experienced rib control difficulties because of deterioration in the tailgate corner of the longwall face as overburden depth has increased. This paper summarises an investigation to optimise support and develop strategies to improve the serviceability of the tailgate roadways.

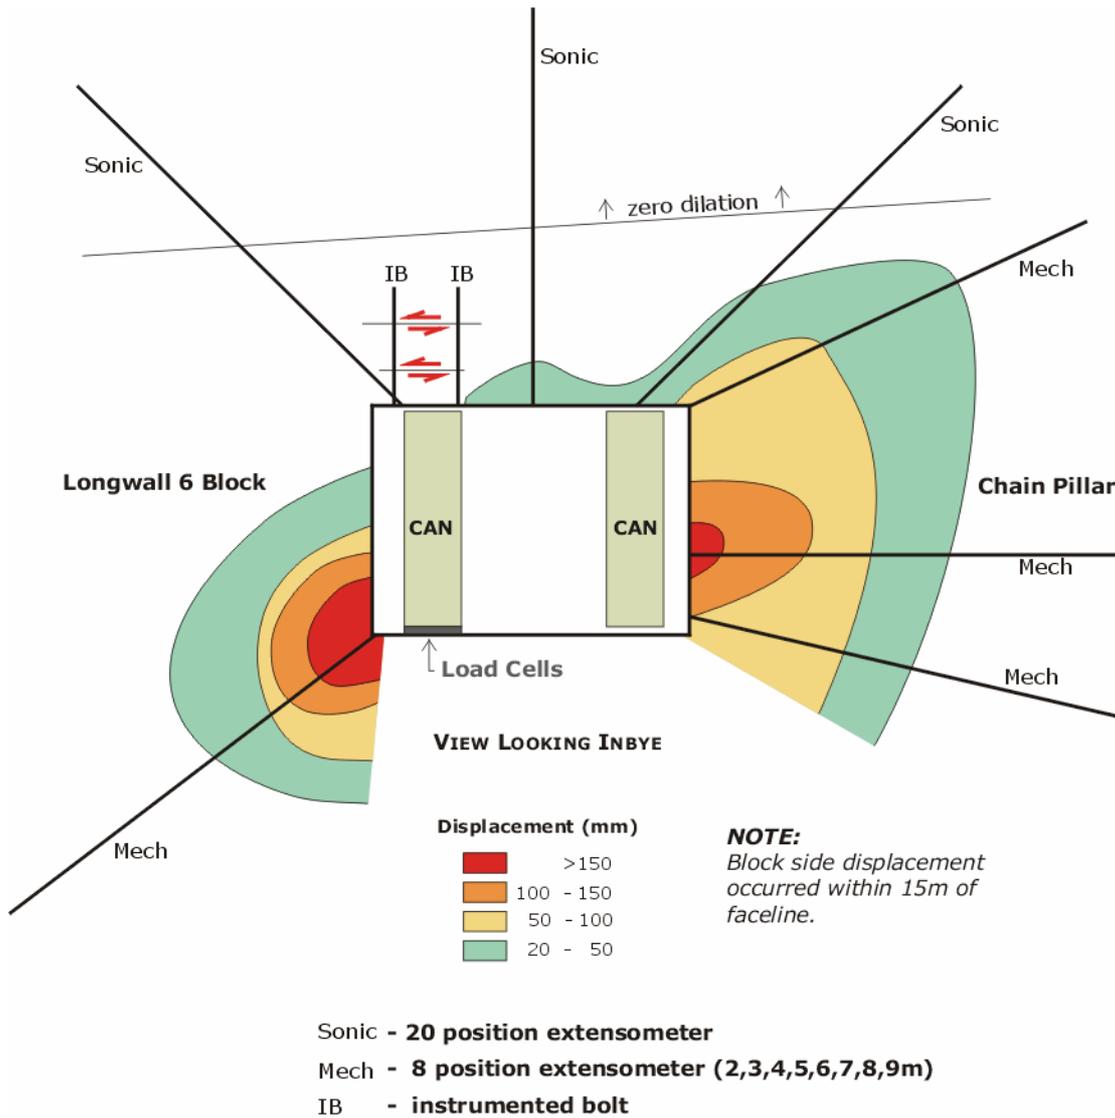
**Figure 1** Displacement summary and layout of instrumentation Longwall 6 tailgate, inbye 10 C/T.

The deformation characteristics of the monitoring sites are included in Fig. 1. Results are summarised as follows:

- Softening of the ribs both sides of the roadway (5.4m wide by 4.0m high) occurred to a depth of approximately 5m.
- The softening within the ribs extended into the floor on the block side and the roof on the chain pillar side.
- The intensity of the softening increased steadily from approximately 75m outbye the faceline and accelerated within 20m of the faceline.
- The roof and floor outside the area described above exhibited minimal deformation until within 20m of the faceline. Then the movement within this area was characterised by shear displacement along horizontal planes, essentially creating a shortening of the roof and floor heave.

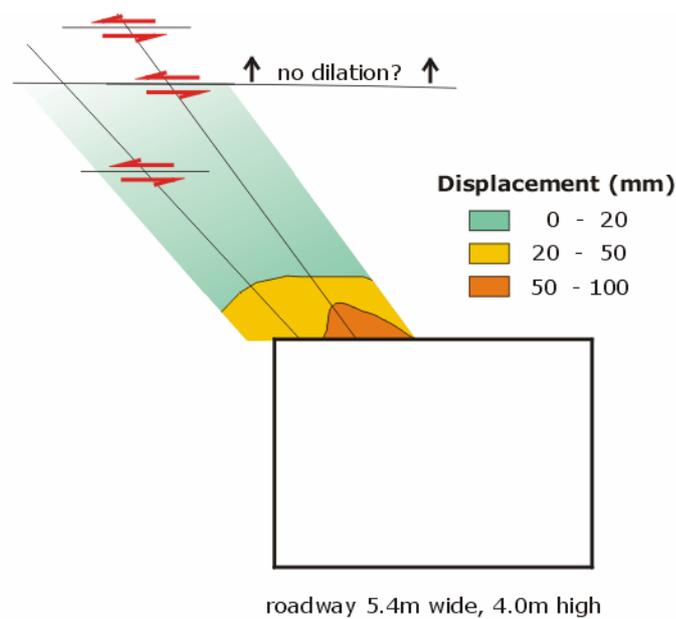
Results from the 5 Cut-through monitoring site are summarised in Figure 2. The location of and sense of shear displacement is apparent. A contour of displacement measured by the extensometers is also shown.

**Figure 2 Displacement summary - Longwall 6 tailgate, inbye 5 C/T.**

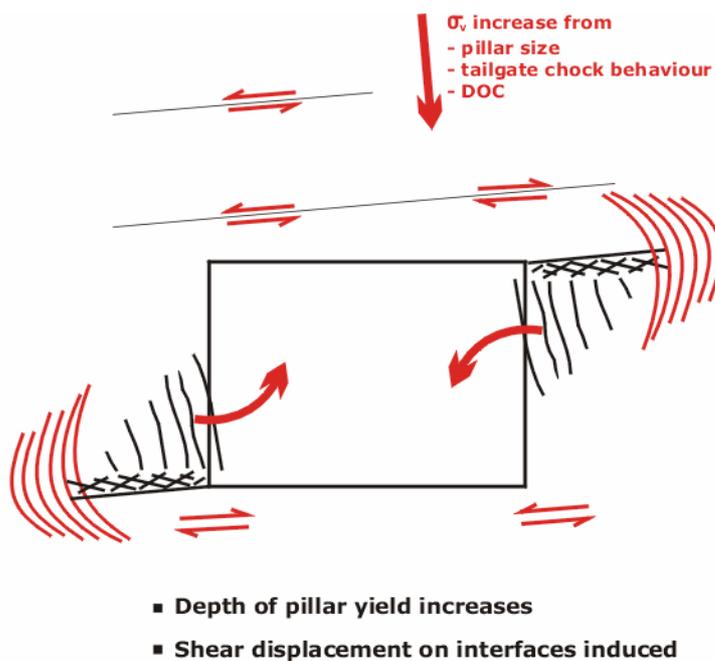
Deformation is characterised by intense shearing of the rib in the top right and lower left corners of the ribs looking inbye as shown in Fig. 3. The zone of intense shearing extends sub-horizontally into the rib for an estimated distance of up to 2m. Further rib spall associated with cleat produces a softened zone extending into the rib some 50% to 65% of the rib height. The lower right and upper left ribs looking inbye typically exhibit no visible signs of deterioration.

Figure 3(a) State of softening during longwall advance Longwall 6 tailgate (<75m from face).

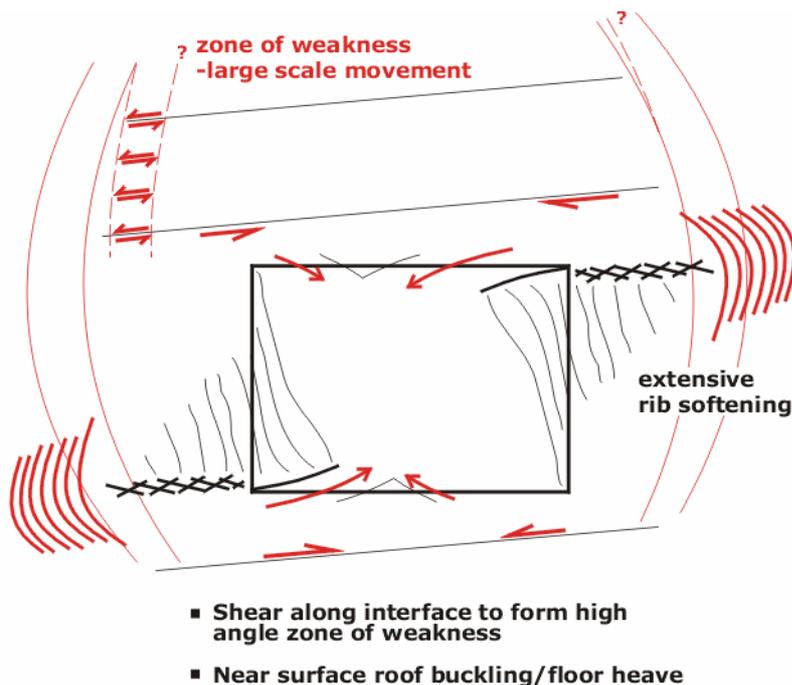
Figure 3(b) Late stage deformation (<20m from face).
