## **Strata Management at the Goonyella Exploration Adit Project**

## STRATA MANAGEMENT AT THE GOONYELLA EXPLORATION ADIT PROJECT

*ABSTRACT:* The Goonyella Exploration Adit is a three heading development into the highwall at Ramp 4 at Goonyella Riverside Mine that was driven between September 1999 and November 2000. The principal was BHP Billiton Mitsubishi Alliance (BMA) and the contractor was Allied Mining Australia. Strata management began at the pre-tender phase and evolved as greater knowledge of the ground became available.

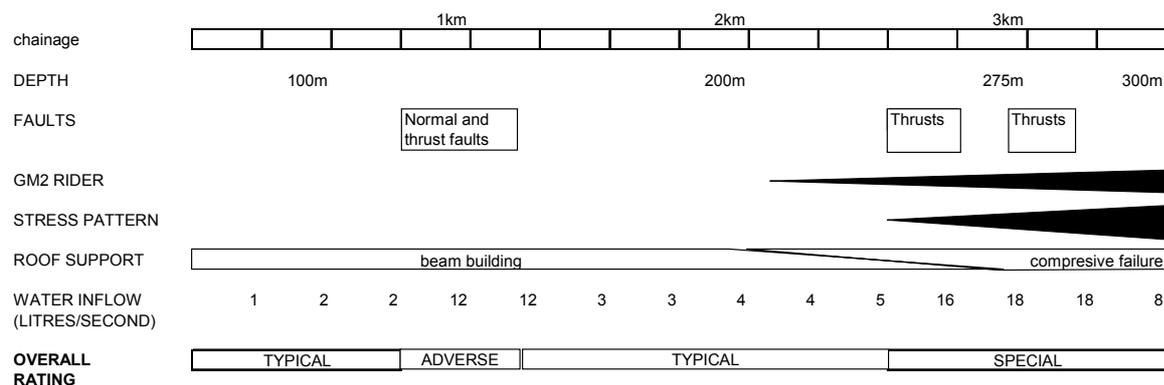
Special conditions were identified beyond chainage 2500m as a result of a combination of thrust zones, higher ground stresses related to the greater depth of cover, proximity of rider seams, higher water inflows and other factors. It was recognised that there could be undetected faults at any depth that would be classified as special ground.

Fig. 1 Zonation of the adit at tender stage

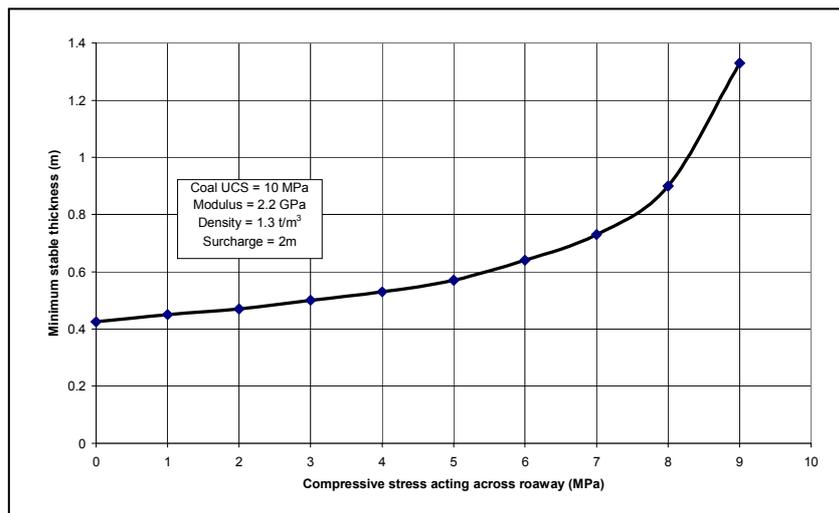
The top ply is highly banded and experience shows that it is not self-supporting. Ply 2 is a massive coal band and calculations suggested that so long as 0.4m to 0.5m was left uncut it could span across a 5.5m roadway (Figure 2). If such a unit could be formed then an extended cut could be taken and hence allow cut and flit mining. The 1.5m roof coal criterion at Moranbah North was interpreted to be the composite of the 1m Ply 1 acting as a surcharge on a 0.5m structural beam of massive Ply 2 coal.

Fig 2 Analysis of a coal beam

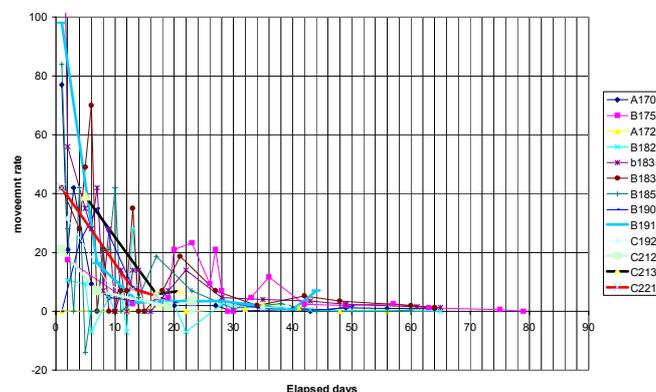
**Fig.3 Examples of tell-tale measurements - movements in mm/week**

The coal beam analysis gave an allowable movement of 10mm and in unstructured areas this was never exceeded. In the more structured areas, additional movement was recorded and in most cases this reduced to very low rates within ten days (Fig. 3).

In faulted ground, pretensioned cables were used with a design based on dead weight suspension. To achieve design load, it was calculated that the cables would stretch an additional 20mm after installation, so a threshold was set of 10mm for management review, and 20mm for remedial action.

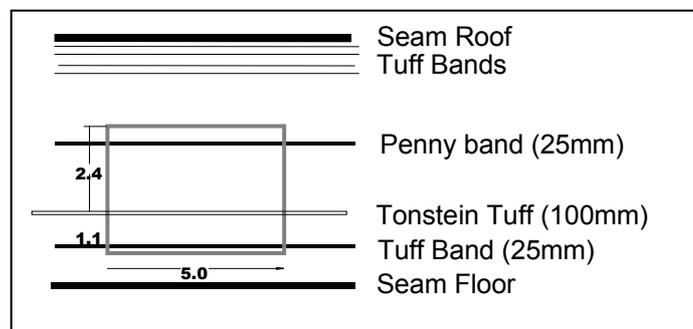
Typical ground was defined as that part of the driveage having a massive immediate coal roof. To achieve this, horizon control was essential and it was instilled into the work force. They all carried the simple diagram shown in Fig. 4 which was an idea copied from Moranbah North. Since Ply 2 is about 2m thick and only 0.5m had to be left, normal faults with throws of up to 1.0m to 1.5m could be traversed (so long as the fault plane itself was supported).

**Fig. 4 Horizon control for typical ground**

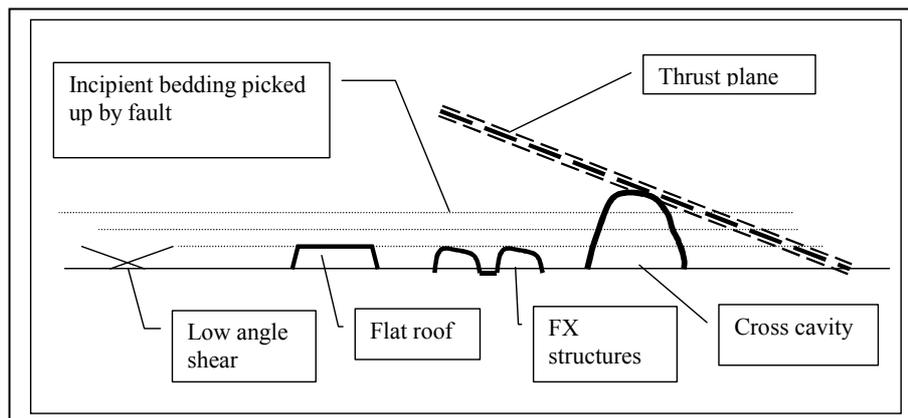
Back analyses of the roof conditions as the thrust faults were approached from the footwall (downthrown) side allowed the formulation of a predictive model for the proximity to such faults (Fig. 5). The shallow, flat-topped roof falls began about 20m - 30m prior to the thrust plane being intersected. This model successfully identified all subsequent thrust faults and complemented the surface exploration: 3 D seismic survey were invaluable as a planning tool and was found to be accurate for faults greater than 3m, but less than 50% for smaller throws for which the observational model was essential.

**Fig. 5 Roof conditions on the footwall of thrust faults**

The roof support pattern was altered once any of these precursors were observed or when thrust faults predicted from the seismic exploration were approached. The major concern was that the development roadway did not intersect the fault plane before long tendon support had been installed. In such circumstances, experience had shown that a large roof fall could develop outbye.

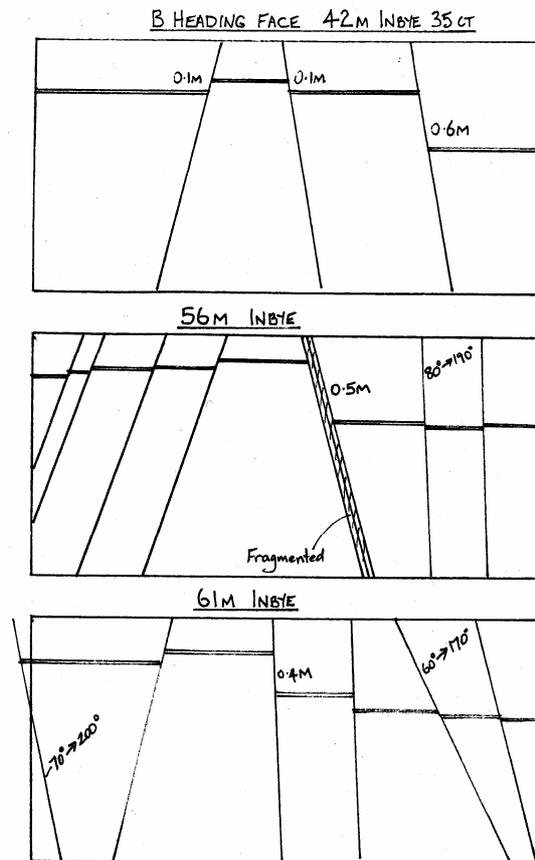
At around 21 c/t in A heading, and particularly in C heading inbye of 29 c/t, the driveage encountered what became referred to as 'trench roof'. This coincided with the presence of small-scale normal faults in a horst/graben configuration (Fig 6). The headings were sub-parallel to the strike of the horst/grabens.

Fig. 6 Face mapping of horst/grabens

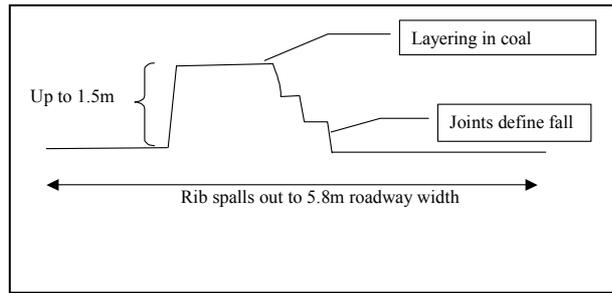
Fig. 7 Cartoon of the roof falls

Roof falls developed soon after the start of each plunge (Fig. 7). The falls involved the collapse of joint/fault-bounded blocks of coal from the roof. These blocks were often in the order of 300 mm to 500 mm wide and resulted in the formation of a trench in the roof. There was no rock noise associated with the falls. The longer the plunge, the higher were the roof falls – the maximum fall height recorded was about 1.5m and this happened when the plunge was extended to 5m. Trench roof was only recorded in the headings, not in the cutthroughs. The falls occur as joint-bound trenches over about half of the roadway. The fall zone migrated from the north rib to the south rib of each roadway and in this way migrated from A heading to C heading.

The mining strategy was to limit the plunges to 5m, and to support progressively with 2.1m bolts, mesh straps, and butterflies. Once supported, there was no further movement. To restrict the plunge to 5m and to bolt at 1m intervals with hand held bolters was an operational decision based on the significant increase in bolting time if the falls were allowed to extend higher as a result of the plunges being taken deeper. At the same time as C heading was experiencing trench roof, the conditions in both A and B heading allowed 15m plunges. This introduced a substantial imbalance in the panel advance.

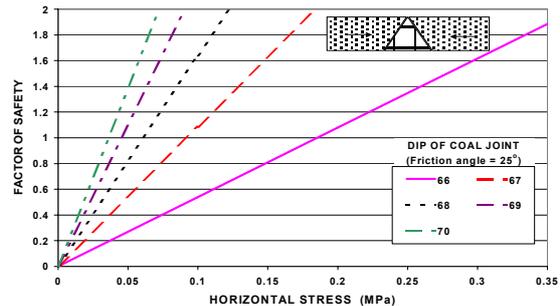
Fig. 8 Wedge analysis for coal roof with low horizontal stresses

The falls were interpreted as being the result of low horizontal stresses acting on wedges of coal defined by the horst grabens. The low horizontal stresses resulted from the interplay of the roadway shape with a low magnitude stress field where the major principal stress is vertical. Simple wedge analysis indicated that falls were likely for discontinuities dipping at between 70° and 65°, and inevitable for surfaces dipping at less than 65° (Figure 8). The height of the falls was controlled by the onset of a more compressive regime higher in the roof.

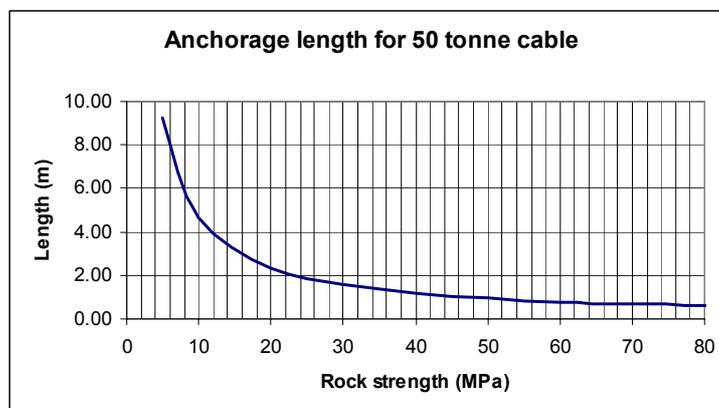
Fig. 9 Required anchorage length for cables

Monitoring identified some areas where the post-installation movement of cables exceeded the 10mm threshold. A review of the ground conditions identified that these areas were associated with low strength strata in the anchorage horizon. The distribution of overall stone roof strengths was known from sonic logs. A nomogram was developed relating anchorage length to rock strength using standard ground engineering concepts (Fig. 9). From this nomogram came the requirement for 10m long vertical cables to achieve adequate anchorage in some areas. In other areas, higher strength sandstones within the fall horizon could be exploited if angled cables were installed over the pillars.

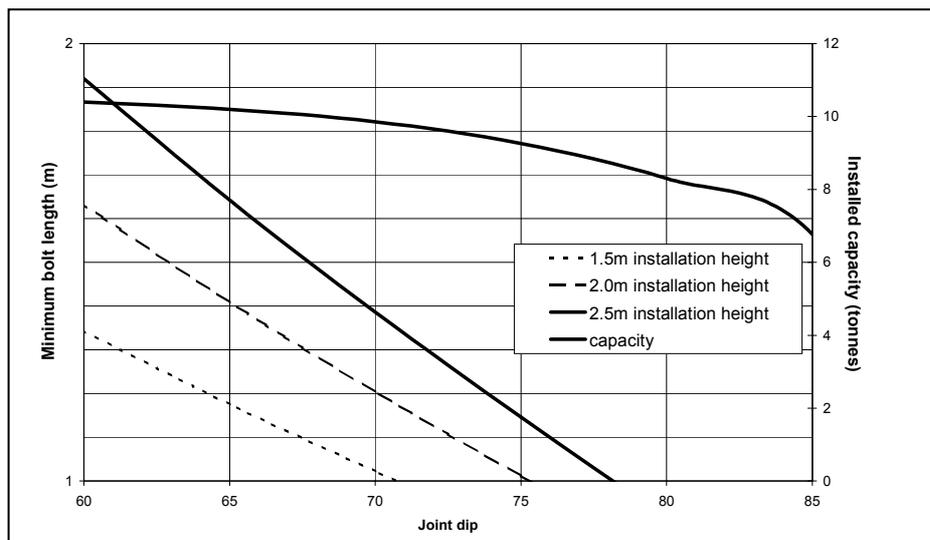
The high ribs required support in areas where the spacing of coal joints was less than about 300mm, and also in the horst/graben areas. The support design was based on the assumption of joint defined planar slides. The dip of the joint is an important control on the weight and dimensions of the failure block (Fig. 10). Ten tonne capacity rib bolts gave a factor of safety of two against the design blocks. Depending on the height of installation, bolt lengths of 1.2 to 1.5m were required to ensure anchorage beyond the joint plane.

Fig. 10 Rib bolt requirements

- ten tonne capacity (10 tonnes/metre of rib)
- spacing of 1m or less
- minimum 1.5m length
- installed at no more than 2.5m above the floor
- point-anchored, with plate, nominal tension.
