Appin Colliery explosion reassessed

Bob Kininmonth Retired Senior Inspector of Coal Mines

This conference paper was originally published as Kininmonth, B, Appin Colliery explosion reassessed, in Aziz, N (ed), 10th Underground Coal Operators' Conference, University of Wollongong & the Australasian Institute of Mining and Metallurgy, 2010, 299-311.

APPIN COLLIERY EXPLOSION REASSESSED

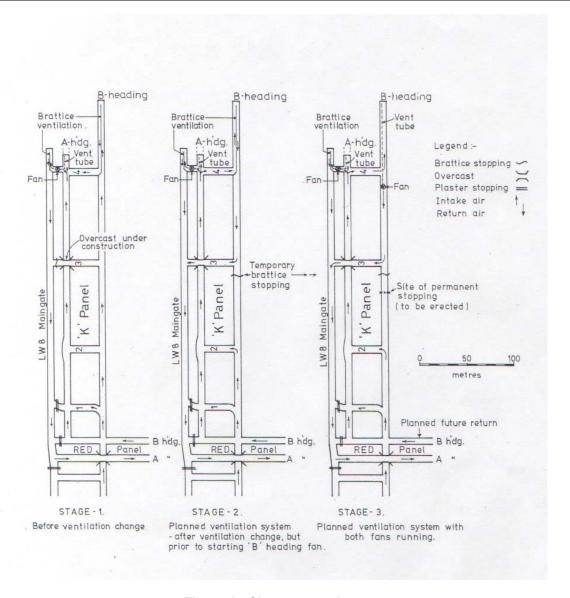
Figure 1 - Changeover plan

Ventilation conditions in K Panel prior to the changeover and the intended affect of the changeover are shown in three stages in Figure 1 as follows:

Stage 1 shows the panel layout on the morning of Tuesday 24th July with A and B headings as intakes and LW8 Maingate as the return. The overcast at the intersection of C/T 3 and A heading was being built. The LW8 Maingate stub was brattice ventilated. An auxiliary fan in C/T 4 provided ventilation for A heading while B heading that had been advanced 70 m as an intake stub, was ventilated on brattice

Stage 2 shows the post-changeover ventilation flow. This situation was planned to be reached, after completion of the overcast, by erection of the temporary brattice in B heading and removal of the brattice stopping in C/T 3.

Stage 3 was to be the completion of the changeover with a fan, that had been placed in B heading being used to ventilate the stub.

Near the end of the afternoon shift the overcast had been completed and the brattice in B heading had been erected. The Deputy who was meant to remove the C/T 3 brattice did not do so because he noticed leakage from the overcast. It was near the end of his shift and he left the panel. During the inquiries it could not be established what messages were passed to the evening shift Deputy, but it is clear that for some undetermined time the whole of B heading inbye of C/T 3 was virtually unventilated.
