Coal Operators' Conference

Pike River Royal Commission outcomes

Stewart Bell

PIKE RIVER ROYAL COMMISSION OUTCOMES

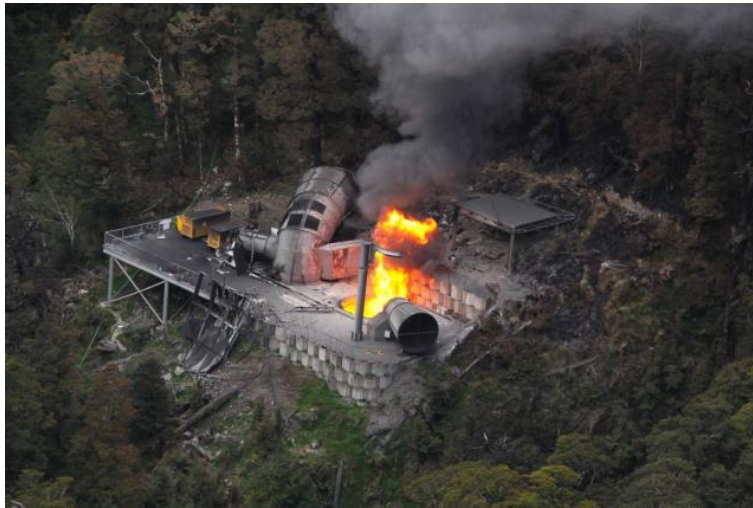
There were three subsequent explosions on 24, 26 and 28 November. Again it is thought that the primary fuel was methane though there is evidence of coal dust contributing to the fourth explosion. These appear to have been ignited close to the fan shaft, probably by an ongoing fire within the mine.

Figure 2 - Fire burning at top of fan shaft after fourth explosion (NZ Police, 2012)

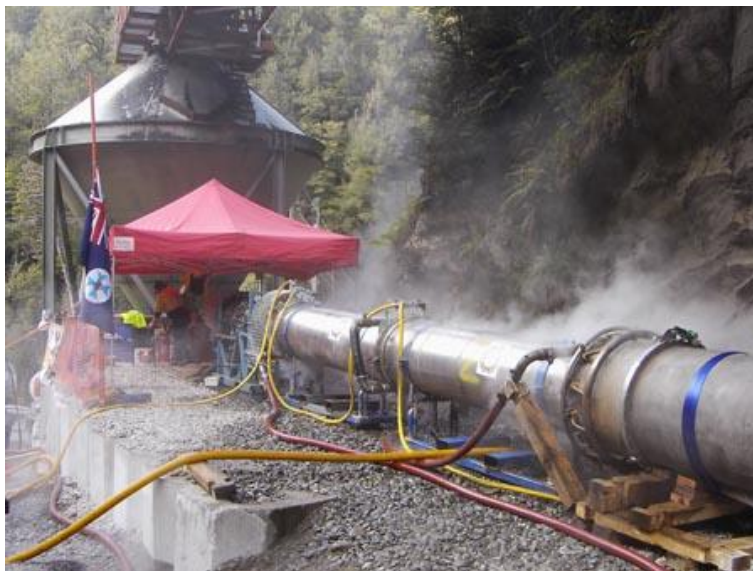
Figure 3 - The GAG jet inertisation system in operation at Pike River (NZ Police, 2012)

Suppression of the residual active fire(s) and prevention of subsequent explosions was achieved by deploying the GAG jet inertisation system (Figure 2 and 3). The process of establishing control was complicated by the rugged surface terrain and access to the area above the mine only being feasible by helicopter. It took many weeks to drill boreholes to establish that the mine atmosphere had been rendered inert and for the mine portal to be sealed and the fan shaft capped safely (Figure 4).

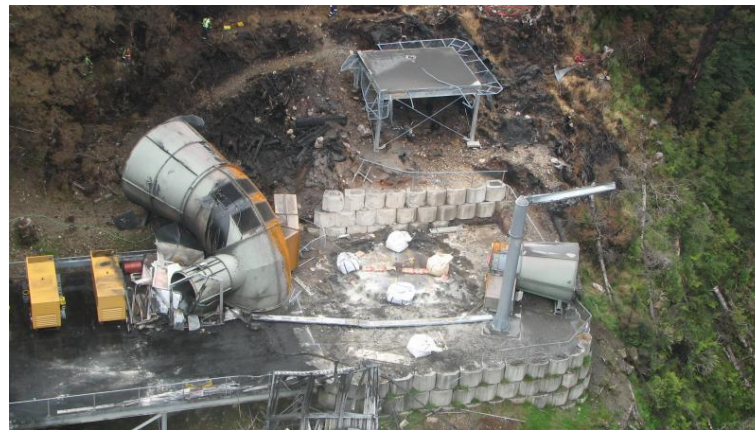
Figure 4 - The capped fan shaft, showing the evasee where it was deposited after the fourth explosion (NZ Police, 2012)
