Pike River Royal Commission outcomes

Department of Minerals and Energy Brisbane

PIKE RIVER ROYAL COMMISSION OUTCOMES

Stewart Bell

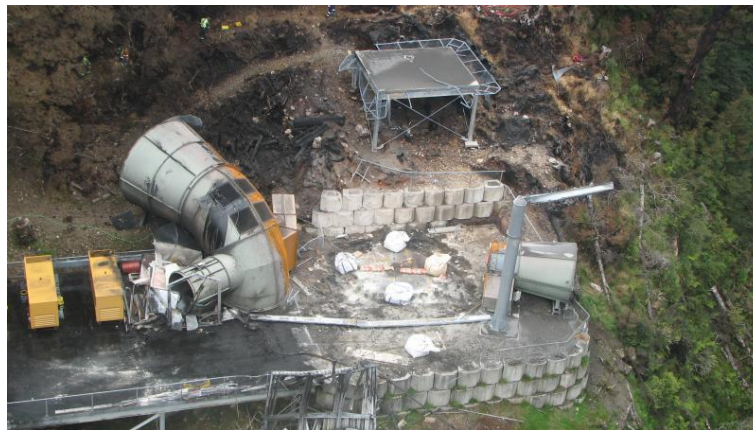
Figure 4 - The capped fan shaft, showing the evasee where it was deposited after the fourth explosion (NZ Police, 2012)

Suppression of the residual active fire(s) and prevention of subsequent explosions was achieved by deploying the GAG jet inertisation system (Figure 2 and 3). The process of establishing control was complicated by the rugged surface terrain and access to the area above the mine only being feasible by helicopter. It took many weeks to drill boreholes to establish that the mine atmosphere had been rendered inert and for the mine portal to be sealed and the fan shaft capped safely (Figure 4).
