# ANALYSIS OF BREAKAGES OF LONGWALL POWERED SUPPORTS - WHY CYCLE TESTING DOES NOT GUARANTEE HAPPINESS

Peter McInally<sup>1</sup>

**ABSTRACT:** In recent years, SUEK has suffered serious breakages of four sets of powered supports, including caving shields and the attachment of the powered supports to the AFC. All of these supports had undergone prototype testing prior to manufacture, but the design errors were not manifested under conventional test conditions. Breakages occurred underground where it is not possible to instrument the equipment, and where reliable data is hard to obtain by visual means. This paper describes the "forensic engineering" that led to the identification of the root cause of the damage, and the ways in which this was rectified. Two new sets of supports have also undergone design changes to prevent the same risk of damage. The solutions are simple, but developing this knowledge has cost a lot.

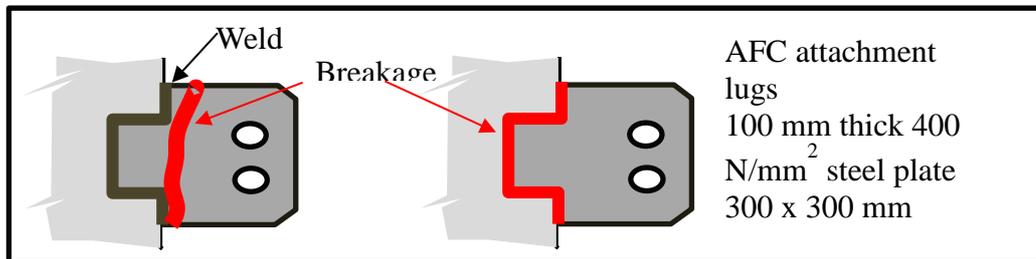
SUEK has experienced failures of AFC attachment lugs on two AFCs since 2007, with a total of more than 200 lugs broken. Typical results are shown in Figure 1, for a welded AFC, and Figure 2 for a cast AFC. In both cases the system included an articulated clevis, as shown in Figure 3. The vertical pin of the clevis allowed approximately 8° of articulation in both directions – which exceeds the maximum rotation of the AFC pan in the middle of the snake. The other point to note is the very limited clearance between the attachment and the AFC lug – presumably because the designers believed that the swivel on the clevis could accommodate all necessary articulation. In both 2008 and 2015, the AFC lugs started to break within days of commencement of operation and 50 or more pans were damaged in the first few months. In both cases inspection of the adjacent, unbroken lugs did not reveal any signs of defects, excessive loadings or bending or deformation. The lugs then broke suddenly and with no prior permanent bending or cracking. This indicated that the cause was a loading condition that only occurred intermittently and whenever it occurred it broke the lug. This opinion was reinforced when breakages were found with half the broken surface showing slight rust, and the other half with a clean, fresh break, indicating two discrete failure events, at least several hours apart and not more than one or two days apart.

Figure 1: Breakage of welded AFC attachment lugs – 2008

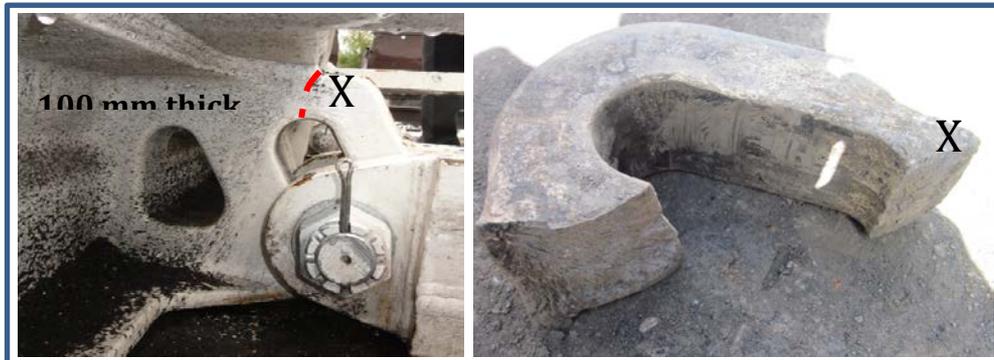
Figure 2: Breakage of cast AFC lugs 2015 (every line pan was broken in this manner)

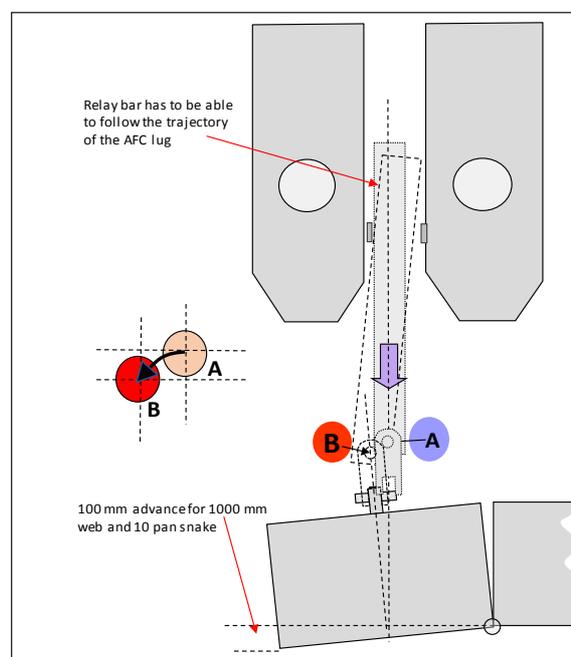
**Figure 4: Lateral movement of AFC and relay bar**

As a pan is pushed forward, the pan joint on the goaf side opens up and the pan rotates. This causes the attachment lug to move along the face and the relay bar must be able to follow this lug. If it hits the internal sides of the base tunnel, it can impede the rotation of the AFC pan, even if there is articulation available at the pin connecting the relay bar and the lug, or even if there is a swivelling clevis between the end of the relay bar and the lug attachment. This is shown in Figure 4.

Once the relay bar cannot move laterally, the system is almost locked. If there is clearance between the sides of the attachment and the AFC lug, then the lug can slide along the pin,

but once the lug comes into contact with the side plates of the relay bar attachment, the system is fully locked, and severe stresses will be generated if the AFC pan continues to rotate.

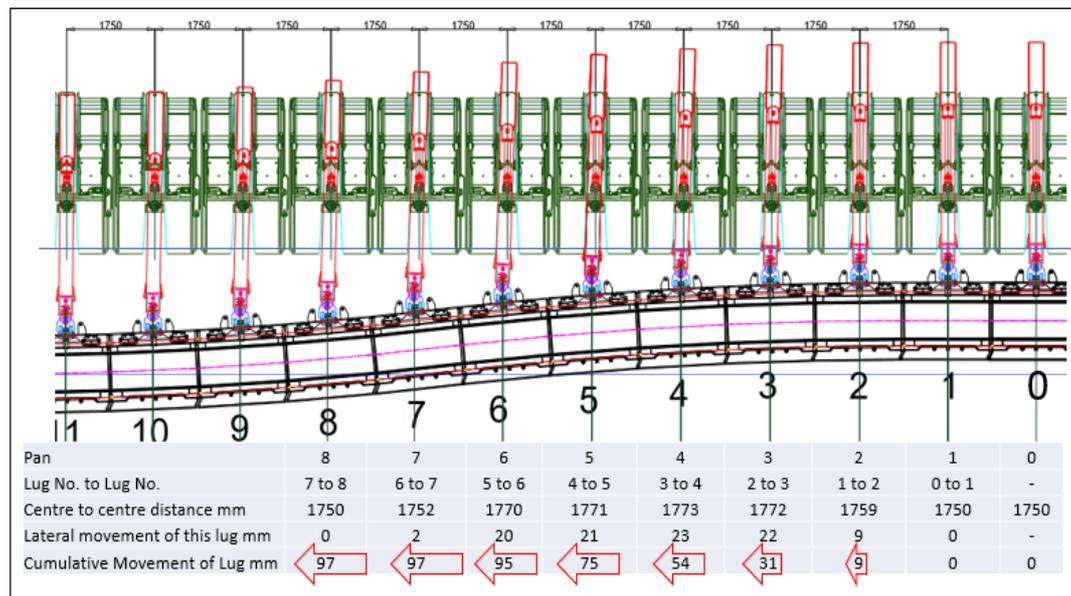
**Figure 5: 15 pan snake of 1 m web - showing lateral movement of the AFC attachment points in the convex part of the snake**

This clearly showed that the AFC would be broken - unless the relay bars or clevises broke first. The AFC attachments needed to move a total of 97 mm along the face but the front end of the relay bars could not follow this. Note that the wedges are not in contact with the internal sides of the support base on support No.1 in this drawing, but they are in contact on supports 4, 5, 6 and 7. If they were shown in contact before the start of the push-over, then the relay bar would be trapped, and high forces would be developed.

As soon as the AFC push commences and the relay bar has moved forward approximately 50 to 75 mm, contact is broken. If "banana" slots are used on the AFC attachment lugs then contact is broken during the lost-motion phase, before any force is applied to the AFC and before advance and rotation of the pans commences. The second way is to use wedges, but these create less clearance and must be positioned well forward so contact with the base is broken at an early stage in the AFC push. This means that the internal faces of the base must be carefully designed to prevent contact. Deep wedges are required to ensure there is adequate room for the relay bar to follow the AFC, but they must be short in order to break contact before the AFC starts to rotate. It appears that contact with blocks inside the narrow section of the base is a considerably more effective mechanism, as it provides maximum free rotation of the relay bar. When combined with suitable internal angles of the base, it can guarantee that contact does not occur throughout the full push-over.

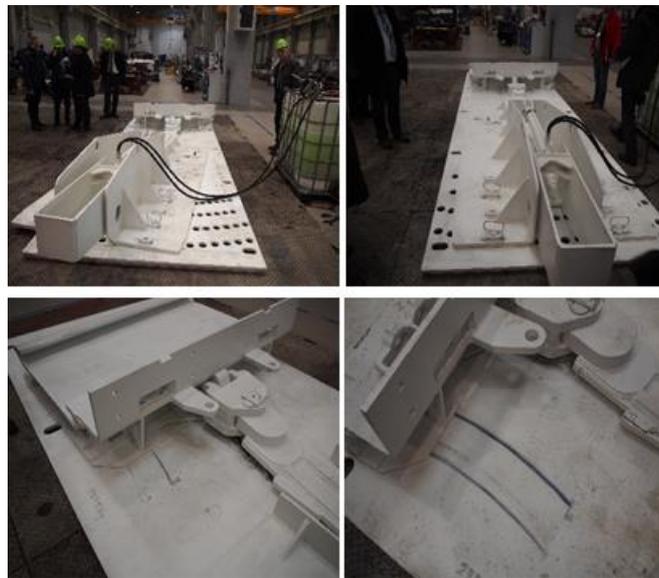
**Figure 7: Photographs of test rig replicating the snake of AFC in the supplier's premises**

Use of this rig revealed that the wedges on the relay bar had to be positioned close to the tips of the support base, so they could break contact as soon as the push-over commenced, and also demonstrated the inherent advantage of contact being made inside the base tunnel, instead of on the angled tips.

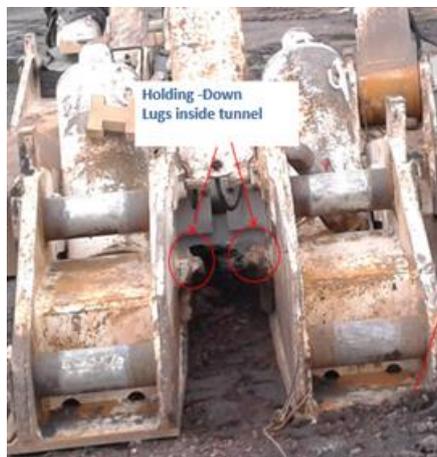
**Figure 8: Internal lugs for holding down the relay bar**

The Polisaevskaya supports also suffered damage from internal collision between the AFC advance mechanism and the inside of the base. Damage included ripping out the bracket that attaches the AFC advance ram to the base bridge, severe deformation of the piston head on some advance rams, and deep indentations on the collars of the cylinders. The location and nature of the holding down lugs is shown in Figure 8 and the damage is shown in Figure 9.

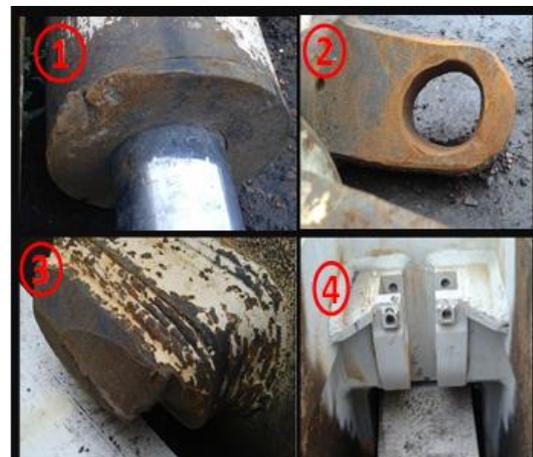
**Figure 9: Impact damage to AFC advance rams**

SUEK carried out a survey of a number of broken supports that had been brought to the surface, and this established that the breakage of the mountings was due to the collar of the cylinder of the AFC advance ram impacting with the lugs inside the base that hold the relay bar down.

Item 1 of Figure 9 shows obvious damage to the collar of the outer cylinder. This has been hitting the holding-down lug, shown as item 3, and gouging metal off it. Item 2 is the forged head of the piston on the advance ram and this serious deformation has occurred after only 2.5 Mt. The proposed ram mounting is shown in item 4. This requires extensive welding that could only be done on the surface.

The root cause was the design of the mechanism for holding the relay bar down. The broken supports were face end and transition supports, which had larger diameter advance rams, which greatly increased the likelihood and severity of contact. Inspection of the line supports revealed that approximately 50% had visible damage to the collar of the cylinders of the advance ram and to the lugs, but this was minor – with about 10-15 mm of metal ripped off.

SUEK had developed a mechanism to hold the piston head of the advance ram in place even if the original mounting failed, so it was decided to repair the face end and transition supports by fitting new mounting brackets, trimming the holding lugs down to increase clearance and replacing the seriously damaged advance rams under warranty, but to do a face to face transfer of the line supports. It was hoped that the bits knocked off the advance rams and the lugs would have created adequate clearance to prevent further damage. This avoided the significant loss of output associated with transport of all supports to the surface, and it has been successful. No further failures have occurred.

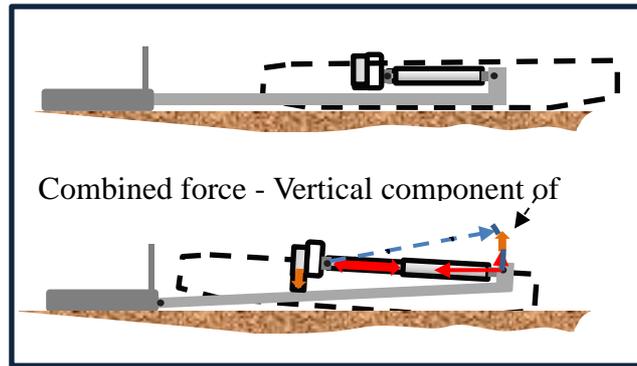
**Figure 10: Resultant forces during support advance with base lift**

These are intended to prevent the rear end of the relay bar lifting when the base-lift mechanism is activated. This lifts the front of the support by pushing against the relay bar, but this steepens the angle between the advance ram and the relay bar. This increases the vertical component of the resultant force, and this acts at the rear attachment of the advance ram to the relay bar, lifting it vertically as it moves backwards relative to the base of the support, as shown in Figure 10. This vertical force must be counteracted by some form of retainer inside the base of the support, or lift at the front of the base will be reduced, and the rear of the relay bar could be trapped inside the support.

The Kirova supports could not be changed to a rear hold-down arrangement as used by Joy and DBT because the bases are too short to allow an internal bearer plate to be used. A complete redesign, FEA and cycle testing of a new base was not feasible in the available time. Based on the limited damage to line supports on the Polisaevskaya set due to interference between the advance rams and the holding down lugs, it was decided to accept the design, along with warranty for damage. The hold down arrangement has been checked and clearances have been maximised as far as possible.

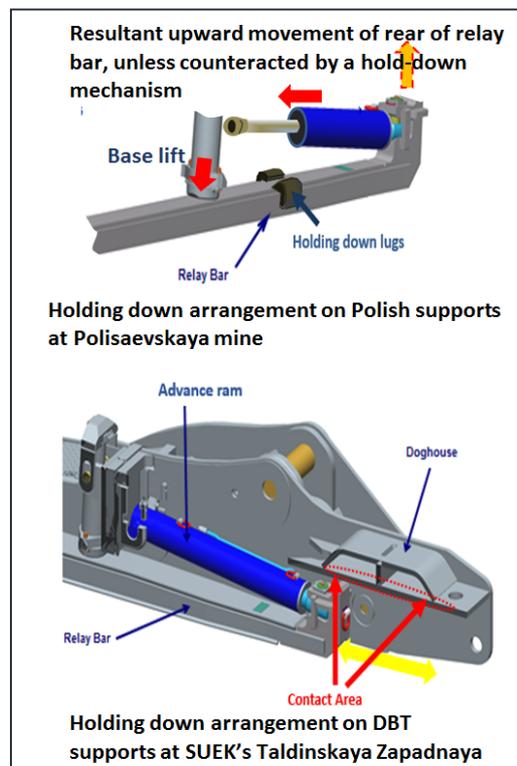
**Figure 11: Comparison of different holding-down mechanisms**

The function of the holding-down mechanism is to counteract the combined effect of the base lift ram and the retraction of the advance ram, to pull in the support. These forces form a couple that will lift the rear of the relay bar, thus reducing the area of contact between the relay bar and the floor, which serves to lift the base of the shield as it advances. If this is located at the rear of the relay bar then the base rotates about this contact point and the contact between the relay bar as the front is lifted by the base lift ram, raising the whole base and allowing dirt to pass underneath. The system using lugs a short distance from the base lift ram does not appear to be as effective as the doghouse and bearing block used by DBT and unless the advance ram is mounted with the cylinder at the front so that it is stationary, there is also a risk of collision between the lugs and the advance ram.

Another partial set from the same supplier for use in 4.5 m extraction was also checked by SUEK. In this case there was adequate height and length available to change these supports to rear hold-downs for the relay bars. The design of the base was changed completely as a result of SUEK's concerns, with an effective contact make/break mechanism inside the base tunnel, and a similar system to DBT for holding down the rear end of the relay bar, using a "doghouse" with an internal bearer plate that is in contact with a boss at the rear of the relay bar and ram, as shown in Figure 11.

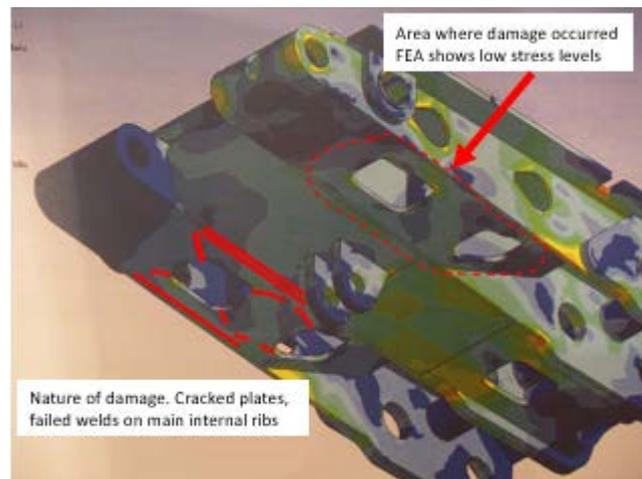
Four months after a face set of Tagor supports was commissioned cracking was observed on the lower surface of the caving shields on four or five supports. A full, detailed survey was carried out and this showed that the majority of the caving shields had long, wide cracks at the corners of the access cut-outs. Initially most were in the corners of the access pockets, but with time these became more extensive and then cracks developed along the outer edges of the underplates. The steel underplates in the area where cracks occurred were supposed to be low stress areas, with only 6 MPa in plate that should withstand 500 MPa. The supplier's FEA is shown in Figure 12.

**Figure 12: FEA plot of caving shield, showing failures in low stressed plates and welds**

Clearly the cracks were occurring at areas of excessive stress concentrations, but it was necessary to establish the source of the stress and to determine how it was being concentrated. The supports were in use at this time so each hypothesis had to be checked out underground. The roof in this seam was irregular and difficult to hold and the telescopic canopies were ineffectual, so the face was difficult, with supports angled, and with areas along the face where the supports converged by 1 m or more. There was also a tendency for the canopies to be set at an angle with the tips up and the rear of the canopy lower, which flattened the inclination of the caving shields.

The only solution was to cut off all underplates and replace them with thicker, higher grade steel, with redesigned cut-outs to reduce stress concentration, and to change operating procedures to maintain a high angle on the caving shields in order to limit contact. The supports have worked continuously without further breakages.

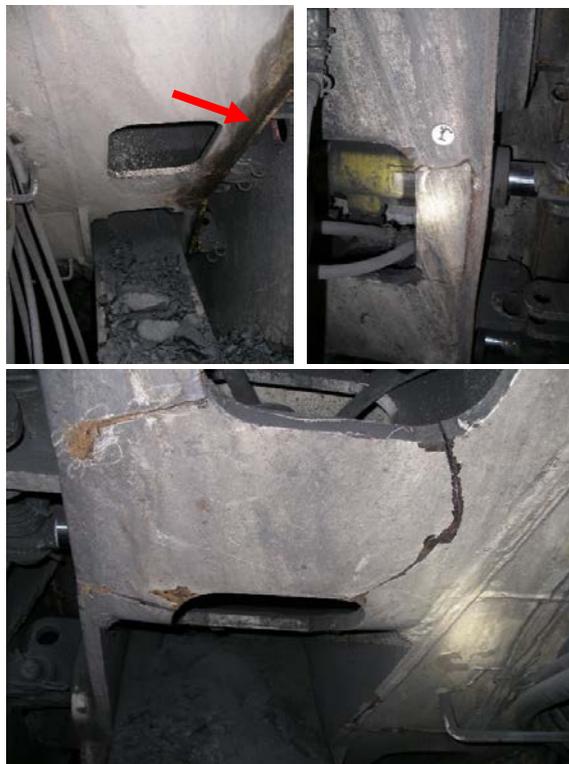
The lack of clearance between the links and the caving shield is clearly visible in the photograph at the bottom of Figure 13. This small design error resulted in breakage of every caving shield on line, transition and roadhead supports. A 25 mm narrower link with a 12 mm spacer on each side would have prevented this damage.

**Figure 13: Examples of breakage of caving shields, 2008**

In the case of SUEK's Tagor supports the design could have been changed relatively easily – by narrowing the whole upper link, or by stepping it in by 20 mm on each side, immediately past the ends that fit on the pivot pins. Either of these very minor modifications could have prevented damage to the caving shields.
