Railway turnout failure mode analysis

Railway Turnout Failure Mode Analysis

H. Li¹, M. Carkagis¹, A.K. Hellier¹, H. Zhu¹, J. McLeod² and S. Pannila²

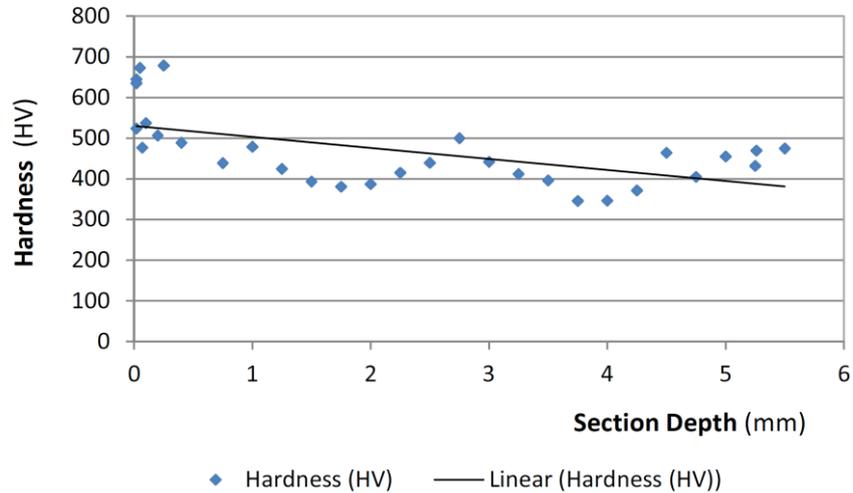
Figure 1 – Vickers hardness depth profile for sample #2.

- Heavily deformed and fractured/or cracked microstructure under the working surface. The Vickers hardness results show this region to be extremely hard. There has been a work-hardening process by way of the large amount of rail traffic. This has led to the surface structure

hardening to the point of brittleness, resulting in the subsequent micro-fracturing of the structure (see Photo 11).

The sample was tested for hardness using the Vickers method. Figure 1 illustrates the results from the working surface of the specimen down to a depth of 5.5mm.

Regarding the second mode of failure, a potential 'field-fix' solution is as follows. As the hardness decreases towards normal values after 8 to 10 millimetres from the track working surface, it is recommended that the top of the rail head be ground down several millimetres below the work hardened zone and reclaimed with an appropriate weld fill material, then ground to achieve an industry standard profile and surface finish. The finished surface should be examined using NDT techniques to verify the quality of the rail head reclamation process.

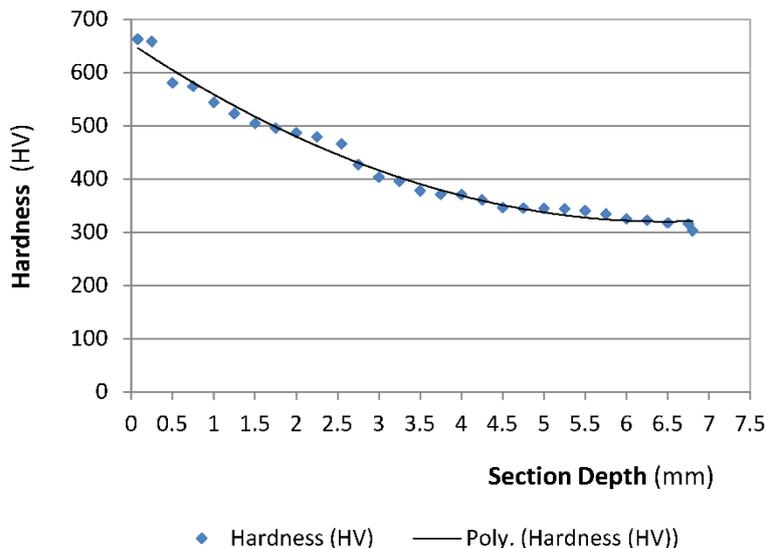
Figure 2 – Vickers hardness depth profile for sample #3 (manganese steel cross-section). The hardness value appears to decrease exponentially as the sample is examined further away from

This sample was also tested for hardness using the Vickers method with a 100g indenter. Figure 2 illustrates the results from the manganese steel cross-section of the specimen down to the depth described.

the working surface. As mentioned previously, manganese steel has a propensity to work harden very rapidly, as demonstrated by these results.

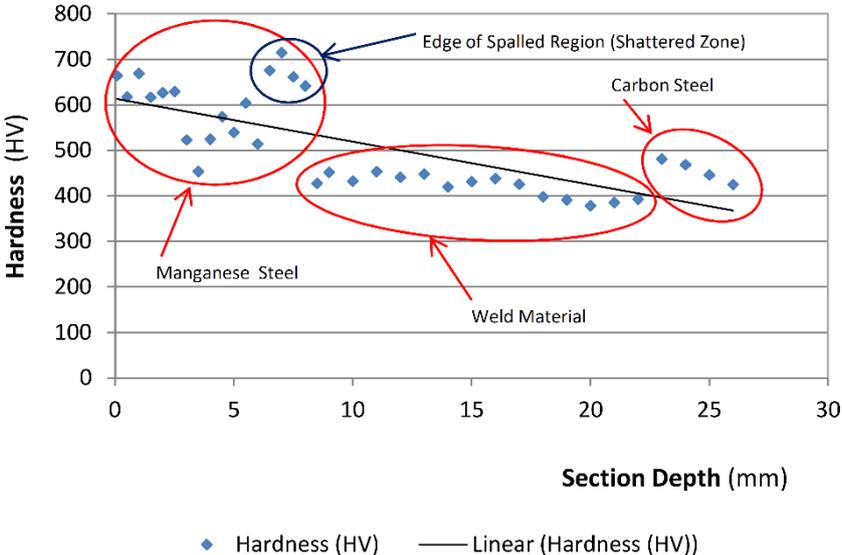
Figure 3 – Vickers hardness depth profile for sample #3 (trimetal surface material).

Figure 3 shows the results from hardness testing of the polished working surface of the specimen to the depth described. This trimetal region consists of manganese steel, weld metal and carbon steel.

The material used in the weld metal is very bright in lustre and exhibits a fine granular microstructure. It is thought that the weld metal contains alumina as a result of the Thermit welding process used. Optical Emission Spectroscopy (OES) is recommended to investigate this further. OES is a proven and widely used analytical technique for determining the elemental composition of a broad range of metals.

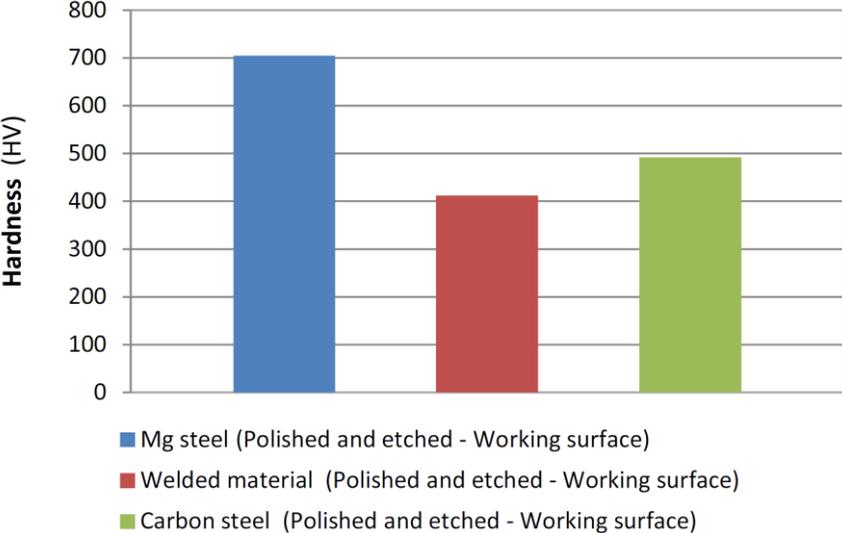
Figure 4 – Working surface Vickers hardness test results for sample #3 (trimetal average locations).

Figure 4 shows the working surface hardness test results at an average location for each zone in the trimetal region.

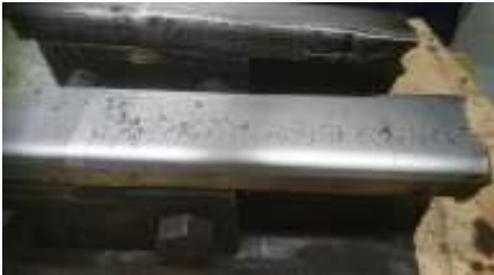
A section of New South Wales' railways rail turnout was removed, since testing revealed that it had become defective and no longer fit-for-purpose (see Photo 1 in Appendix). The University of Wollongong was commissioned to investigate the failure mode of the track section, and to provide a detailed report on the material composition, heat treatment, surface finish, wear and any material defects [2]. Since the turnout is over 25 years old, there are no test certificates or other quality assurance documents available for review.

Photo 1 – Rail head cleaned and ready for inspection.

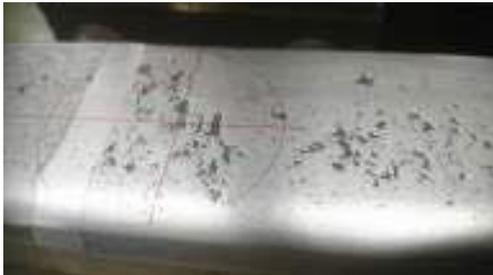
- Work hardening of the top face of the rail head resulting in surface spallation (see Photo 2).
- Stress concentration due to loading in the convergence of the turnout, initiating fatigue and resulting in a partial fracture of the local area (see Photos 3 and 4).

The extreme nature of the degradation by way of spallation from the working surface of the rail head is attributed to exposure to high loading cycles over a long period of time. This has led to a hardening and consequent shattering of the microstructure closest to the working surface, resulting in the observed spallation.

Photo 2 – Close-up of major spallation site.

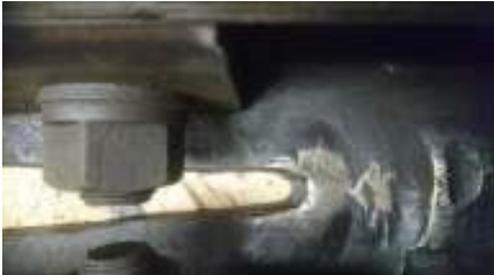
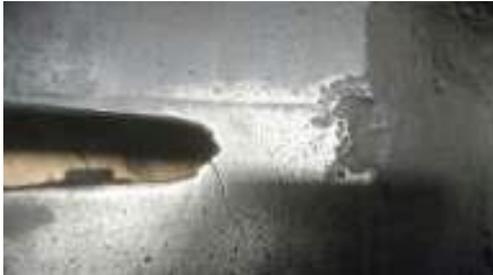
A railway turnout has been examined for its mode of failure and to determine an appropriate course of action when this fault is found in the field. The turnout has cracked within the convergence where the two rails meet. The turnout possessed a manufacturing defect exacerbating a high stress concentration within the convergence, resulting in fatigue failure. The sample shows a lack of burr removal during the dressing of the final product, which is the most likely cause of the stress concentration.

Photo 3 – Fracture site in rail convergence.

Photo 4 – Fracture site as viewed from below.

A potential 'field-fix' solution to the first mode of failure is as follows. The fracture would need to be examined from both the top and the bottom aspects of the site. This may require the excavation of an undetermined amount of ballast in order to gain access below the fracture zone. Once the site has been declared suitable for field repairs, the horizontal surfaces should be cleaned with a linishing belt. Magnetic particle testing would then be carried out to determine the extent of the fracture, thus locating the point of propagation. At this point, to stress relieve the fracture site, a hole is to be drilled through the full thickness of the material encapsulating the point of convergence within the fracture site. The turnout root radius should then be deburred to ensure that any obvious sources of stress concentration are removed. The fault line is then notched and prepared for welding. Finally, the fracture is fused using an appropriate welding technique and the weld bead ground/finished to the original surface level. Non-destructive testing (NDT) techniques of the affected area should be employed to ensure that the repair process has been successful.

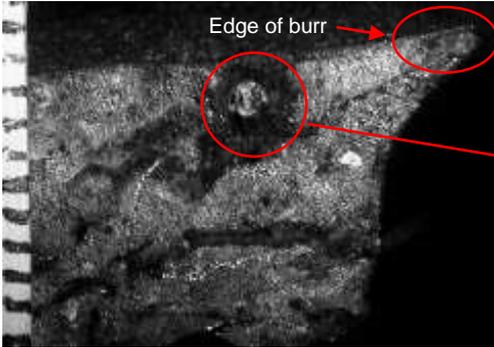
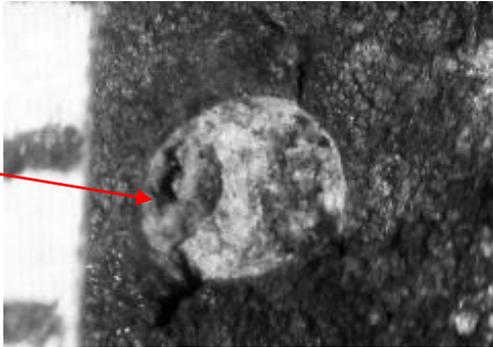
- A spheroidal inclusion 'white' in colour and 'marble-like' in texture (see Photos 5 and 6).
- A 'wave-like' structure akin to ratchet marks, suggesting that the damage was progressive and over a long period (see Photo 7).
- Minute spheroidal inclusions 'black' in colour and 'coal-like' in texture (see Photo 8).
- Secondary cracking not far from the primary fracture zone (see Photo 9).
- Surface cracking as seen on the inner radius of the turnout convergence. The cracking appears to follow the intergranular formation of the material itself (see Photo 10).

It is therefore apparent that the turnout contained a manufacturing defect, predisposing the product to eventual fatigue failure.

Photo 5 – Inclusion within casting (7x mag).

Photo 6 – Inclusion within casting (40x mag).

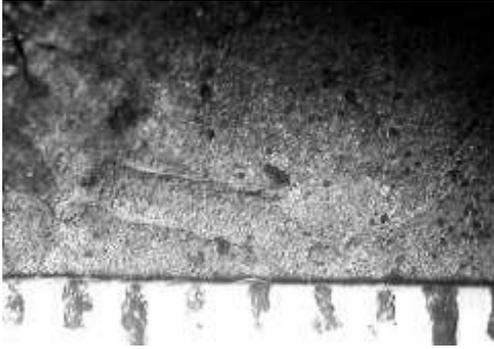
Photo 7 – Potential ratcheting (14x mag).

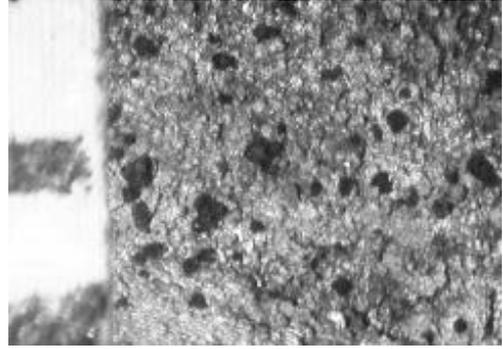
Photo 8 – Foreign inclusions at fracture site (45x mag).

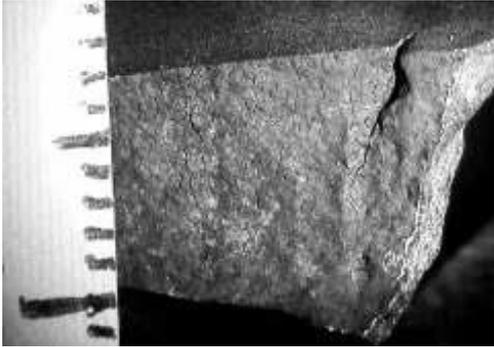
Photo 9 – Secondary cracking (7x mag).

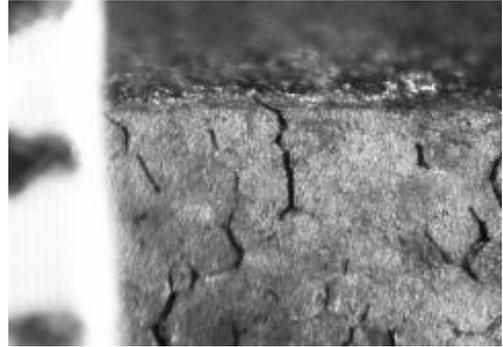
Photo 10 – Root radial surface (40x mag).

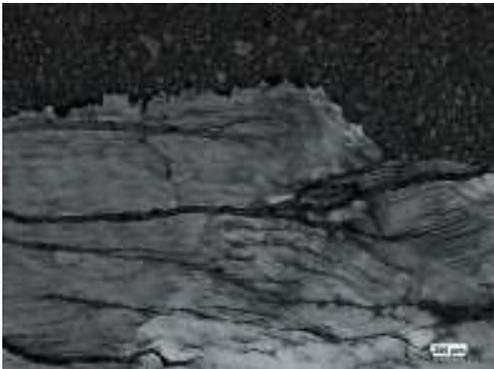
Photo 11 – Heavily deformed and cracked surface region.

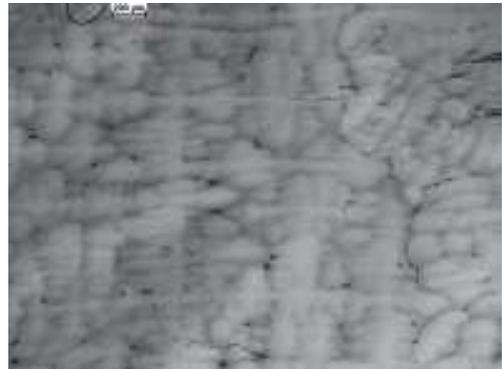
- 'Cloudy' appearance to the microstructure.
- Micro-cracking mostly along the grain boundaries.
- Fracturing of the microstructure below the spallation regions.
- Presence of 'dendritic' cast structure within grains in the body of the material (see Photo 12).

Photo 12 – Dendritic structure within grains.

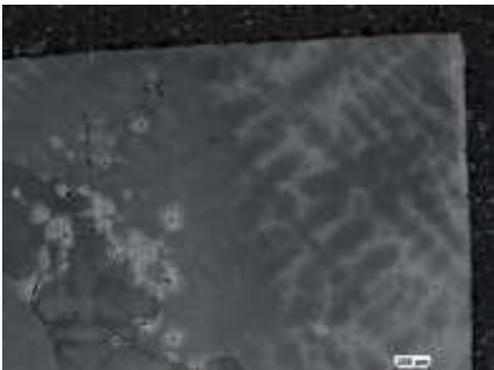
- Large grain structure with what appear to be carbide inclusions (see Photo 13).
- Fracturing of the microstructure below the working surface (see Photo 14).
- Cracking along grain boundaries.
- Foreign inclusions which appear to be 'black' in colour with a blocky 'cubic' morphology.

Photo 13 – Large grain with inclusions.

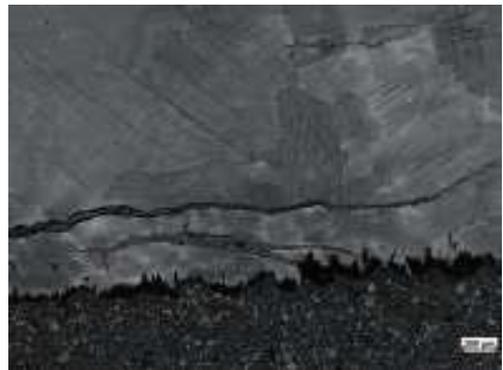
Photo 14 – Subsurface cracking.
