Railway Turnout Failure Mode Analysis

H. Li¹, M. Carkagis¹, A.K. Hellier¹, H. Zhu¹, J. McLeod² and S. Pannila²

²Engineering & System Integrity Engineering Maintenance Division, Sydney Trains, NSW
AUSTRALIA

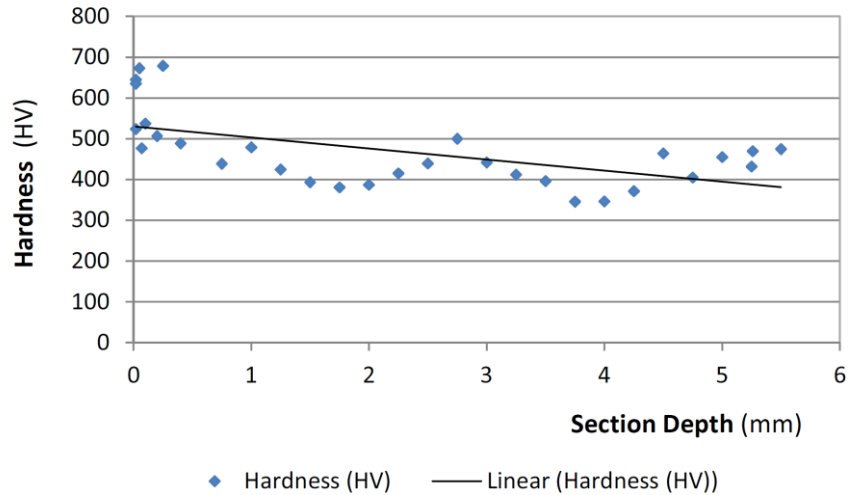
Figure 1 – Vickers hardness depth profile for sample #2.

- Heavily deformed and fractured/or cracked microstructure under the working surface. The Vickers hardness results show this region to be extremely hard. There has been a work-hardening process by way of the large amount of rail traffic. This has led to the surface structure

The sample was tested for hardness using the Vickers method. Figure 1 illustrates the results from the working surface of the specimen down to a depth of 5.5mm.

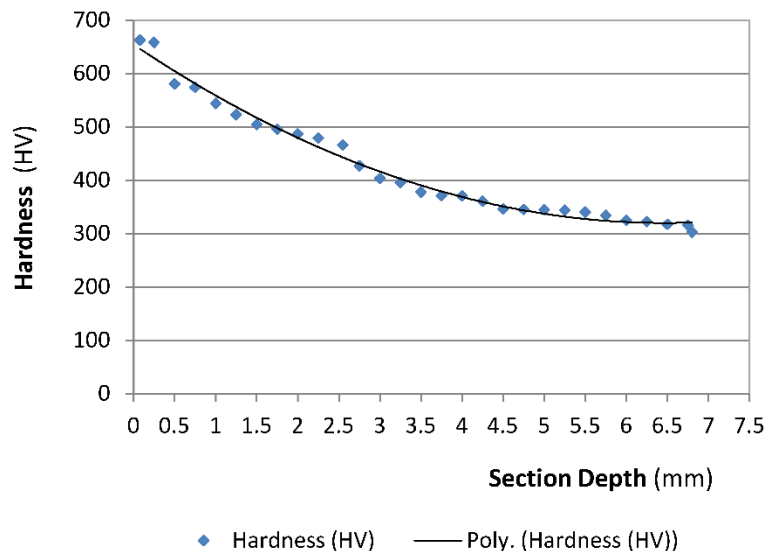
Figure 2 – Vickers hardness depth profile for sample #3 (manganese steel cross-section). The hardness value appears to decrease exponentially as the sample is examined further away from

the working surface. As mentioned previously, manganese steel has a propensity to work harden very rapidly, as demonstrated by these results.

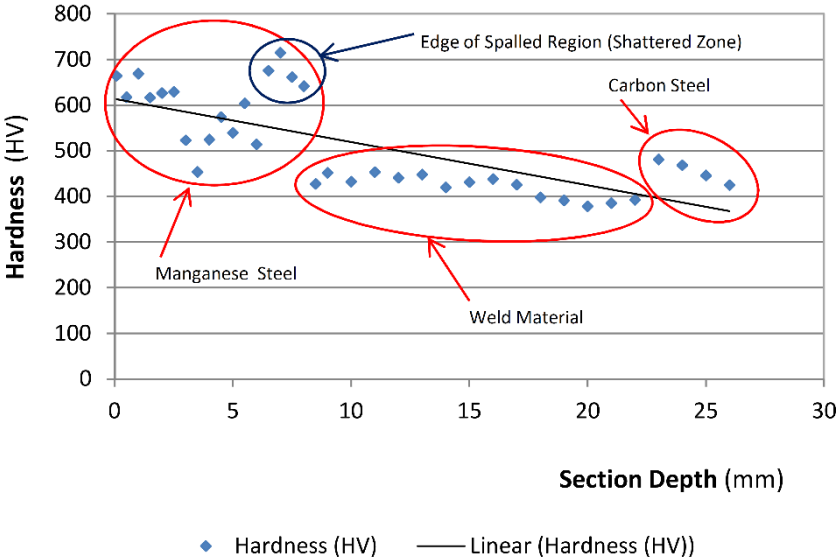
Figure 3 – Vickers hardness depth profile for sample #3 (trimetal surface material).

Figure 3 shows the results from hardness testing of the polished working surface of the specimen to the depth described. This trimetal region consists of manganese steel, weld metal and carbon steel.

The material used in the weld metal is very bright in lustre and exhibits a fine granular microstructure. It is thought that the weld metal contains alumina as a result of the Thermit welding process used. Optical Emission Spectroscopy (OES) is recommended to investigate this further. OES is a proven and widely used analytical technique for determining the elemental composition of a broad range of metals.

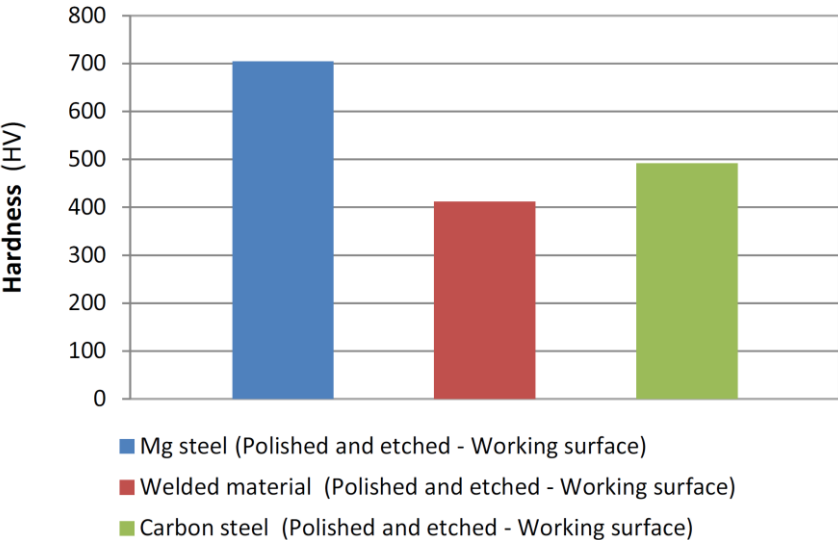
Figure 4 – Working surface Vickers hardness test results for sample #3 (trimetal average locations).

Figure 4 shows the working surface hardness test results at an average location for each zone in the trimetal region.

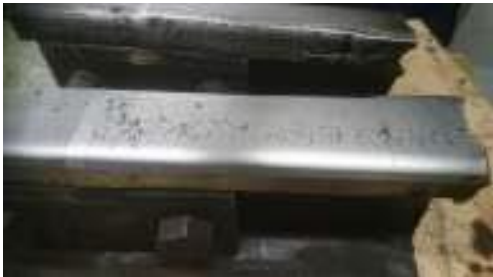
A section of New South Wales' railways rail turnout was removed, since testing revealed that it had become defective and no longer fit-for-purpose (see Photo 1 in Appendix). The University of Wollongong was commissioned to investigate the failure mode of the track section, and to provide a detailed report on the material composition, heat treatment, surface finish, wear and any material defects [2]. Since the turnout is over 25 years old, there are no test certificates or other quality assurance documents available for review.

Photo 1 – Rail head cleaned and ready for inspection.

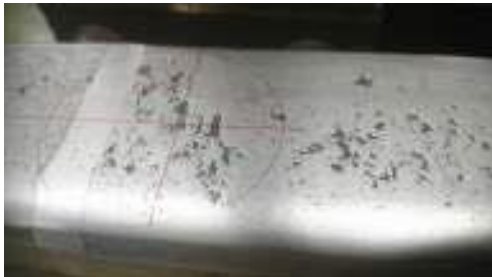
- Work hardening of the top face of the rail head resulting in surface spallation (see Photo 2).
- Stress concentration due to loading in the convergence of the turnout, initiating fatigue and resulting in a partial fracture of the local area (see Photos 3 and 4).

The extreme nature of the degradation by way of spallation from the working surface of the rail head is attributed to exposure to high loading cycles over a long period of time. This has led to a hardening and consequent shattering of the microstructure closest to the working surface, resulting in the observed spallation.

Photo 2 – Close-up of major spallation site.

Regarding the second mode of failure, a potential 'field-fix' solution is as follows. As the hardness decreases towards normal values after 8 to 10 millimetres from the track working surface, it is recommended that the top of the rail head be ground down several millimetres below the work hardened zone and reclaimed with an appropriate weld fill material, then ground to achieve an industry standard profile and surface finish. The finished surface should be examined using NDT techniques to verify the quality of the rail head reclamation process.

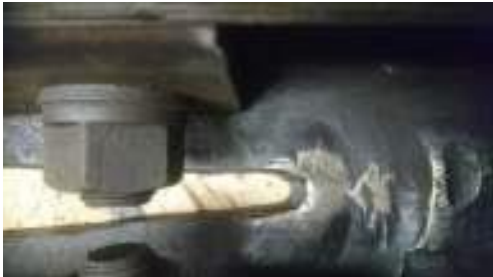
A railway turnout has been examined for its mode of failure and to determine an appropriate course of action when this fault is found in the field. The turnout has cracked within the convergence where the two rails meet. The turnout possessed a manufacturing defect exacerbating a high stress concentration within the convergence, resulting in fatigue failure. The sample shows a lack of burr removal during the dressing of the final product, which is the most likely cause of the stress concentration.

Photo 3 – Fracture site in rail convergence.

A potential 'field-fix' solution to the first mode of failure is as follows. The fracture would need to be examined from both the top and the bottom aspects of the site. This may require the excavation of an undetermined amount of ballast in order to gain access below the fracture zone. Once the site has been declared suitable for field repairs, the horizontal surfaces should be cleaned with a linishing belt. Magnetic particle testing would then be carried out to determine the extent of the fracture, thus locating the point of propagation. At this point, to stress relieve the fracture site, a hole is to be drilled through the full thickness of the material encapsulating the point of convergence within the fracture site. The turnout root radius should then be deburred to ensure that any obvious sources of stress concentration are removed. The fault line is then notched and prepared for welding. Finally, the fracture is fused using an appropriate welding technique and the weld bead ground/finished to the original surface level. Non-destructive testing (NDT) techniques of the affected area should be employed to ensure that the repair process has been successful.

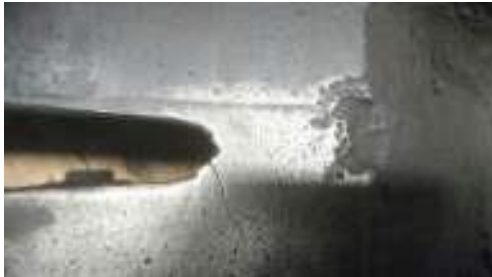
Photo 4 – Fracture site as viewed from below.

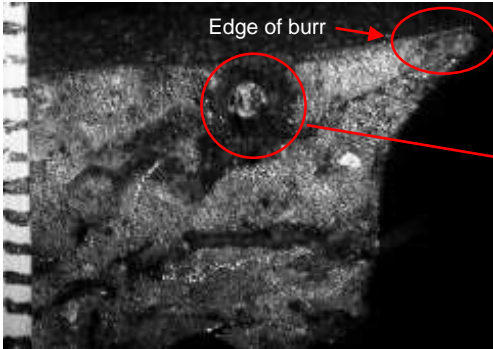
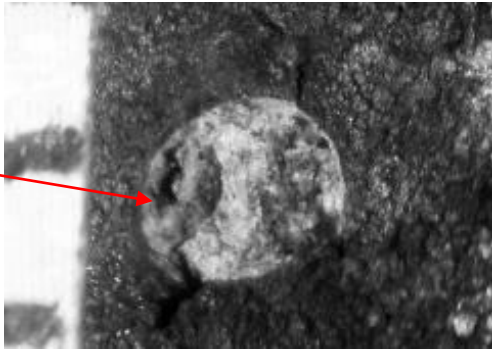
- A spheroidal inclusion 'white' in colour and 'marble-like' in texture (see Photos 5 and 6).
- A 'wave-like' structure akin to ratchet marks, suggesting that the damage was progressive and over a long period (see Photo 7).
- Minute spheroidal inclusions 'black' in colour and 'coal-like' in texture (see Photo 8).
- Secondary cracking not far from the primary fracture zone (see Photo 9).
- Surface cracking as seen on the inner radius of the turnout convergence. The cracking appears to follow the intergranular formation of the material itself (see Photo 10).

Photo 5 – Inclusion within casting (7x mag).

Photo 6 – Inclusion within casting (40x mag).

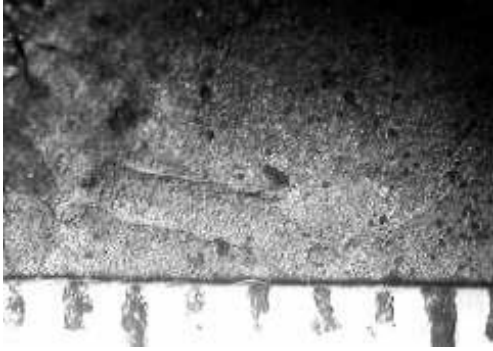
Photo 7 – Potential ratcheting (14x mag).

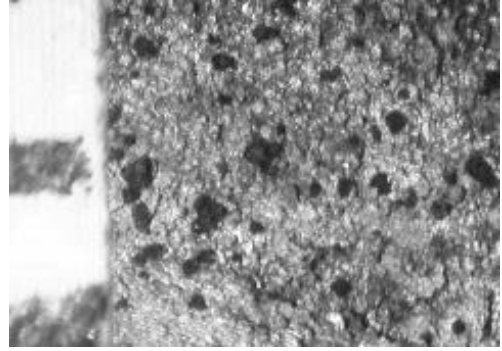
Photo 8 – Foreign inclusions at fracture site (45x mag).

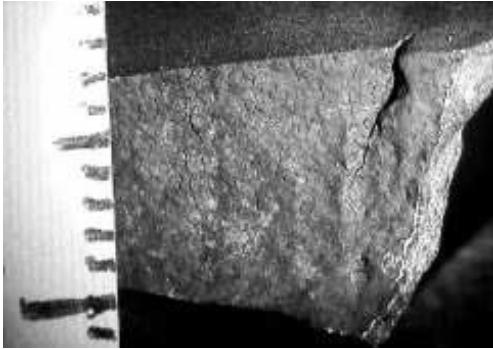
Photo 9 – Secondary cracking (7x mag).

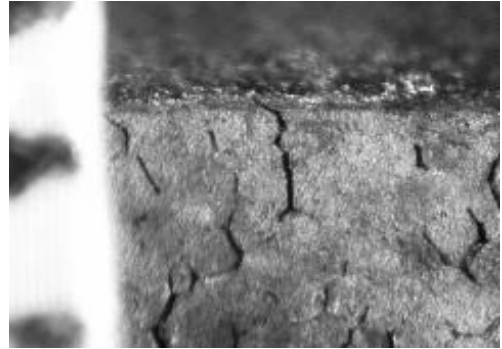
Photo 10 – Root radial surface (40x mag).

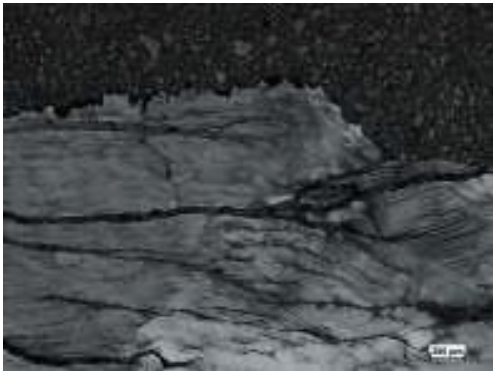
hardening to the point of brittleness, resulting in the subsequent micro-fracturing of the structure (see Photo 11).

Photo 11 – Heavily deformed and cracked surface region.

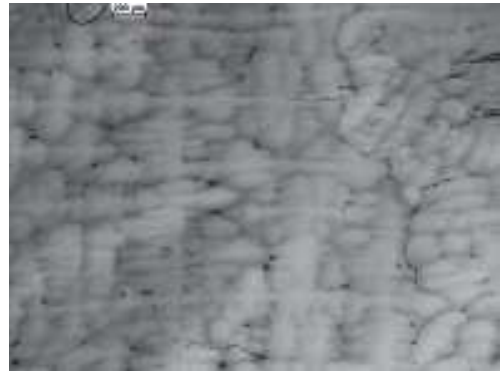
- 'Cloudy' appearance to the microstructure.
- Micro-cracking mostly along the grain boundaries.
- Fracturing of the microstructure below the spallation regions.
- Presence of 'dendritic' cast structure within grains in the body of the material (see Photo 12).

Photo 12 – Dendritic structure within grains.

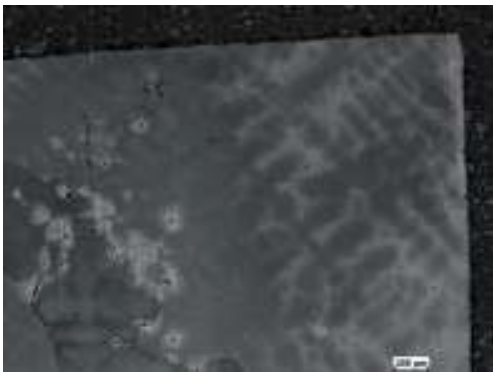
- Large grain structure with what appear to be carbide inclusions (see Photo 13).
- Fracturing of the microstructure below the working surface (see Photo 14).
- Cracking along grain boundaries.
- Foreign inclusions which appear to be 'black' in colour with a blocky 'cubic' morphology.

Photo 13 – Large grain with inclusions.

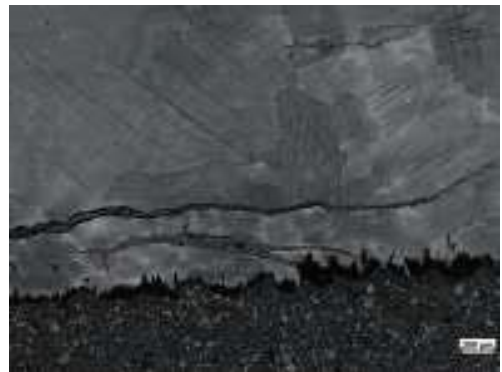
Photo 14 – Subsurface cracking.
