Diagnosing fouling of hollow fibre MF membranes in wastewater reclamation

Diagnosing Fouling of Hollow Fibre MF Membranes in Wastewater Reclamation

Long D. Nghiem and Andrea I. Schäfer*

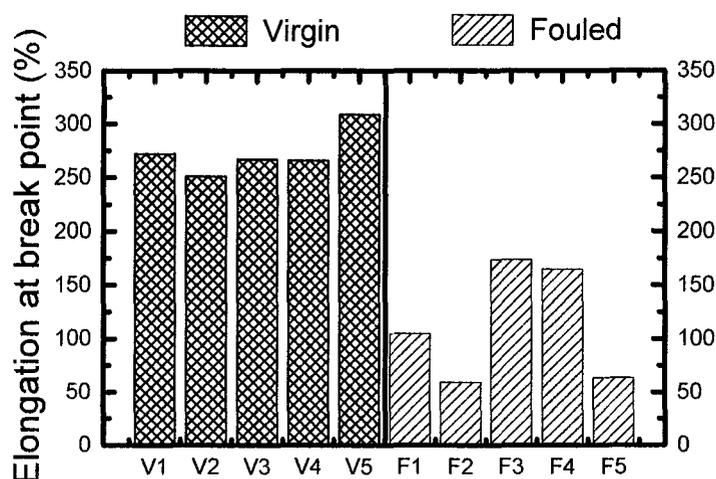
Figure 5: Elongation at break point of the fouled membrane fibres as compared to virgin membrane fibres.

In this case, it appears that the fouled membrane has become more brittle, possibly because the membrane has been allowed to dry prior to testing. This may also be attributed to normal wear and tear during the filtration process and backflush operation. A significant variation in elongation at break point can also be observed for the fouled membrane. However, it is interesting to note that both fouled and virgin membranes have approximately the same young modulus, yield point & elastic profile (data not shown). No clear evidence of material degradation could be observed for the membranes investigated.

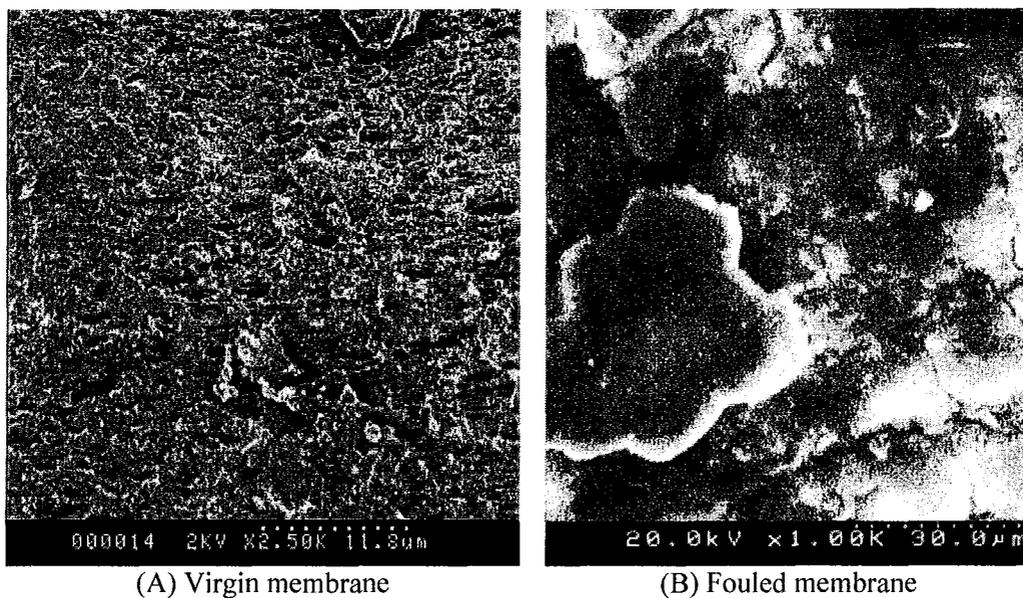
Figure 7: Electron microscopic pictures of a virgin membrane (A) and fouled membrane (B) taken by the FESEM.

The fouling layer morphology is further examined in detail and an electron microscopic picture of the fouling layer is shown in Figure 7. An electron microscopic picture of the clean membrane surface is also presented for comparison purposes. Schäfer *et al.* [1] methodically summarise four distinctive common fouling categories namely scaling/inorganic, organic, colloidal/particulate, and biofouling. There is no evidence of bacteria or fungi on the fouling layer and biofouling is unlikely the main cause in this instance. Figure 7 reveals a firm cake layer on the membrane surface. This cake layer is probably made up of organic matters or colloidal particles or most likely the combination of both. While scaling is uncommon in microfiltration processes and no

evidence of crystallisation can be observed on the fouling layer, it is possible that multivalent cations, for example Ca^{2+} , can act to cement colloidal particles, organic matters, and the membrane surface one another as previously shown in another of our study [10]. This phenomenon has also been exquisitely examined by Li and Elimelech by measuring attractive force between these entities with and without the presence of multivalent cations [11].

particles and organic matter. Complexation and other interactions between multivalent cations, organic matter, and colloidal particles have most likely worsened the fouling process caused by the suspended solids load itself. It is advisable to enhance pre-treatment prior to the MF unit, possibly by applying coagulants, to maintain a low and stable turbidity level in the feed. Chemical cleaning protocol and air backflushing frequency may also need to be modified for an optimal fouling mitigation approach. Monitoring of the feedwater composition over a period of time will provide further insight into the fouling process.

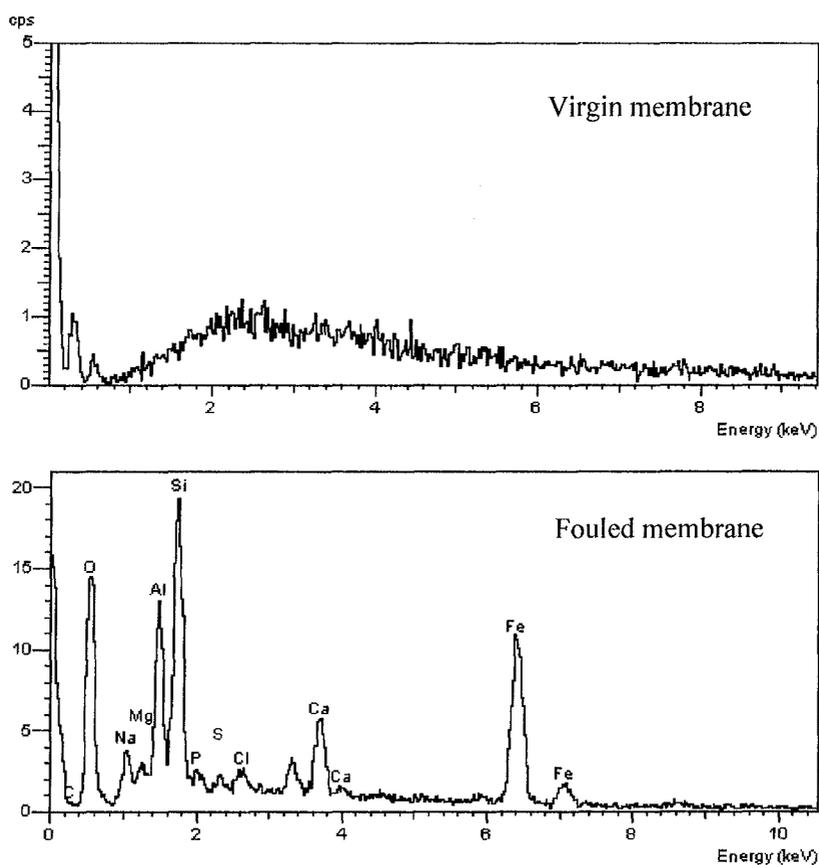
The presence of metallic elements such as iron, aluminium, calcium, and magnesium is clearly evident in the energy dispersive X-ray (EDX) spectrometry graph of the fouling layer as shown in Figure 8. A significant amount of silica can also be observed. Furthermore, Figure 8 reveals a large peak of oxygen and trace amount of other non-metallic elements such as chlorine, sulphur, and phosphate. Such significant amount of oxygen may be attributed to organic matters present in the fouling layer, although it is prudent to note that it can also be from the membrane polymeric material. While a small peak of oxygen can be observed in the EDX spectrometry graph of the virgin membrane, no chlorine, sulphur, or phosphate can be found (see Figure 8).

Figure 8: Energy dispersive X-ray spectrometry of the virgin membrane surface (top) and the foulant layer (bottom). Excitation energy was set at 20 000 kV (note difference in y-axis scale).
