# Appin Colliery explosion reassessed

Bob Kininmonth

This conference paper was originally published as Kininmonth, B, Appin Colliery explosion reassessed, in Aziz, N (ed), 10th Underground Coal Operators' Conference, University of Wollongong & the Australasian Institute of Mining and Metallurgy, 2010, 299-311.

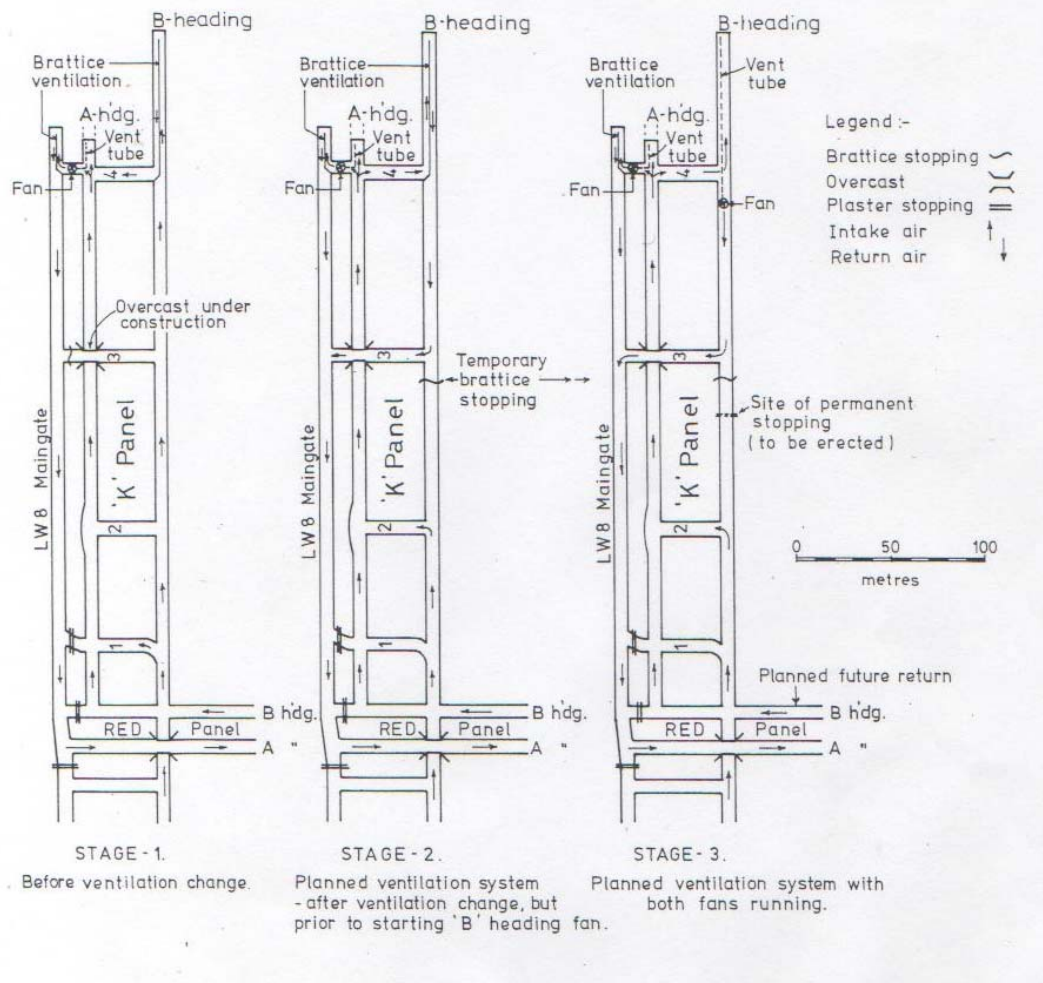
Figure 1 - Changeover plan

Ventilation conditions in K Panel prior to the changeover and the intended affect of the changeover are shown in three stages in Figure 1 as follows:

*Stage 1* shows the panel layout on the morning of Tuesday 24<sup>th</sup> July with A and B headings as intakes and LW8 Maingate as the return. The overcast at the intersection of C/T 3 and A heading was being built. The LW8 Maingate stub was brattice ventilated. An auxiliary fan in C/T 4 provided ventilation for A heading while B heading that had been advanced 70 m as an intake stub, was ventilated on brattice

*Stage 2* shows the post-changeover ventilation flow. This situation was planned to be reached, after completion of the overcast, by erection of the temporary brattice in B heading and removal of the brattice stopping in C/T 3.

*Stage 3* was to be the completion of the changeover with a fan, that had been placed in B heading being used to ventilate the stub.

Near the end of the afternoon shift the overcast had been completed and the brattice in B heading had been erected. The Deputy who was meant to remove the C/T 3 brattice did not do so because he noticed leakage from the overcast. It was near the end of his shift and he left the panel. During the inquiries it could not be established what messages were passed to the evening shift Deputy, but it is clear that for some undetermined time the whole of B heading inbye of C/T 3 was virtually unventilated.
