## Innovative Approach to Maintaining Mine Ventilation During Fan Upgrade at Carborough Downs Mine, June 2008

O. Morgan Carborough Downs Mine

# INNOVATIVE APPROACH TO MAINTAINING MINE VENTILATION DURING FAN UPGRADE AT CARBOROUGH DOWNS MINE, JUNE 2008

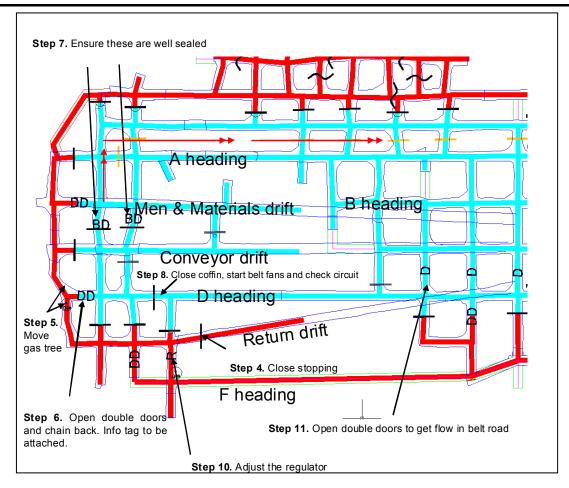
Figure 2 - Plan detailing ventilation changes on stopping of the main fans

- No road the E heading road header district.
- 3. Shut down main fans and ensure underground power is tripped.
- 4. Enter the mine via fan drift and close stopping appliance at bottom of fan drift. (See Figure 2 for appliance locations and steps)
