Coal Operators' Conference

Innovative Approach to Maintaining Mine Ventilation During Fan Upgrade at Carborough Downs Mine, June 2008

INNOVATIVE APPROACH TO MAINTAINING MINE VENTILATION DURING FAN UPGRADE AT CARBOROUGH DOWNS MINE, JUNE 2008

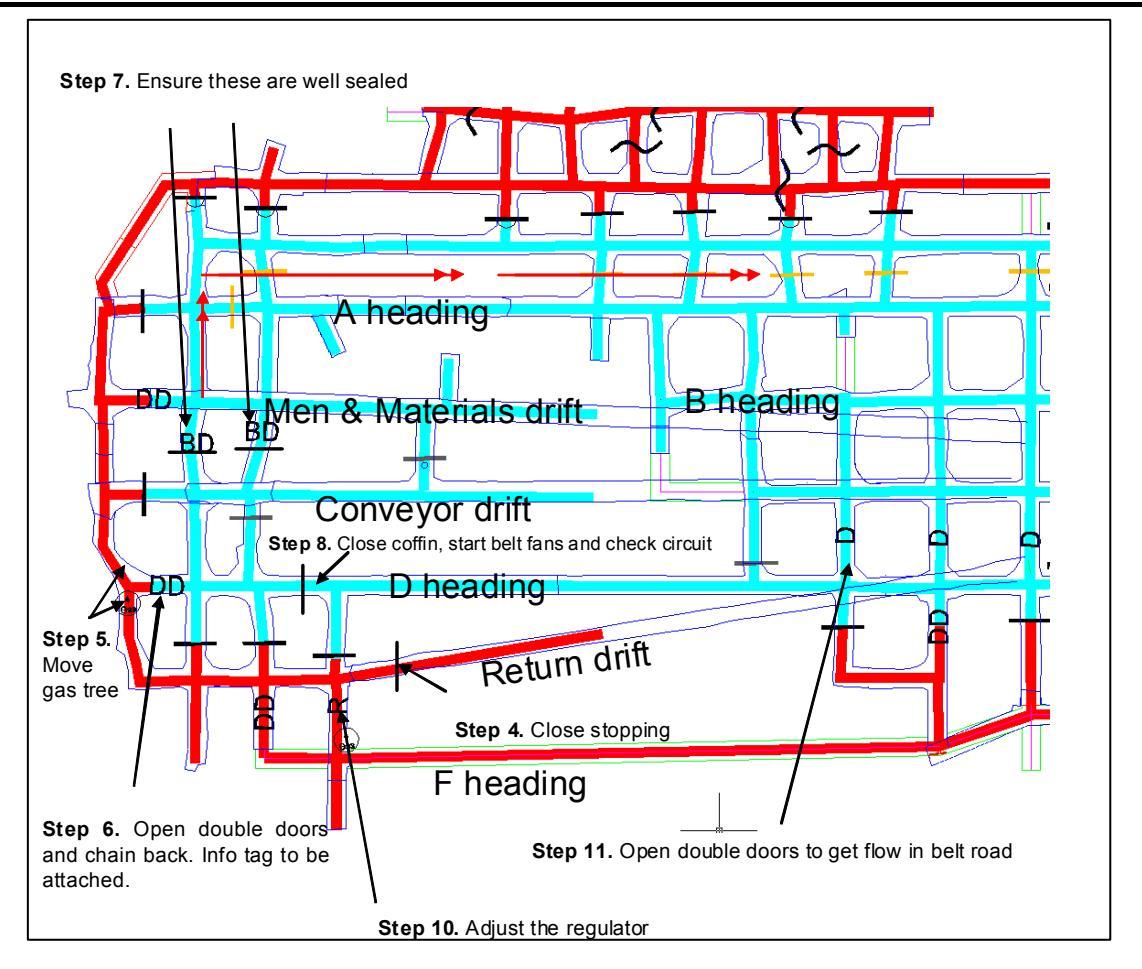
Figure 2 - Plan detailing ventilation changes on stopping of the main fans

Conducting these ventilation changes meant the mine return roadways connected to the conveyor drift which then became the temporary return drift. All other ventilation circuitry remained the same in the mine and therefore only minor changes were required to maintain the gas monitoring system, consisting of a 4 gas tree (CO, CO_2 , O_2 and CH_4) at the shipping container and the minor relocation of the 3 cut-through gas tree (around 5 m).

A sensor change from Explosion Risk Zone/Non-Explosion Risk Zone (ERZ/NERZ) status to environmental status was carried out at 16 cut-through as the return for the outbye drift drivage was closed off during the fan shut down and the face area no-roaded. This negated the requirement to have the ERZ/NERZ boundary in place and re-directed the ventilation that was normally sent to this return further into the mine to the critical face areas. As the drift area was being driven in stone and the face area was only 20 m in, the no-roading of the area was predicted not to cause any concerns with gas accumulations

- 1. Ensure all appliances are pre-erected as required before commencing change and ensure any air leaking through or past the tubes at the road-header fan site has been sealed.

- 2. No road the E heading road header district.
- 3. Shut down main fans and ensure underground power is tripped.
- 4. Enter the mine via fan drift and close stopping appliance at bottom of fan drift. (See Figure 2 for appliance locations and steps)

- 5. Move the four gas tree at 3 line D heading to ensure the it is in the ventilation stream from the northern return.
- 6. Open D heading 3 to 4 cut-through double doors and chain back. Information tag must be attached with reason for doors being open recorded.

- 7. Close both brattice stoppings in B to C heading 4 and 5 cut-through.
- 8. Drop bag around temporary coffin seal D 5 to 6 line.
- 9. Start the three temporary portal fans (Flactwoods 50 kW fans) and check airflow is established.

- 10. Close the regulator in 6 line E-F heading to allow 25 m³/s to return along F heading 6-12 cutthrough. (The target regulator pressure drop is around 60 Pa)

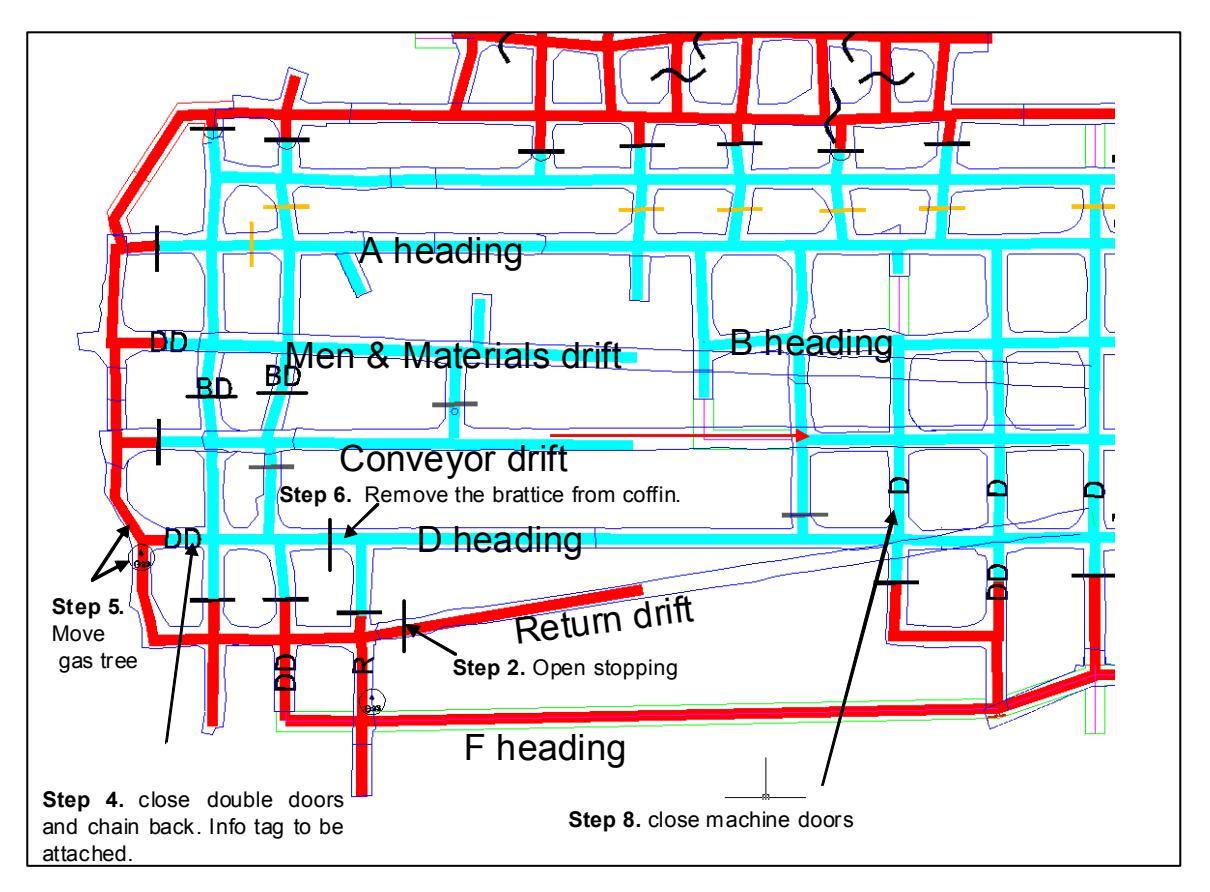
Figure 3 - Plan showing changes for recommissioning of the upgraded fans

The main fan upgrade and ducting change out was actually completed four hours before the schedule and the ventilation circuit was then returned to its original state. Steps in Ventilation change to reestablish the normal mine ventilation were:

- 1. Ensure that the air lock doors, explosion doors and the damper doors on the main fan installation are closed
- 2. Enter the mine via the ventilation drift, dismantle the substantial brattice stopping at the bottom of the drift and store the material in 6 cut-through D-E heading to recover later.
- 3. Shut down the three temporary fans, open all doors and the flap on the Belt Portal and remove brattice
- 4. Close the machine doors at 3-4 line D heading and remove the information tags
- 5. Move the 4 gas tree in 3 line D heading back into the original position in the ventilation stream
- 6. remove the brattice from the temporary stopping in D heading 5-6 cut-through
- 7. Start the main fans
- 8. Close the machine doors at 11 cut-through C-D heading

- Reopen the man door at 14 cut-through E-F to establish ventilation back in the E heading drift district
- 10. Reset the ERZ/NERZ sensor at 16 cut-through E heading
- 11. Change the ERZ/NERZ sensor at 16 cut-through E heading back over from environmental to ERZ/NERZ
- 12. Adjust the brattice stopping out-bye of the overcast in 53 cut-through B heading to allow 10-15 m³/s to ventilate the drill stub 54 cut-through B heading.
- 13. Measure quantities and pressures sufficient to update the mine model and record the panel quantities for the ventilation change report.
- 14. Update the alarm set points on Citect to reflect the relative quantities.
