Coal Operators' Conference

Coal Bumps in an Eastern Kentucky USA Longwall Coal Mine 1989 to 1997

COAL BUMPS IN AN EASTERN KENTUCKY USA LONGWALL COAL MINE 1989 TO 1997

John Hoelle¹

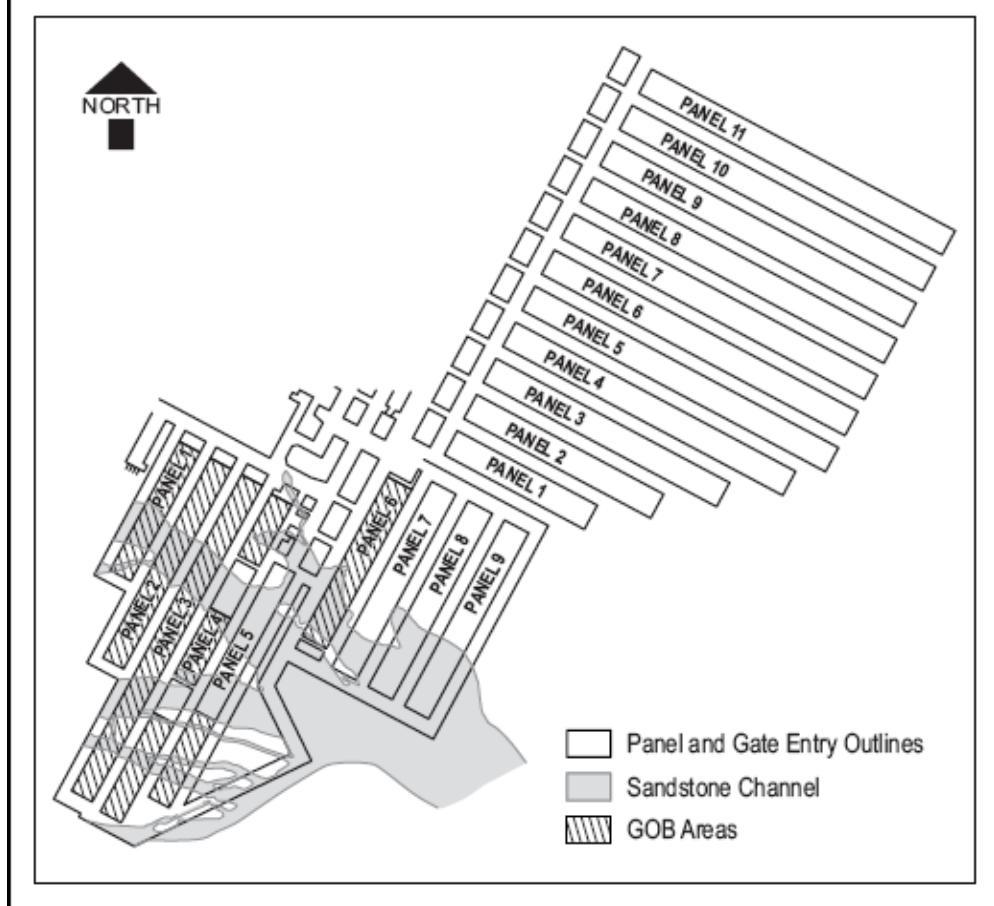
Figure No 2 - Mine plan for Groups 3, 4 and 5

Based on movement of the coal pillars along coal bench-parting contacts and information from nearby mines, there was a regional stress field to the north-east, which trended approximately N55E. Three in-situ stress tests were conducted at the mine. There were five groups of panels with the last three shown in Figure 2. Group 3 is shown with five panels (numbered 1 through 5) and Group 4 had four panels (numbered 6 through 9 in Figure 2). Group 5 is shown with 11 panels. The panel widths were 152 m for Group 3 and 4 shown in Figure 2. Panels 1 through 11 in the last group were 183 m wide.

Mining started in April 1990 in Group 4 and the first panel (panel 6 in Figure 2) was mined without major incident but there were two minor bumps near the beginning of the panel. The second panel (panel 7 in Figure 2) had 2 minor bumps and then a large bump after mining a short distance into the panel, with the bump damaging the shearer. Since this bump was under the same sandstone channel feature that was affiliated with the bumps in Group 3, the decision was made to move the longwall around the sandstone channel. Seven more minor bumps occurred before two large bumps occurred on the 8th October 1990 when the face was under a high mountain peak as well as under a barrier pillar that was in the overlying adverse mine. At about the same time, an abutment pillar in the headgate bumped, totally destroying the integrity of the pillar. No additional bumps occurred during mining of the rest of the panel. The bumps that occurred in the longwall panel were within 46 m of the tailgate

The third panel (panel 8 in Figure 2) was started inbye the sandstone channel. There were no bumps until the panel was under a barrier pillar in the overlying adverse mine when a minor bump followed by a major bump approximately 46 m from the tailgate. The decision was made to conduct an in-panel move around the high cover area that caused the bumps in the second panel. This also avoided the area of the previously destroyed abutment pillar in the tailgate. There were no further bumps in the rest of panel 8 or in panel 9.

The Group 5 set of 11 panels was started in October 1991. These panels were oriented at 90° to the orientation of the first four set of panels, as shown in Figure 2. Since a large number of bumps occurred in Group 4, the size and configuration of the gate road pillars were evaluated and major changes were made. The abutment pillars were designed as a 4-entry yield-abutment-yield arrangement. In the initial two panels, the gate road pillars were designed with the length at 47.5 m and the width at 12 and 47.5 and 12 m respectively. As part of this re-design, the smaller pillars were designed as true yield pillars. The length of the pillars was shortened to 46 m in the third panel and the 4th through the 11th abutment pillars were 45 m long by 46 m wide. The yield pillars remained 12 m wide. The pillar configurations are summarised in Table 2. The memory cut capabilities of the shearer continued to be used in the Group 5 panels.

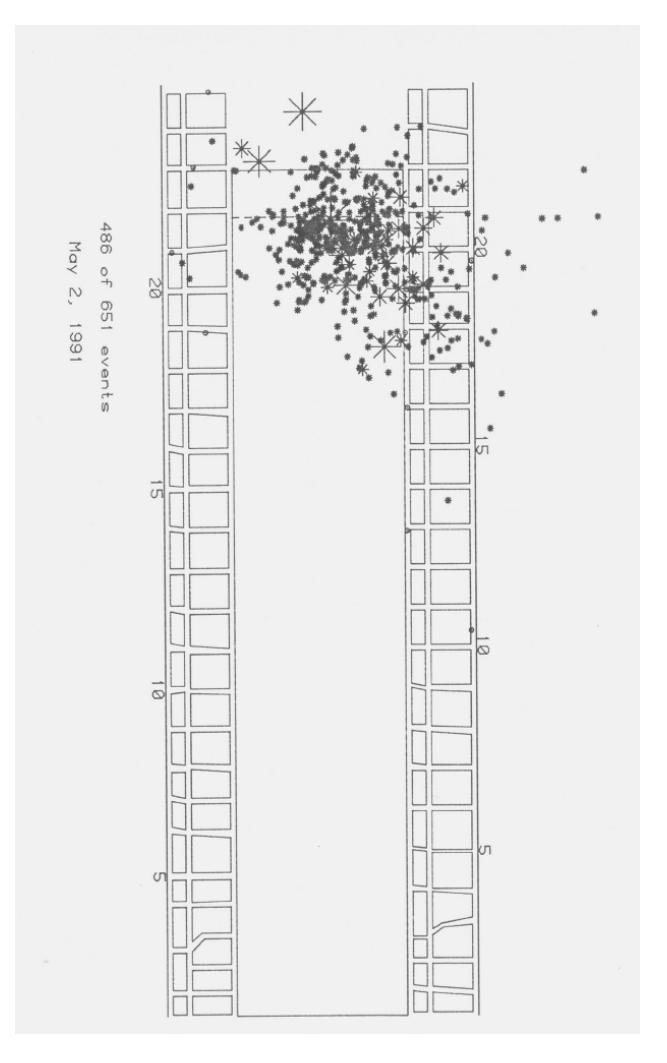
Figure 5 - Microseismic activity, Group 4, Panel 4

- The US Bureau of Mines installed geophones in the head and tail gates starting in Panel 4 of Group 3 with the objective of determining if precursors of events could be obtained. An example of the number of events that were recorded in one of the panels (Group 4, panel 4) is shown in Figure 5. However, a definitive precursor was never determined (Coughlin and Rowell, 1993). Microseismics were recorded from mid 1989 until mid 1993.
