## Innovative Approach to Maintaining Mine Ventilation During Fan Upgrade at Carborough Downs Mine, June 2008

O. Morgan  
*Carborough Downs Mine*

M. Watkinson  
*Vale Australia*

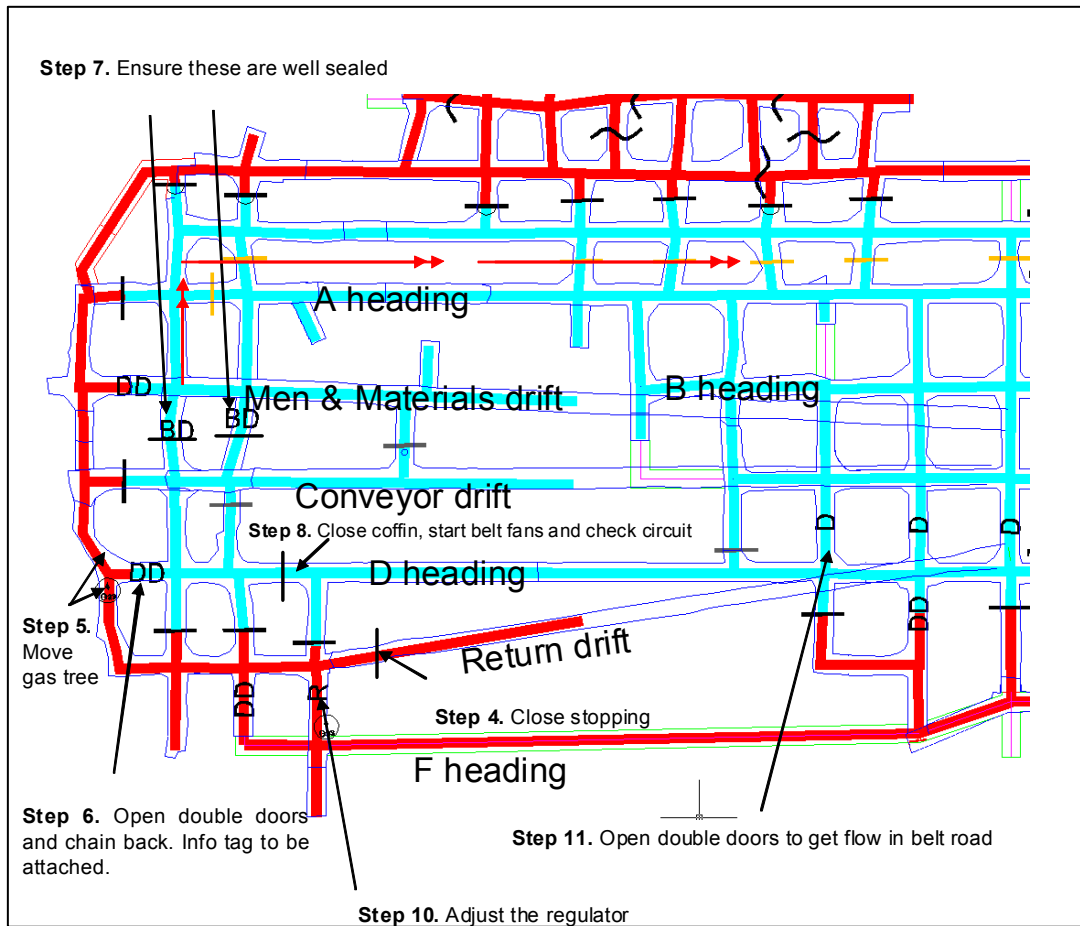
**Figure 2 - Plan detailing ventilation changes on stopping of the main fans**

2. No road the E heading road header district.
3. Shut down main fans and ensure underground power is tripped.
4. Enter the mine via fan drift and close stopping appliance at bottom of fan drift. (See Figure 2 for appliance locations and steps)

Conducting these ventilation changes meant the mine return roadways connected to the conveyor drift which then became the temporary return drift. All other ventilation circuitry remained the same in the mine and therefore only minor changes were required to maintain the gas monitoring system, consisting of a 4 gas tree (CO, CO<sub>2</sub>, O<sub>2</sub> and CH<sub>4</sub>) at the shipping container and the minor relocation of the 3 cut-through gas tree (around 5 m).

A sensor change from Explosion Risk Zone/Non-Explosion Risk Zone (ERZ/NERZ) status to environmental status was carried out at 16 cut-through as the return for the outbye drift drivage was closed off during the fan shut down and the face area no-roaded. This negated the requirement to have the ERZ/NERZ boundary in place and re-directed the ventilation that was normally sent to this return further into the mine to the critical face areas. As the drift area was being driven in stone and the face area was only 20 m in, the no-roading of the area was predicted not to cause any concerns with gas accumulations
