Coal Operators' Conference

# Innovative Approach to Maintaining Mine Ventilation During Fan Upgrade at Carborough Downs Mine, June 2008

O. Morgan  
*Carborough Downs Mine*

M. Watkinson  
*Vale Australia*

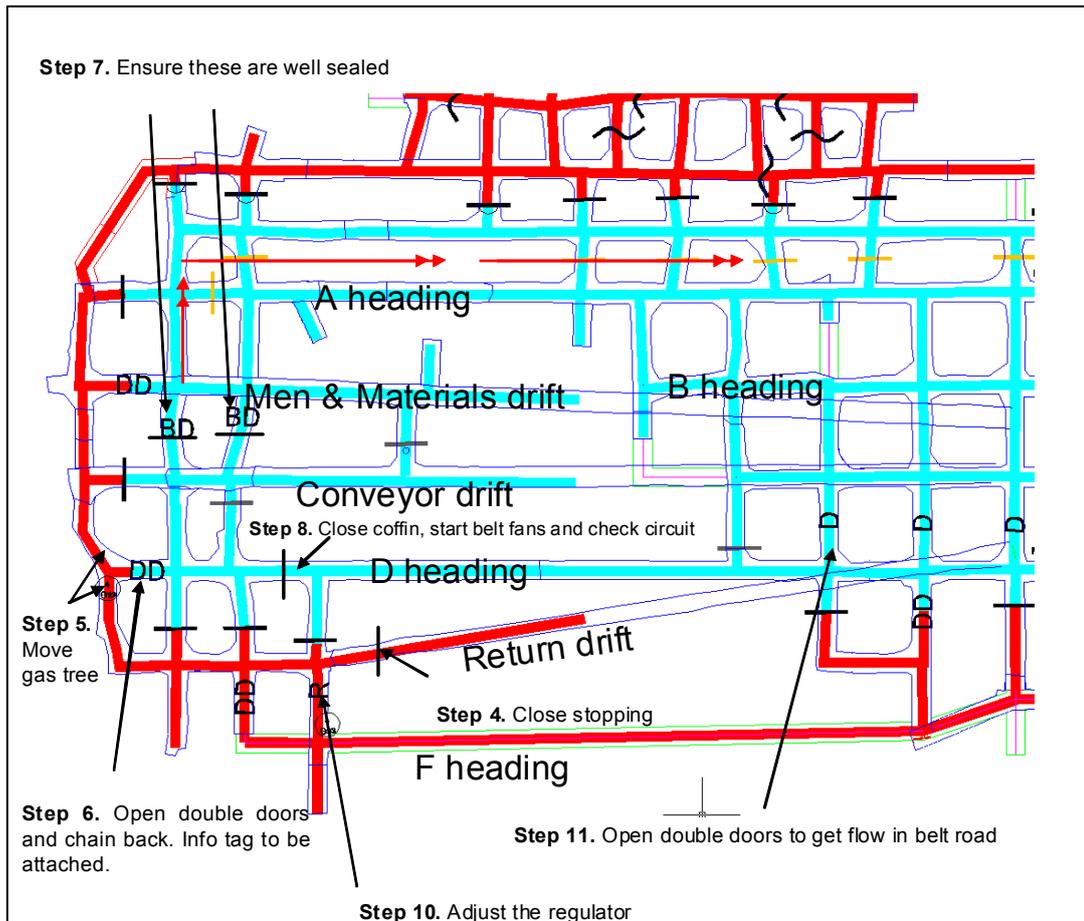
**Figure 2 - Plan detailing ventilation changes on stopping of the main fans**

2. No road the E heading road header district.
3. Shut down main fans and ensure underground power is tripped.
4. Enter the mine via fan drift and close stopping appliance at bottom of fan drift. (See Figure 2 for appliance locations and steps)

Conducting these ventilation changes meant the mine return roadways connected to the conveyor drift which then became the temporary return drift. All other ventilation circuitry remained the same in the mine and therefore only minor changes were required to maintain the gas monitoring system, consisting of a 4 gas tree (CO, CO<sub>2</sub>, O<sub>2</sub> and CH<sub>4</sub>) at the shipping container and the minor relocation of the 3 cut-through gas tree (around 5 m).

A sensor change from Explosion Risk Zone/Non-Explosion Risk Zone (ERZ/NERZ) status to environmental status was carried out at 16 cut-through as the return for the outbye drift drivage was closed off during the fan shut down and the face area no-roded. This negated the requirement to have the ERZ/NERZ boundary in place and re-directed the ventilation that was normally sent to this return further into the mine to the critical face areas. As the drift area was being driven in stone and the face area was only 20 m in, the no-roding of the area was predicted not to cause any concerns with gas accumulations
