# The Illawarra Escarpment

R. W. Young

This report was originally published as Young, RW, The Illawarra Escarpment, Wollongong Studies in Geography No.2, Department of Geography, University of Wollongong, 1980, 4p.

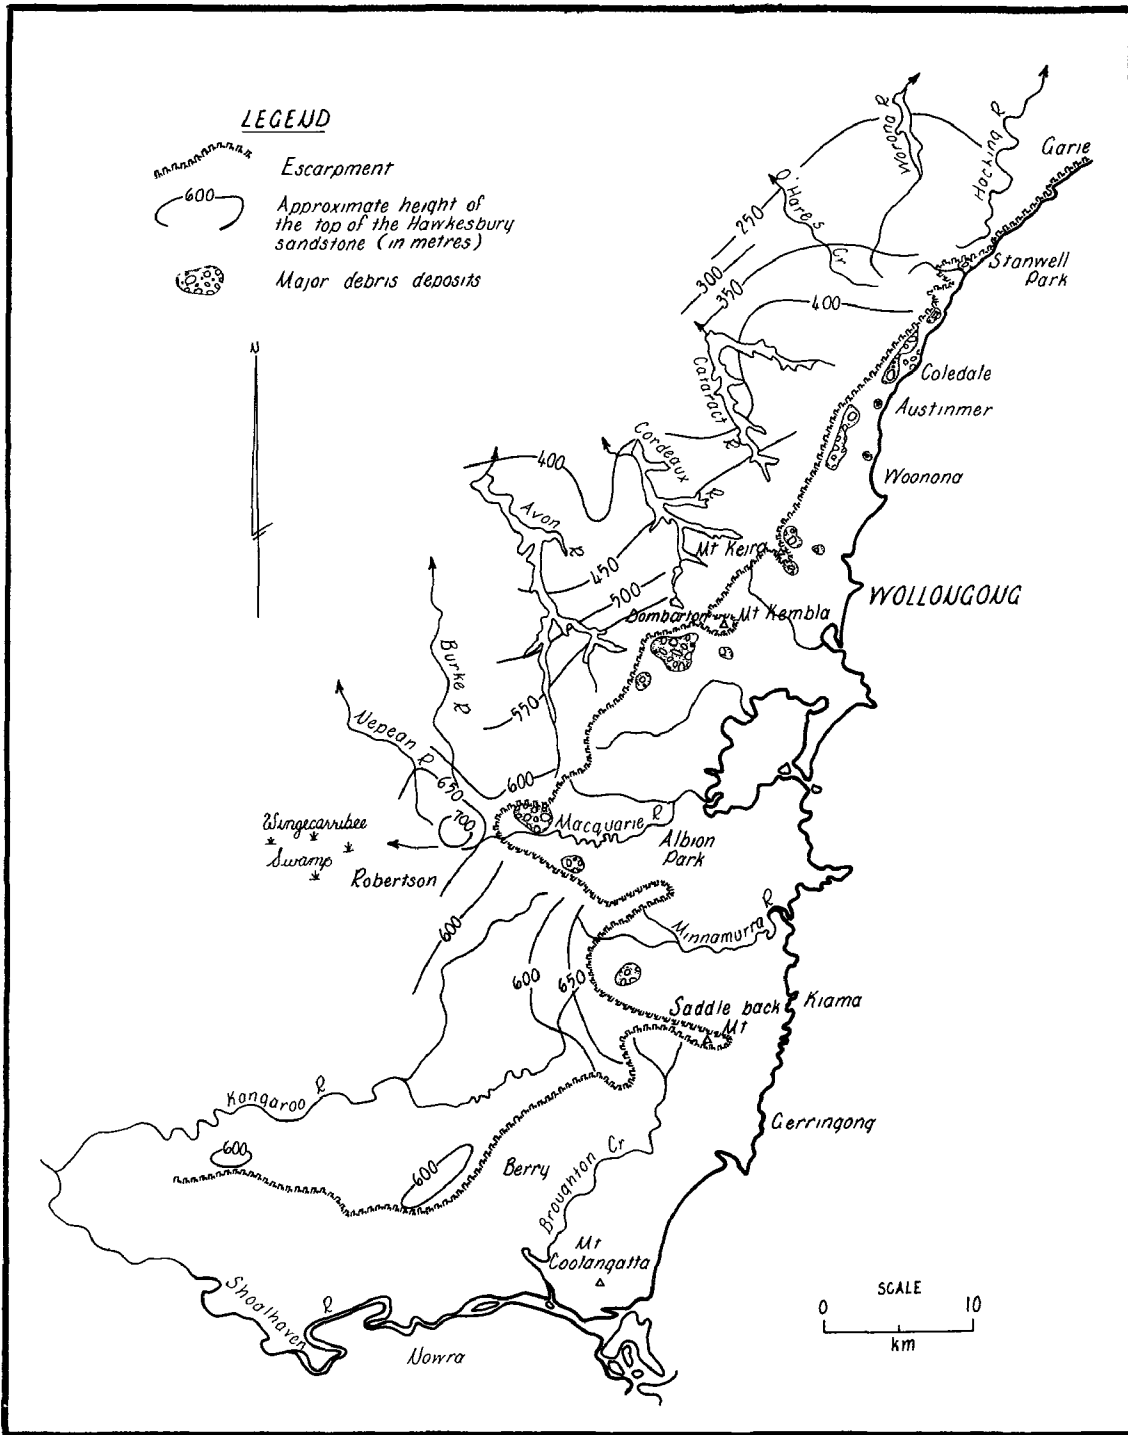
Although the escarpment is often regarded as beginning at Stanwell Park, it extends farther northwards forming the sea cliffs of the Royal National Park (Fig. 1). Along this northern extremity cliffs of 200 to 300m are broken only by short valleys and small bays. South of Coal Cliff the shoreline and the escarpment diverge until the coastal plain reaches a width of some 20km near Albion Park. Over this same section the height of the escarpment increases from about 350m to 650m; thereafter it remains fairly constant between 650 and 700m. South of Albion Park the escarpment swings eastward until its foothills reach the sea between Kiama and Gerrigong. Although an outlying line of hills continues southwards within a few kilometres of the coastline, the main escarpment swings again to the southwest, then near Nowra turns westward. It can be traced as far as the junction of the Kangaroo and Shoalhaven Rivers where it becomes indistinguishable in a complex network of canyons and cliffs.

The significance of the concentration of erosive energy along the major streams is readily seen in the contrast between the deep valleys cut behind the escarpment by the tributaries of the Nepean and the much smaller valleys cut into the face of the escarpment by the tiny coastal streams. In the extreme north the Hacking River has eroded a long valley parallel to, and only a few kilometres or so behind the sea cliffs, while none of the coastal streams has been able to breach the intervening divide. Only in the vicinity of Otford, where Stanwell Creek cuts a few kilometres back into the escarpment and where the Hacking Valley lies immediately behind the sea cliffs, has even the sandstone capping of this divide been removed. Farther south much larger coastal streams such as the Macquarie Rivulet have worn the escarpment well back from the shoreline. Then behind Kiama, where the major drainage lines

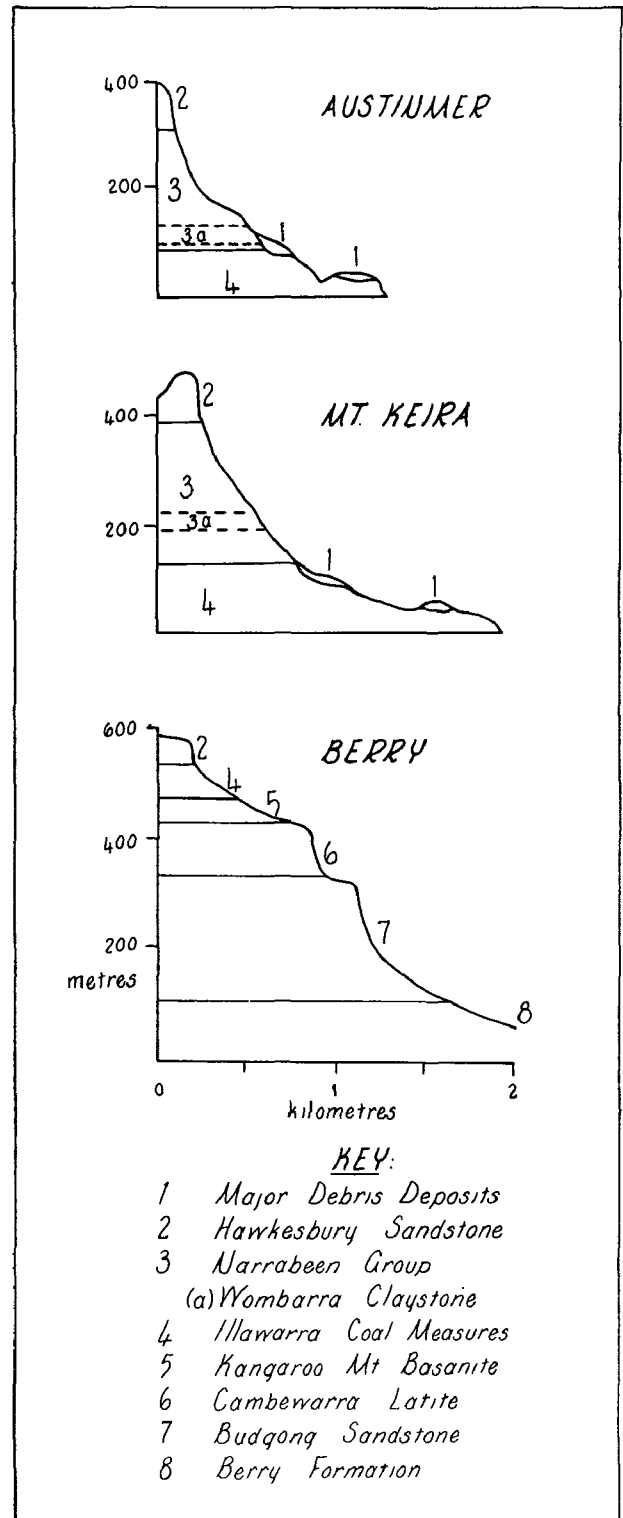
The main expression of the varied resistance of rock types to erosion is in the benched topography of the escarpment, for some rocks can support much steeper slopes than can others (Fig. 2). Along almost its entire length the escarpment is capped by a prominent cliff line of Hawkesbury Sandstone. Even where little of the sandstone remains it still forms near-vertical faces. The small flat-topped sandstone residuals on the Cambewarra Range between Berry and Nowra, for example, are strikingly reminiscent of the mesas of arid lands, and incidentally demonstrate that mesas are by no means limited to dry climates as many textbooks would have us believe. The cliffs seem to be retreating very slowly for, with the exception of the great rock fall at Dombarton near Dapto where subsidence due to mining may have had some effect, there is evidence of only a few quite small contemporary collapses along the entire escarpment.

Not only do the slope forms change vertically on the escarpment, they also change laterally along its length as additional beds are exposed. For example on the northern sea cliffs, where the Narrabeen Group is thick and is being undercut by wave erosion, the Bulgo, Scarborough and Coal Cliff Sandstones form bold vertical faces. Farther south these three sandstones form only small, discontinuous cliff lines. In contrast to the steep slopes on the sandstones, the claystones of the Narrabeen Group support much gentler slopes. There are two prominent claystone benches north of Wollongong, one lying on the Stanwell Park Claystone and a generally larger one lying on the Wombarra Claystone. The Wombarra Claystone bench has been the site of recent residential development and, as is discussed below, the weakness of the rock poses serious land slip problems.

As exposures firstly of the Coal Measures and then on the Gerringong Volcanics increase, the pattern of benching becomes more and more complex. Excellent examples of these numerous breaks of slope can be seen around Kiama and Jamberoo, where the latites and some of the tougher sandstones stand in quite steep faces. South of Saddleback Mountain secondary cliffs, especially those developed on the Cambewarra Latite and the Budgong Sandstone, become increasingly prominent on the middle slopes of the escarpment. In fact the Budgong Sandstone forms by far the most prominent cliffs on the escarpment west of Nowra. In contrast to cliffs developed on this sandstone, much gentler slopes are found on the shales of the Berry Formation in the Berry and Nowra districts, though thin sandier beds in the shales do form small sharp breaks of slope north of Nowra. Yet of all the slope forms in the entire region probably the most visually striking are the steep convex slopes formed on the volcanic agglomerate (a rock composed of fragments of volcanic material) of the old plug at Saddleback Mountain. Saddleback looms large from virtually all sections of the escarpment and the coastal lowlands.
