# The Illawarra Escarpment

R. W. Young

This report was originally published as Young, RW, The Illawarra Escarpment, Wollongong Studies in Geography No.2, Department of Geography, University of Wollongong, 1980, 4p.

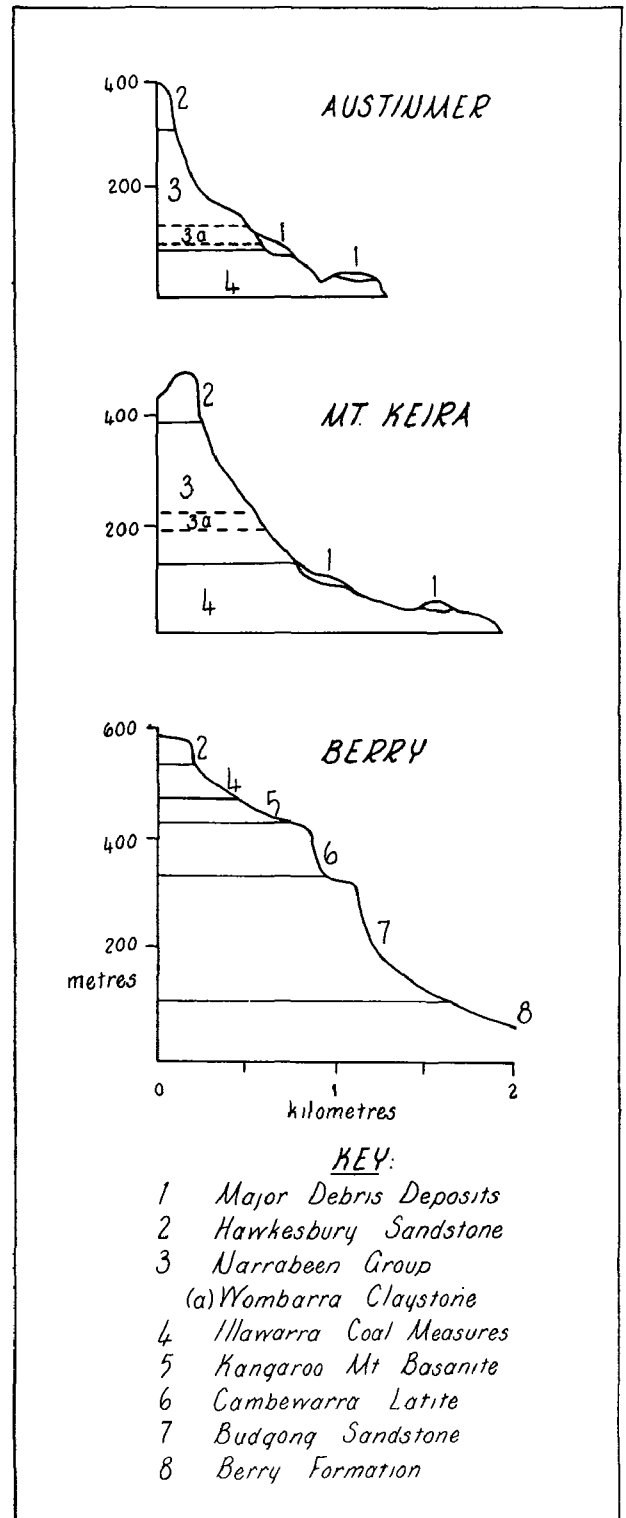
The main expression of the varied resistance of rock types to erosion is in the benched topography of the escarpment, for some rocks can support much steeper slopes than can others (Fig. 2). Along almost its entire length the escarpment is capped by a prominent cliff line of Hawkesbury Sandstone. Even where little of the sandstone remains it still forms near-vertical faces. The small flat-topped sandstone residuals on the Cambewarra Range between Berry and Nowra, for example, are strikingly reminiscent of the mesas of arid lands, and incidentally demonstrate that mesas are by no means limited to dry climates as many textbooks would have us believe. The cliffs seem to be retreating very slowly for, with the exception of the great rock fall at Dombarton near Dapto where subsidence due to mining may have had some effect, there is evidence of only a few quite small contemporary collapses along the entire escarpment.

Not only do the slope forms change vertically on the escarpment, they also change laterally along its length as additional beds are exposed. For example on the northern sea cliffs, where the Narrabeen Group is thick and is being undercut by wave erosion, the Bulgo, Scarborough and Coal Cliff Sandstones form bold vertical faces. Farther south these three sandstones form only small, discontinuous cliff lines. In contrast to the steep slopes on the sandstones, the claystones of the Narrabeen Group support much gentler slopes. There are two prominent claystone benches north of Wollongong, one lying on the Stanwell Park Claystone and a generally larger one lying on the Wombarra Claystone. The Wombarra Claystone bench has been the site of recent residential development and, as is discussed below, the weakness of the rock poses serious land slip problems.

As exposures firstly of the Coal Measures and then on the Gerringong Volcanics increase, the pattern of benching becomes more and more complex. Excellent examples of these numerous breaks of slope can be seen around Kiama and Jamberoo, where the latites and some of the tougher sandstones stand in quite steep faces. South of Saddleback Mountain secondary cliffs, especially those developed on the Cambewarra Latite and the Budgong Sandstone, become increasingly prominent on the middle slopes of the escarpment. In fact the Budgong Sandstone forms by far the most prominent cliffs on the escarpment west of Nowra. In contrast to cliffs developed on this sandstone, much gentler slopes are found on the shales of the Berry Formation in the Berry and Nowra districts, though thin sandier beds in the shales do form small sharp breaks of slope north of Nowra. Yet of all the slope forms in the entire region probably the most visually striking are the steep convex slopes formed on the volcanic agglomerate (a rock composed of fragments of volcanic material) of the old plug at Saddleback Mountain. Saddleback looms large from virtually all sections of the escarpment and the coastal lowlands.
