The role of vegetation in catastrophic floods: A spatial analysis

Bronte Smith

Smith, Bronte, The role of vegetation in catastrophic floods: A spatial analysis, Bachelor of Environmental Science (Honours), School of Earth & Environmental Science, University of Wollongong, 2013.
<http://ro.uow.edu.au/thsci/65>

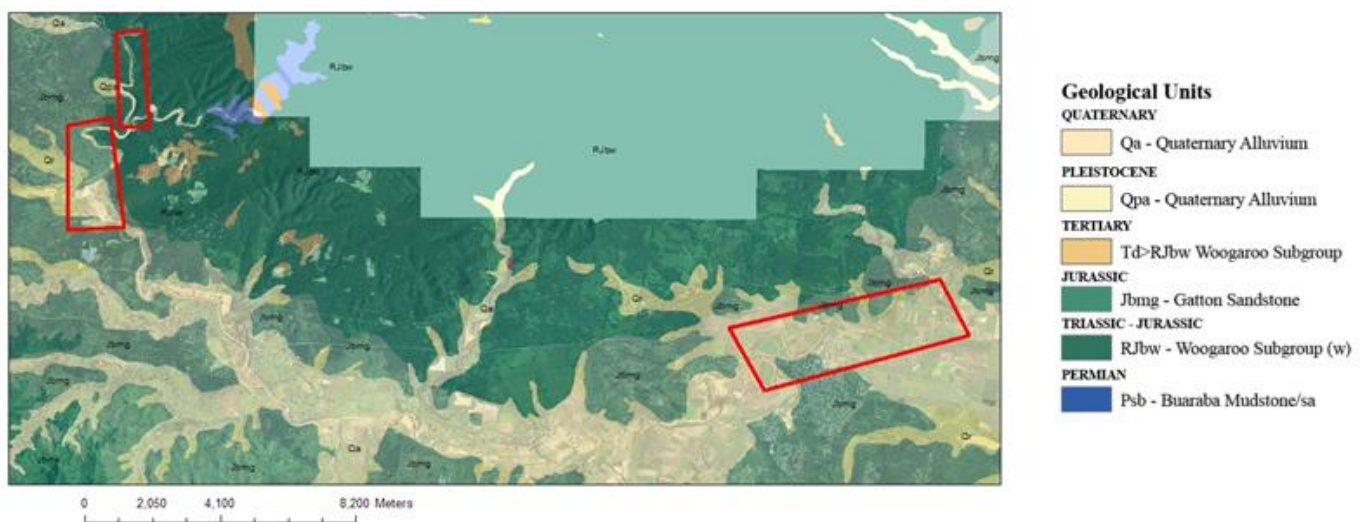
Figure 5 Geology of the Lockyer Valley Catchment (Geological Survey of Queensland 2011). Red boxes outline selected study reaches: Reach 1, Reach 2 and Reach 3.

More continuous floodplain development occurs in the lower gradient reaches downstream, shown in Figure 5, and floodplain pockets are confined by Gatton sandstone. Floodplains throughout the catchment are infilled to varying amounts and are formed of alternating, horizontally bedded layers of Quaternary alluvium, comprising fine grained silts, clays and coarser sand units (Geological Survey of Queensland 2011; Grove et al. 2013). Figure 5 shows the geology of the Lockyer Valley catchment, with selected study reaches highlighted.

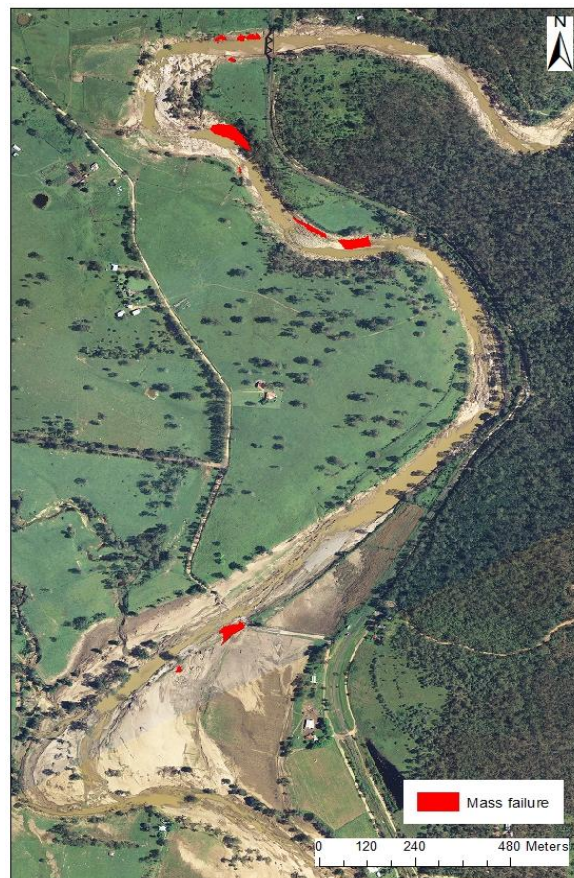
Figure 28 Mass failures occurring in reach 2.

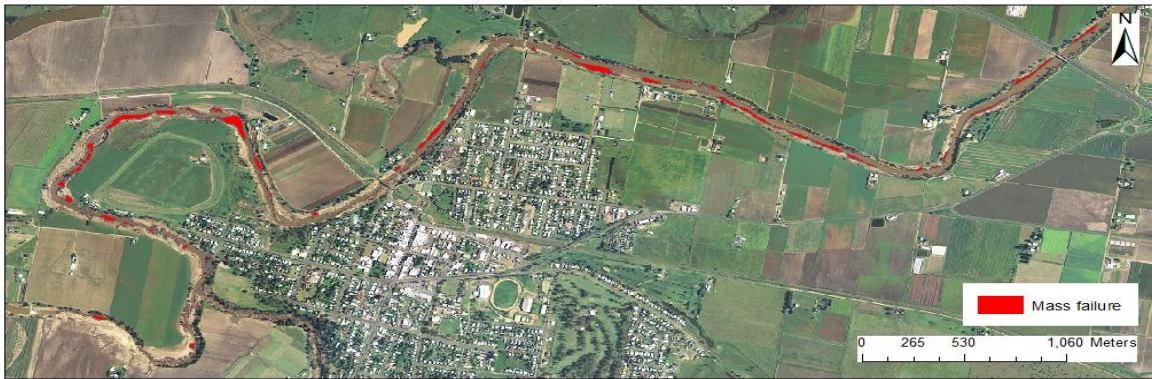
Figure 30 Mass failures occurring in reach 3.

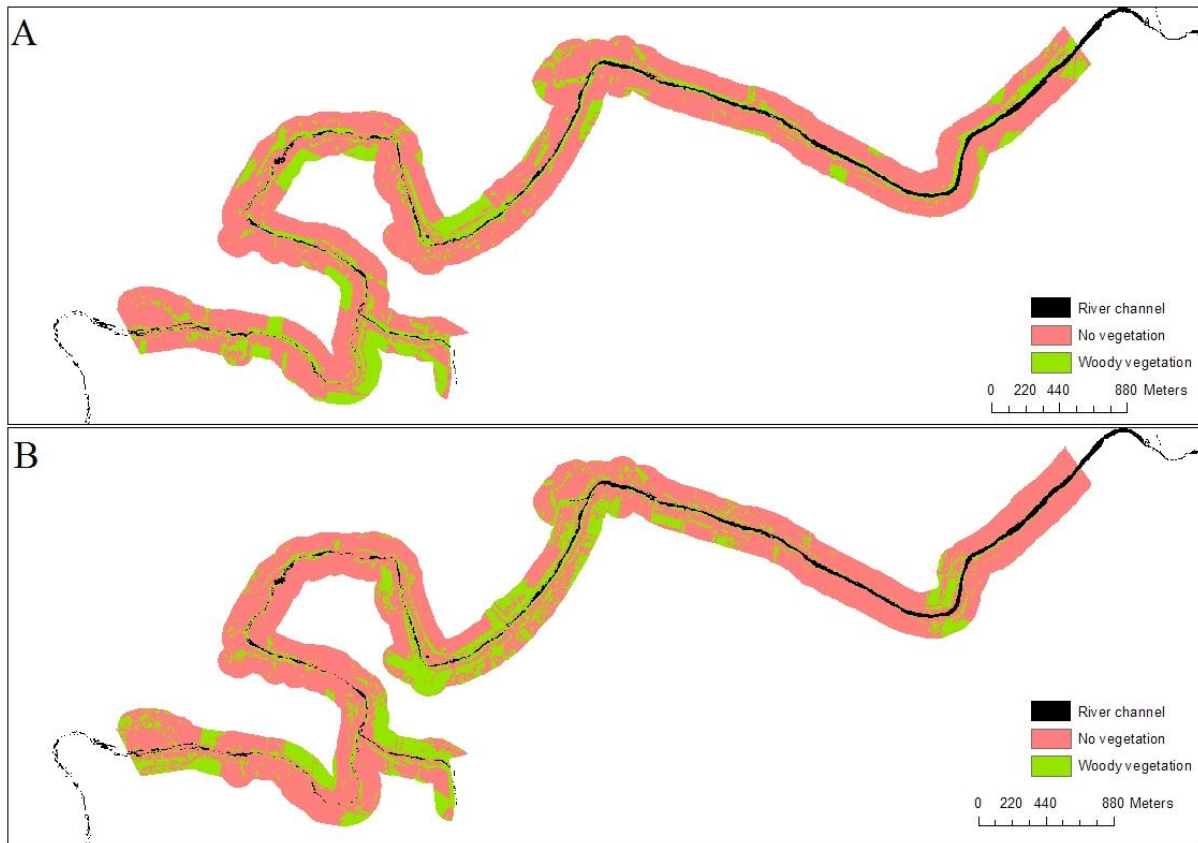
A2. 3 Vegetation classifications for reach 3 in 1971 (A) and 1974 (B).
