## Design and Testing of a Rated Flexible Membrane Stopping

V. Mutton  
*Minova Australia Pty Ltd*

N. Aziz  
*University of Wollongong, naj@uow.edu.au*

## DESIGN AND TESTING OF A RATED FLEXIBLE MEMBRANE STOPPING

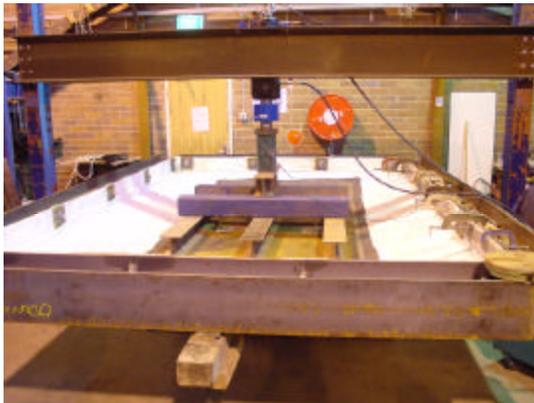
The fabric loading was carried out using a 70t capacity hydraulic jack mounted at the centre of the load frame. The ram was powered by a Rexroth 630 ATO pressure pack with the applied load monitored by an Interface Model 24/HL load cell. Figure 1 details the frame assembly and load testing position.

**Fig 1 - View of the testing frame with Fabric A attached.**

The first test program involved the static load testing of Fabric A and Fabric B. Fabric A was a white PVC non-woven fabric of thickness 0.45mm and tensile strengths documented as 40 kN/m. Fabric B was a green canvas type fabric of thickness 0.65mm with no documented strength characteristics. Both fabrics were fixed to the steel frame by wrapping the periphery of the fabrics around 150mm wide wire mesh (aperture size 50mm x 75mm) then bolting to the steel frame using 150mm square steel plates and 20mm diameter bolts. In addition to this, plywood and G clamps were used to further distribute load of the cloth around the frame perimeter. Figure 1. shows Fabric A loaded into the test frame.

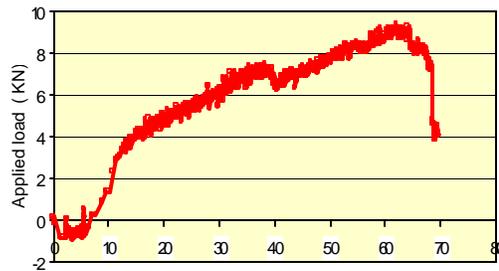
**Fig 2 - Hydraulic jack load vs ram displacement**

Loading of Fabric A commenced with the placement of 1112.10 kg of weights. It was evident during the placement of these weights that the fabric was unevenly loaded. This uneven tension was further evident during loading via the hydraulic ram, which eventually led to failure of the fabric at a total load of 2032 kg, which was well short of the desired load needed to achieve 14 kPa (2psi). Figure 2 shows the Hydraulic jack load vs the ram displacement. Fabric B also exhibited uneven loading with failure occurring during placement of the weights at 661kg.

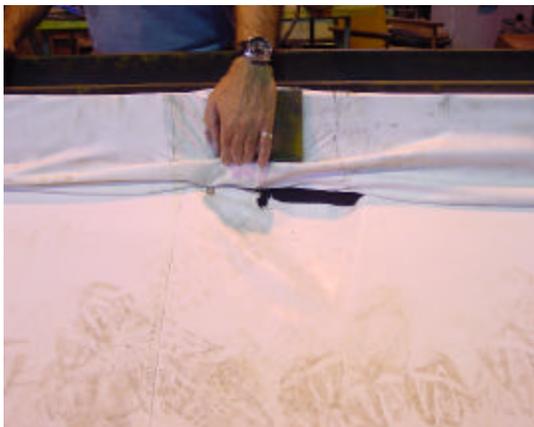
Both Fabrics exhibited failure at the anchor plate zones located in the central positions on the long span section. This failure was due to point loading of the fabrics at these points and characterized by initial puncturing of the fabric then tear propagation of the fabric around the plate zones. Figure 3. shows the failure of Fabric A around plate zones.

**Fig 3 - Fabric A failure at plate zones**

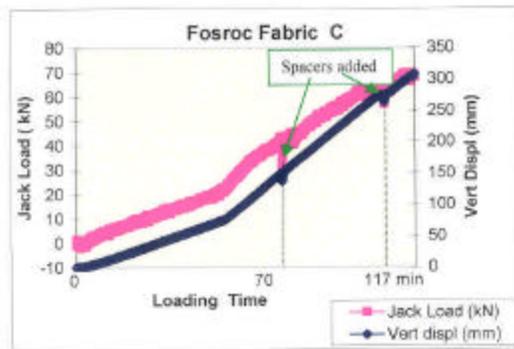
Several stages of failure were evident during the test program including tearing of the TSL, snapping of the geogrid around the plate zones and tearing of the fibrous mat around the plate zones. A total load of 7900kg was achieved during the test with a vertical displacement of 300mm. Figure 4. shows the three failure events seen during the test. Figure 5 shows the hydraulic jack load vs the ram displacement for the test program 2.

**Fig 4 – Jack load and FFC sagging versus loading time**

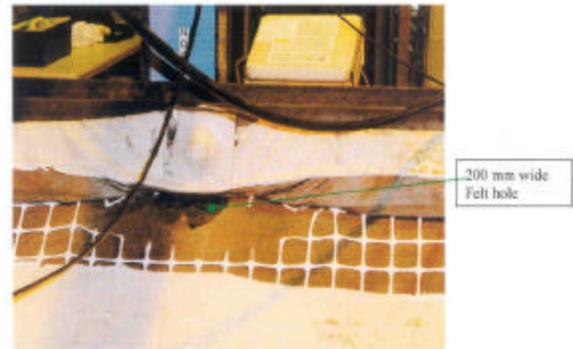
**Fig 5 – 280mm lateral width of the torn felt around the central plate @ 68 kN load (total applied load – 0.795t)**

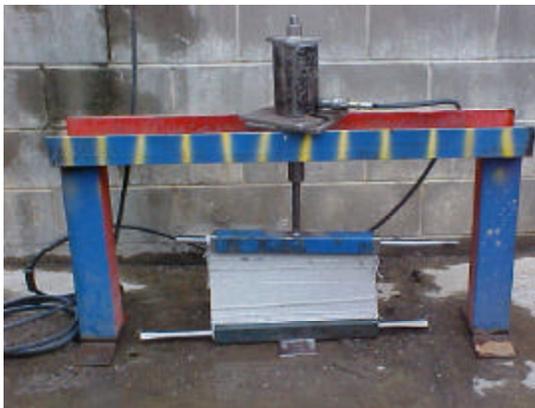
Test program 3 involved the testing of both these items with Fabric D selected for the test work. Fabric D was a PVC coated ultrahigh tensile strength woven fabric with weight of 2kg/m, thickness of 1.7mm and tensile strength of 200kN/m. Initial in-house testing by fixing Fabric D in a steel slot structure indicated that even distribution of load could be more effectively achieved. Figure 6 and Figure 7 detail the test work and slot method used to achieve loads of 7000kg/m. Based on this result it was thought that over the 4m length of the loading frame a load near 28t could be achieved and would give greater confidence to undertake further testing at UOW.

**Fig 6 - In house testing of fixing system and Fabric D**

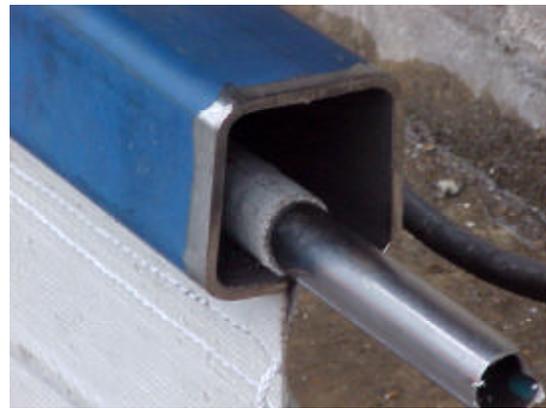
**Fig 7 - Slot fixing system**

The final test program involved fixing fabric D using the slot system along the 4m length of the testing frame and bolting the cloth using square steel plates with rubber washers along the 2.7m lengths. This test program was completed in two sections due to early failure of the slot fixing system in the first section. Adjustments were made to the steel grade of the slot and the method used to hold the fabric in the slot. Section 2 involved loading of fabric D with the same method as for the previous fabrics tested with the addition of sand to further distribute load. After placement of the initial 2226kg of weight it was evident the load was more evenly distributed along the 4m length. During testing additional gussets were added to bond the slot to the test frame and stop bending of the slots. Further timber posts were also added to support the test frame as buckling of the 4m length was beginning to occur. A maximum load of 20.371 t was applied to the cloth, equivalent to 2.71psi

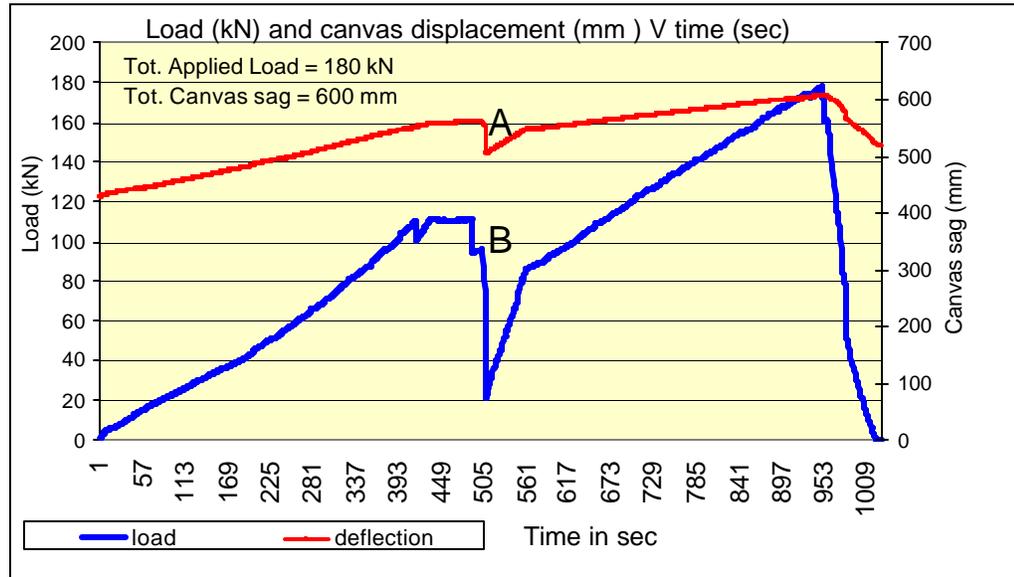
and near to the 2.8psi static load capacity of the test frame. Figure 8 details the Hydraulic jack loads and vertical displacement of Fabric D during the section 2 tests. Figure 9 details Fabric D fixed in the test frame during loading and Figure 10 shows the tests frame buckling under load.

Fig 8 - Hydraulic jack load vs vertical displacement for Fabric D

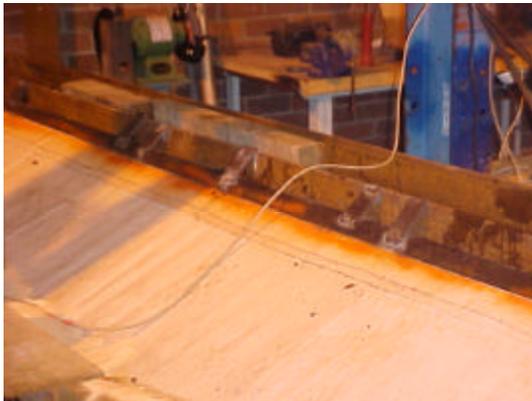
Fig 9 - Fabric D load distribution in slot

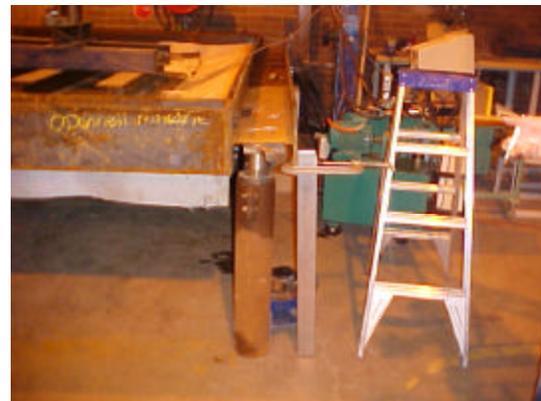
Fig 10 - Buckling of the test frame under load

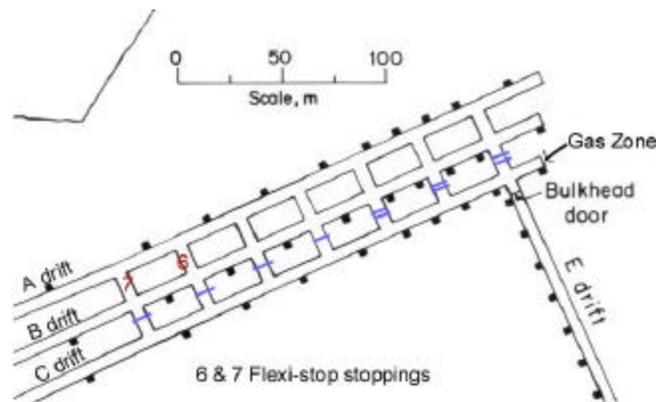
LLEM is one of the world's foremost laboratories in conducting large-scale explosion testing of seals and stoppings and the test area is designed to withstand explosion pressures up to ~700 kPa (~100 psi). Figure 11 shows an expanded view of the stopping test area in the multiple-entry section of LLEM.

Fig 11 – LLEM Layout

The Flexi-Stop flexible stopping designs were located in cut-through 6 at 167.6 metres and cut-through 7 at 197.8 metres from the face of C-drift. Refer to Figure 11 for details.

Two Flexi-Stop stoppings were constructed in cut-throughs 6 and 7 between B- and C- drifts. There were already seals in the first three cut-throughs from the simulated face and concrete block stoppings in cut-throughs 4 and 5. Before each explosion test a hydraulically operated, track mounted, concrete and steel bulkhead was positioned across E-drift to contain the explosion pressures in C-drift.

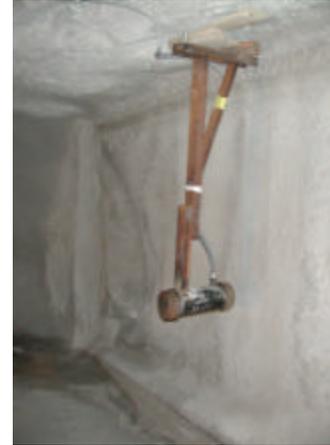
This system collected the sensor data at a rate of 1,500 samples /s over a 5 s period. The data was then processed using LabView software and presented in graphic and tabular format. The reported data were averaged over 10 ms (15 point smoothing). This PC data analysis system allows the data traces to be expanded in time and pressure (or other sensor value) so that the peak values can be read and recorded precisely. Figure 12 shows a pressure sensor mounted on the C-drift side of the Flex-Stop stopping in cut-through 7.

Fig 12– Pressure Transducer

Each drift has ten environmentally controlled data-gathering stations inset in the rib wall. Each data-gathering station houses a strain gauge pressure transducer that is perpendicular to the entry length (and explosion gas flow) and therefore measures the static pressure generated by the explosion. Pressure transducers were located on the C-drift rib at locations 152.7, 182.3 and 230.7 metres from the face near the Flexi-Stop locations. Most of the pressure transducers were rated at 0-100 psia, with 0-5 V output, infinite resolution, and response time less than 1 ms. A few 0-50 psia transducers were also used.

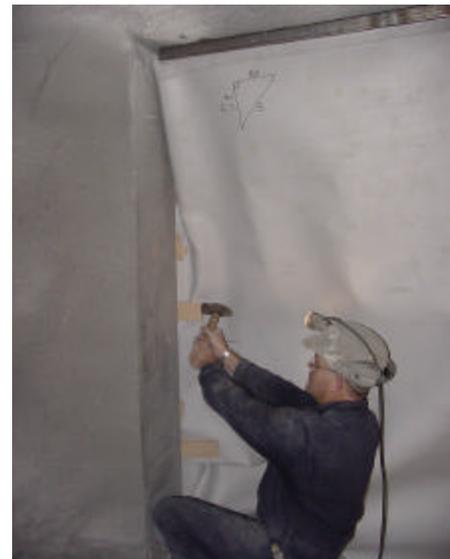
In October 2003 contractors had shotcreted roof to floor rib slots into both stopping sites using the dry application process. These slots were of 20 mm in width and 200 mm in depth. The roof section of each site had been smoothed with shotcrete. The floor of the roadways was a pad of reinforced concrete laid onto a gravel base overlying the limestone. Figure 13 shows the B-drift side of cut-through 6 stopping cloth being wedged into the shotcreted slot.

Figure 13 – Rib Strengthening

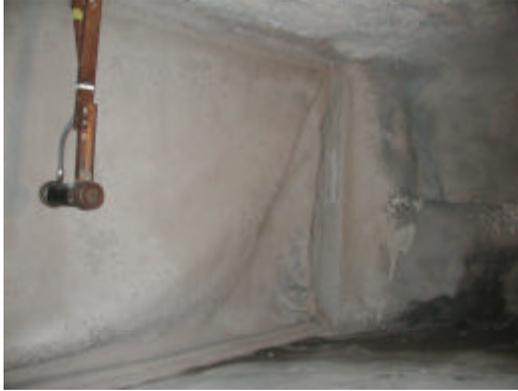
Following the first explosion test (# 359), 4 (for cut-through 7) and 5 (for cut-through 6) equally spaced 25 mm diameter by 400 mm length resin bolts were installed through the cloth material and into each rib (embedded 300 mm) on the C-drift side of the rib slots. Figure 14 shows the finished stopping in cut-through 6 and Figure 15 shows the finished stopping in cut-through 7. Note the curve in the roof profile of cut-through 7 shown in Figure 15.

**Fig 14 – Finished stopping cut-through 6**

The stopping in cut-through 6 failed after the central bolts holding the RHS beam bent and snapped dislodging the upper portion of the stopping.

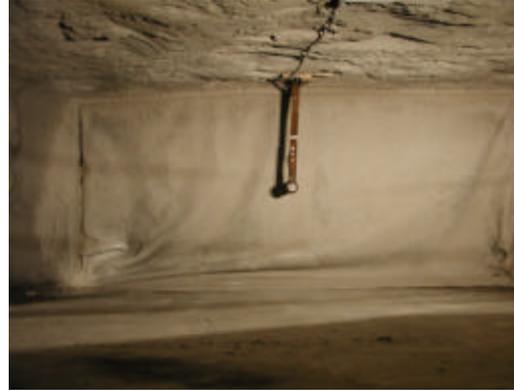
**Fig 15 – Finished stopping cut-through 7**

Test 462# resulted in total pressures of 42.7 kPa (6.1 psi) and 37.8 kPa (5.4 psi) on the stoppings in cut-throughs 6 and 7 respectively. The stopping in cut-through 7 failed when the slot in the roof RHS opened up under the high tension loads on the cloth, letting the cloth go in the central roof portion. This was not an unexpected result for a 14 kPa designed stopping.
