Coal Operators' Conference

# Design and Testing of a Rated Flexible Membrane Stopping

This conference paper was originally published as Mutton, V, Aziz, N & Hawker, R, Design and Testing of a Rated Flexible Membrane Stopping, in Aziz, N (ed), Coal 2004: Coal Operators' Conference, University of Wollongong & the Australasian Institute of Mining and Metallurgy, 2004, 127-135.

## DESIGN AND TESTING OF A RATED FLEXIBLE MEMBRANE STOPPING

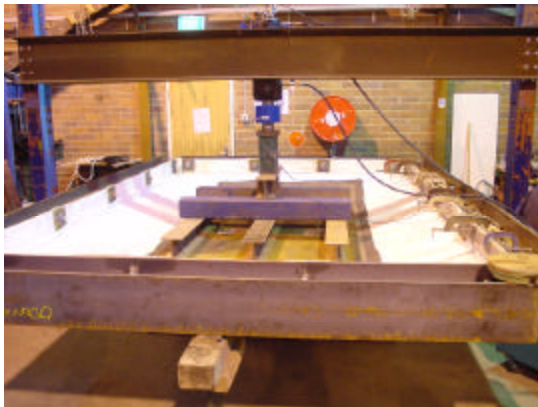
**Fig 1 - View of the testing frame with Fabric A attached.**

The fabric loading was carried out using a 70t capacity hydraulic jack mounted at the centre of the load frame. The ram was powered by a Rexroth 630 ATO pressure pack with the applied load monitored by an Interface Model 24/HL load cell. Figure 1 details the frame assembly and load testing position.

The first test program involved the static load testing of Fabric A and Fabric B. Fabric A was a white PVC non-woven fabric of thickness 0.45mm and tensile strengths documented as 40 kN/m. Fabric B was a green canvas type fabric of thickness 0.65mm with no documented strength characteristics. Both fabrics were fixed to the steel frame by wrapping the periphery of the fabrics around 150mm wide wire mesh (aperture size 50mm x 75mm) then bolting to the steel frame using 150mm square steel plates and 20mm diameter bolts. In addition to this, plywood and G clamps were used to further distribute load of the cloth around the frame perimeter. Figure 1. shows Fabric A loaded into the test frame.

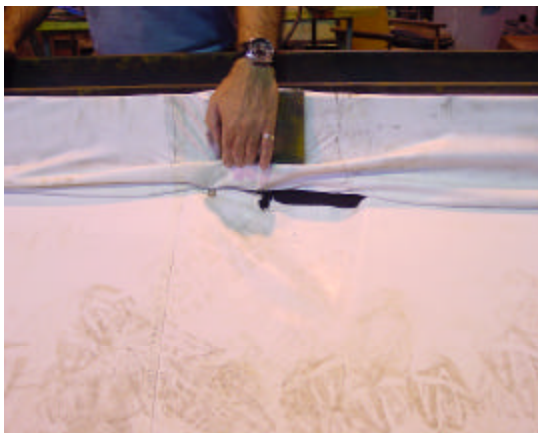
**Fig 3 - Fabric A failure at plate zones**

Both Fabrics exhibited failure at the anchor plate zones located in the central positions on the long span section. This failure was due to point loading of the fabrics at these points and characterized by initial puncturing of the fabric then tear propagation of the fabric around the plate zones. Figure 3. shows the failure of Fabric A around plate zones.

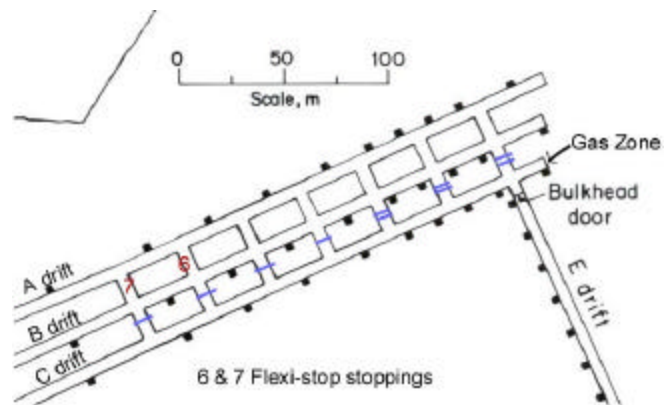
**Fig 11 – LLEM Layout**

LLEM is one of the world's foremost laboratories in conducting large-scale explosion testing of seals and stoppings and the test area is designed to withstand explosion pressures up to ~700 kPa (~100 psi). Figure 11 shows an expanded view of the stopping test area in the multiple-entry section of LLEM.

Two Flexi-Stop stoppings were constructed in cut-throughs 6 and 7 between B- and C- drifts. There were already seals in the first three cut-throughs from the simulated face and concrete block stoppings in cut-throughs 4 and 5. Before each explosion test a hydraulically operated, track mounted, concrete and steel bulkhead was positioned across E-drift to contain the explosion pressures in C-drift.

The Flexi-Stop flexible stopping designs were located in cut-through 6 at 167.6 metres and cut-through 7 at 197.8 metres from the face of C-drift. Refer to Figure 11 for details.

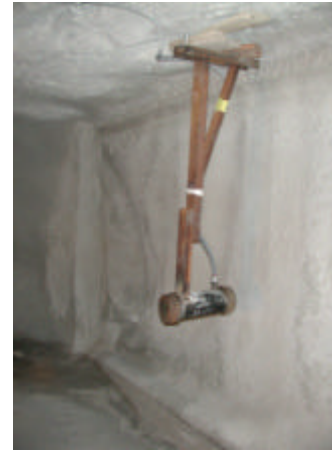
Fig 12– Pressure Transducer

This system collected the sensor data at a rate of 1,500 samples /s over a 5 s period. The data was then processed using LabView software and presented in graphic and tabular format. The reported data were averaged over 10 ms (15 point smoothing). This PC data analysis system allows the data traces to be expanded in time and pressure (or other sensor value) so that the peak values can be read and recorded precisely. Figure 12 shows a pressure sensor mounted on the C-drift side of the Flex-Stop stopping in cut-through 7.

Each drift has ten environmentally controlled data-gathering stations inset in the rib wall. Each data-gathering station houses a strain gauge pressure transducer that is perpendicular to the entry length (and explosion gas flow) and therefore measures the static pressure generated by the explosion. Pressure transducers were located on the C-drift rib at locations 152.7, 182.3 and 230.7 metres from the face near the Flexi-Stop locations. Most of the pressure transducers were rated at 0-100 psia, with 0-5 V output, infinite resolution, and response time less than 1 ms. A few 0-50 psia transducers were also used.

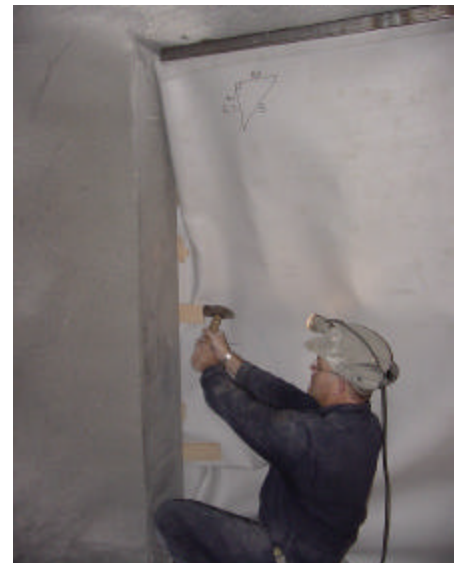
Figure 13 – Rib Strengthening

In October 2003 contractors had shotcreted roof to floor rib slots into both stopping sites using the dry application process. These slots were of 20 mm in width and 200 mm in depth. The roof section of each site had been smoothed with shotcrete. The floor of the roadways was a pad of reinforced concrete laid onto a gravel base overlying the limestone. Figure 13 shows the B-drift side of cut-through 6 stopping cloth being wedged into the shotcreted slot.
