Coal Operators' Conference

# Design and Testing of a Rated Flexible Membrane Stopping

## DESIGN AND TESTING OF A RATED FLEXIBLE MEMBRANE STOPPING

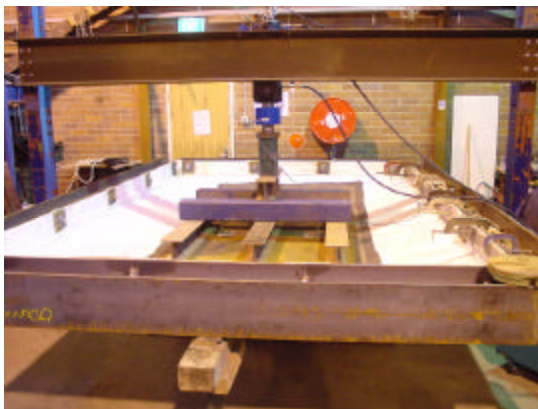
The fabric loading was carried out using a 70t capacity hydraulic jack mounted at the centre of the load frame. The ram was powered by a Rexroth 630 ATO pressure pack with the applied load monitored by an Interface Model 24/HL load cell. Figure 1 details the frame assembly and load testing position.

**Fig 1 - View of the testing frame with Fabric A attached.**

The first test program involved the static load testing of Fabric A and Fabric B. Fabric A was a white PVC non-woven fabric of thickness 0.45mm and tensile strengths documented as 40 kN/m. Fabric B was a green canvas type fabric of thickness 0.65mm with no documented strength characteristics. Both fabrics were fixed to the steel frame by wrapping the periphery of the fabrics around 150mm wide wire mesh (aperture size 50mm x 75mm) then bolting to the steel frame using 150mm square steel plates and 20mm diameter bolts. In addition to this, plywood and G clamps were used to further distribute load of the cloth around the frame perimeter. Figure 1. shows Fabric A loaded into the test frame.

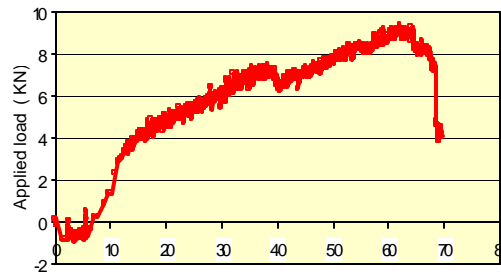
**Fig 2 - Hydraulic jack load vs ram displacement**

Loading of Fabric A commenced with the placement of 1112.10 kg of weights. It was evident during the placement of these weights that the fabric was unevenly loaded. This uneven tension was further evident during loading via the hydraulic ram, which eventually led to failure of the fabric at a total load of 2032 kg, which was well short of the desired load needed to achieve 14 kPa (2psi). Figure 2 shows the Hydraulic jack load vs the ram displacement. Fabric B also exhibited uneven loading with failure occurring during placement of the weights at 661kg.

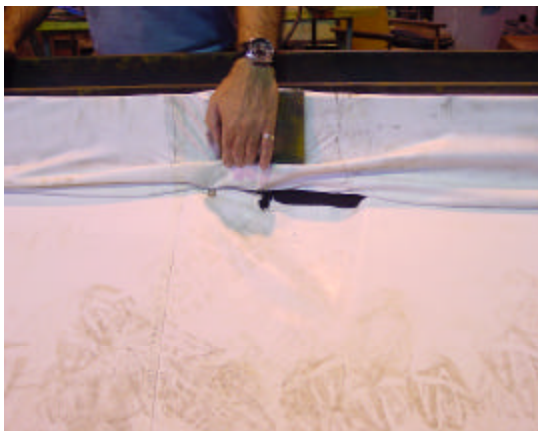
Both Fabrics exhibited failure at the anchor plate zones located in the central positions on the long span section. This failure was due to point loading of the fabrics at these points and characterized by initial puncturing of the fabric then tear propagation of the fabric around the plate zones. Figure 3. shows the failure of Fabric A around plate zones.

**Fig 3 - Fabric A failure at plate zones**

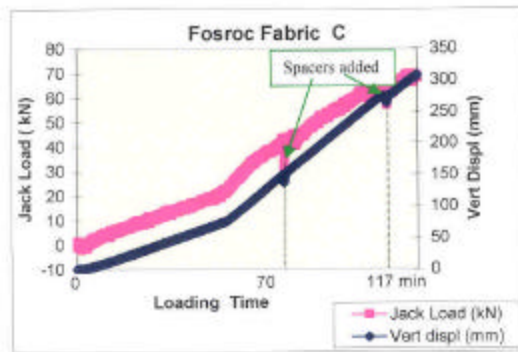
Several stages of failure were evident during the test program including tearing of the TSL, snapping of the geogrid around the plate zones and tearing of the fibrous mat around the plate zones. A total load of 7900kg was achieved during the test with a vertical displacement of 300mm. Figure 4. shows the three failure events seen during the test. Figure 5 shows the hydraulic jack load vs the ram displacement for the test program 2.

**Fig 4 – Jack load and FFC sagging versus loading time**

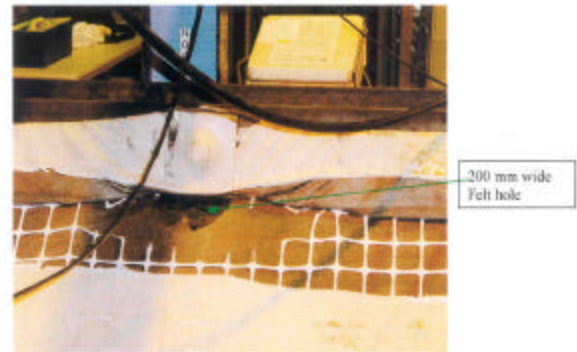
**Fig 5 – 280mm lateral width of the torn felt around the central plate @ 68 kN load (total applied load – 0.795t)**

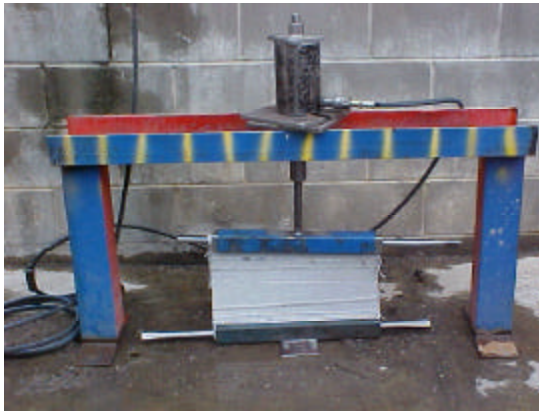
Test program 3 involved the testing of both these items with Fabric D selected for the test work. Fabric D was a PVC coated ultrahigh tensile strength woven fabric with weight of 2kg/m, thickness of 1.7mm and tensile strength of 200kN/m. Initial in-house testing by fixing Fabric D in a steel slot structure indicated that even distribution of load could be more effectively achieved. Figure 6 and Figure 7 detail the test work and slot method used to achieve loads of 7000kg/m. Based on this result it was thought that over the 4m length of the loading frame a load near 28t could be achieved and would give greater confidence to undertake further testing at UOW.

**Fig 6 - In house testing of fixing system and Fabric D**

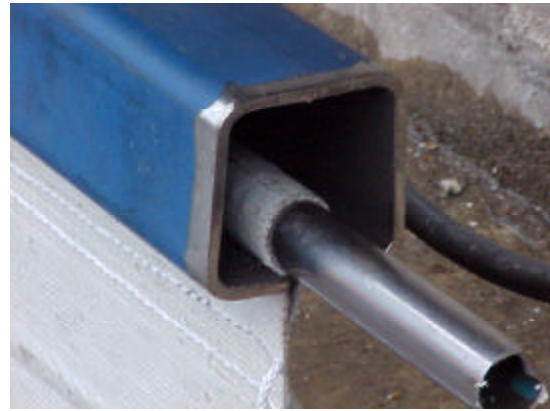
**Fig 7 - Slot fixing system**

The final test program involved fixing fabric D using the slot system along the 4m length of the testing frame and bolting the cloth using square steel plates with rubber washers along the 2.7m lengths. This test program was completed in two sections due to early failure of the slot fixing system in the first section. Adjustments were made to the steel grade of the slot and the method used to hold the fabric in the slot. Section 2 involved loading of fabric D with the same method as for the previous fabrics tested with the addition of sand to further distribute load. After placement of the initial 2226kg of weight it was evident the load was more evenly distributed along the 4m length. During testing additional gussets were added to bond the slot to the test frame and stop bending of the slots. Further timber posts were also added to support the test frame as buckling of the 4m length was beginning to occur. A maximum load of 20.371 t was applied to the cloth, equivalent to 2.71psi

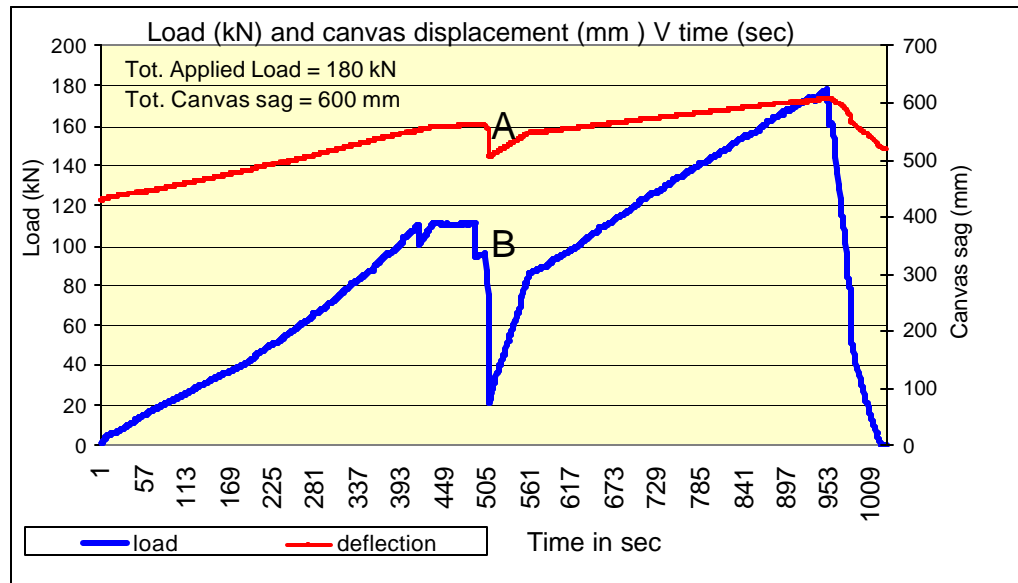
and near to the 2.8psi static load capacity of the test frame. Figure 8 details the Hydraulic jack loads and vertical displacement of Fabric D during the section 2 tests. Figure 9 details Fabric D fixed in the test frame during loading and Figure 10 shows the tests frame buckling under load.

**Fig 8 - Hydraulic jack load vs vertical displacement for Fabric D**

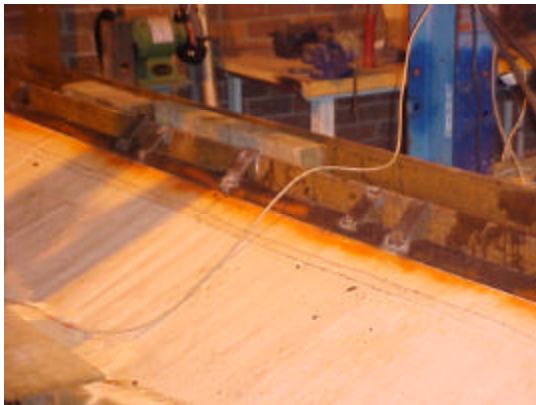
**Fig 9 - Fabric D load distribution in slot**

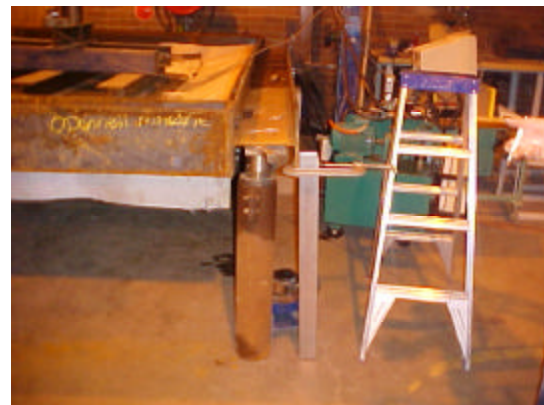
**Fig 10 - Buckling of the test frame under load**

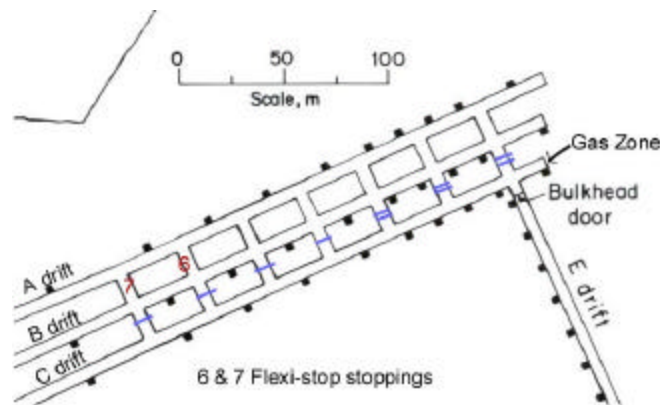
LLEM is one of the world's foremost laboratories in conducting large-scale explosion testing of seals and stoppings and the test area is designed to withstand explosion pressures up to ~700 kPa (~100 psi). Figure 11 shows an expanded view of the stopping test area in the multiple-entry section of LLEM.

Fig 11 – LLEM Layout

Two Flexi-Stop stoppings were constructed in cut-throughs 6 and 7 between B- and C- drifts. There were already seals in the first three cut-throughs from the simulated face and concrete block stoppings in cut-throughs 4 and 5. Before each explosion test a hydraulically operated, track mounted, concrete and steel bulkhead was positioned across E-drift to contain the explosion pressures in C-drift.

The Flexi-Stop flexible stopping designs were located in cut-through 6 at 167.6 metres and cut-through 7 at 197.8 metres from the face of C-drift. Refer to Figure 11 for details.

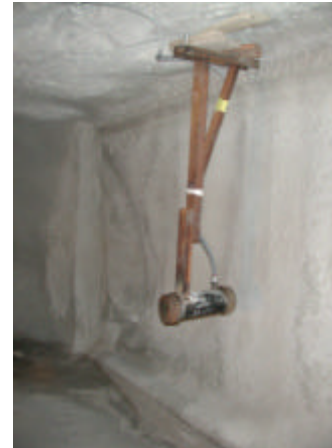
This system collected the sensor data at a rate of 1,500 samples /s over a 5 s period. The data was then processed using LabView software and presented in graphic and tabular format. The reported data were averaged over 10 ms (15 point smoothing). This PC data analysis system allows the data traces to be expanded in time and pressure (or other sensor value) so that the peak values can be read and recorded precisely. Figure 12 shows a pressure sensor mounted on the C-drift side of the Flex-Stop stopping in cut-through 7.

Fig 12– Pressure Transducer

Each drift has ten environmentally controlled data-gathering stations inset in the rib wall. Each data-gathering station houses a strain gauge pressure transducer that is perpendicular to the entry length (and explosion gas flow) and therefore measures the static pressure generated by the explosion. Pressure transducers were located on the C-drift rib at locations 152.7, 182.3 and 230.7 metres from the face near the Flexi-Stop locations. Most of the pressure transducers were rated at 0-100 psia, with 0-5 V output, infinite resolution, and response time less than 1 ms. A few 0-50 psia transducers were also used.

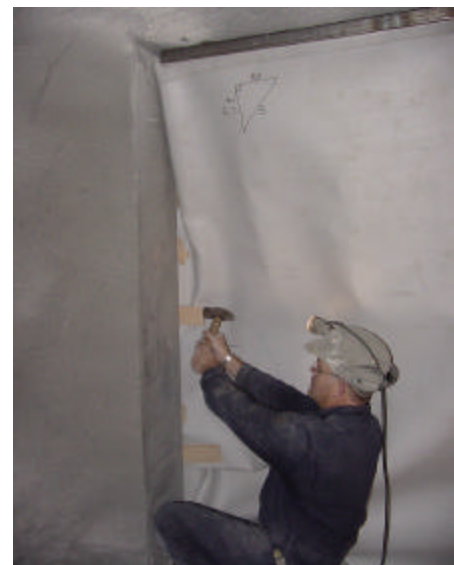
In October 2003 contractors had shotcreted roof to floor rib slots into both stopping sites using the dry application process. These slots were of 20 mm in width and 200 mm in depth. The roof section of each site had been smoothed with shotcrete. The floor of the roadways was a pad of reinforced concrete laid onto a gravel base overlying the limestone. Figure 13 shows the B-drift side of cut-through 6 stopping cloth being wedged into the shotcreted slot.

Figure 13 – Rib Strengthening

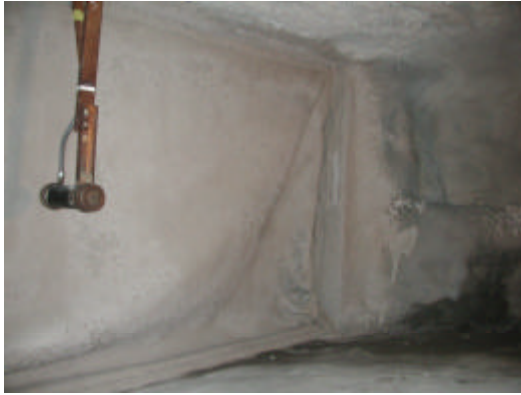
Following the first explosion test (# 359), 4 (for cut-through 7) and 5 (for cut-through 6) equally spaced 25 mm diameter by 400 mm length resin bolts were installed through the cloth material and into each rib (embedded 300 mm) on the C-drift side of the rib slots. Figure 14 shows the finished stopping in cut-through 6 and Figure 15 shows the finished stopping in cut-through 7. Note the curve in the roof profile of cut-through 7 shown in Figure 15.

**Fig 14 – Finished stopping cut-through 6**

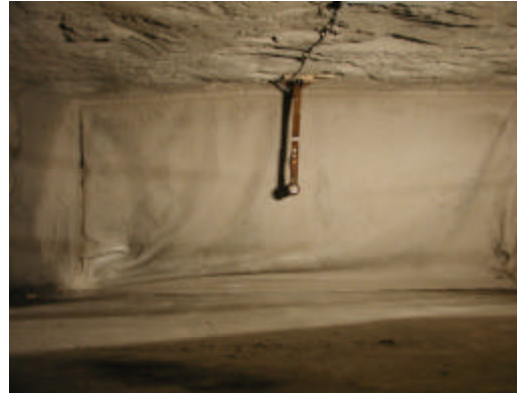
**Fig 15 – Finished stopping cut-through 7**
