USE OF CONE BOLTS IN GROUND PRONE TO ROCKBURST

Ron McKenzie¹

ABSTRACT: Big Bell Mine started using the Cone bolt as a yieldable support to combat rockburst in September 1999. Australia has little experience of mining in rockburst conditions which makes the ground support requirements a new experience to all involved. Much work went into the design of the support patterns and the sequence of operations. The workforce required training in installation procedures, the theory behind yielding support and in the importance of good quality installation practices. Testing has been carried out on various grout mixes to determine the best mix for optimum bolt performance. This paper gives an overview of the introduction of Cone bolts at Big Bell.

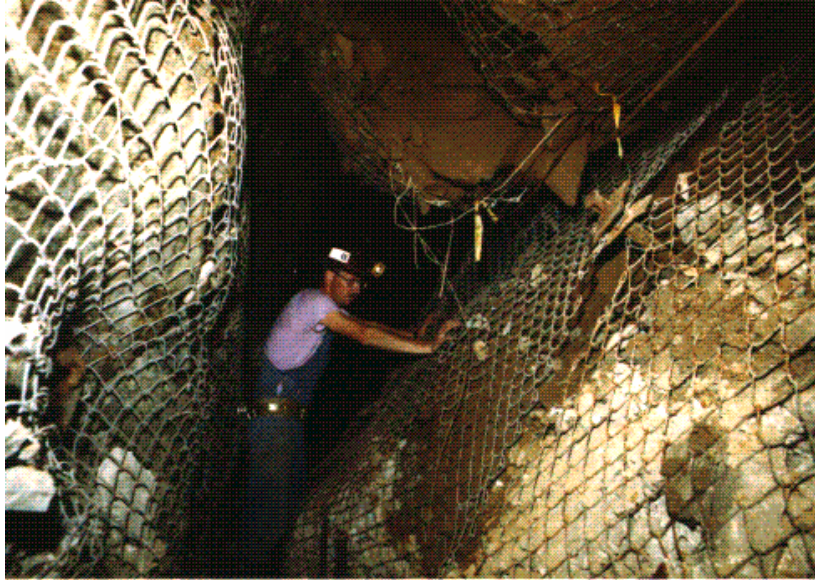
Rockbursts are explosive failures of rock when very high stresses occur around mine openings. They result in the ejection of rock ranging from a fraction of a cubic metre to thousands of cubic metres. Fig. 1 shows the damage caused by an outburst. The seismic energy associated with the rock ejection process can reach the equivalent an earthquake of magnitude five on the Richter scale. An event of this magnitude is usually associated with fault slip activity and has only occurred in South Africa. The largest reading at Big Bell has been 2.4, with the biggest rock fall being approximately 1,000 tonnes. Geophones are positioned throughout the mine to determine intensity and location of seismic events.

Fig. 1 Damage to a drive from rockburst

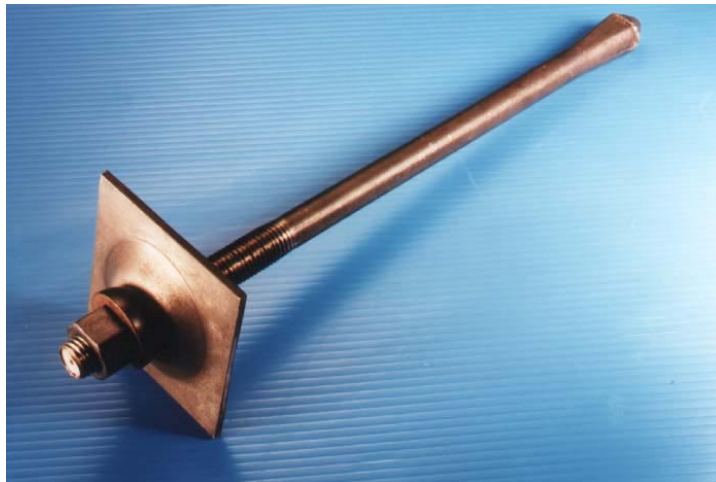
The toe end of the bolt has a forged conical enlargement. The collar end is threaded like a conventional roof/rock bolt or may have a 'Shepherd's Crook' eye to facilitate cable lacing. The entire length of the bolt is coated with a debonding agent to reduce the resistance caused by the bond between the grout and the bolt. Both types of bolt are used with a bearing plate and in the case of the threaded bolt, a nut and hemispherical washer is also used (Fig. 2).

The bolt chosen for Big Bell had a diameter of 22mm, a cone diameter of 32mm and an M24 thread. The bolt has a yield strength of 22 tonne.

Fig. 2 Threaded Cone Bolt

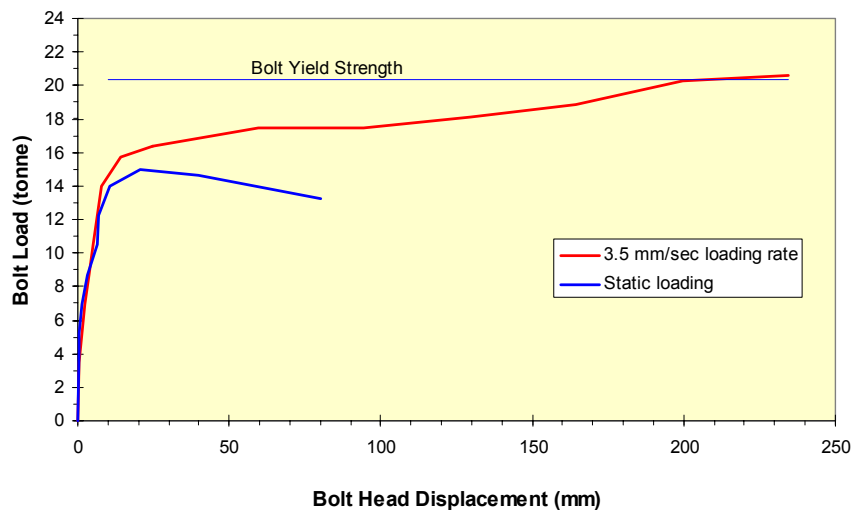
Fig. 5 shows the results of pull tests on a three metre Cone bolt for static testing and quasi-dynamic testing. The static test was the standard pull test where the rate of loading of the bolt is low (less than one tonne per minute) and displacement readings are taken only after stabilisation. The quasi-dynamic test involved loading the bolt at the maximum rate of the testing equipment, 3.5 mm/sec, and recording the maximum load reached during each extension of the ram.

The results from the latter test showed that the bolt was reaching loads approaching the yield strength of the bolt. Numerous UCS tests on the grout mixes gave varying results but tended to be on the high side, that is, greater than 50MPa. However from a number of seismic events that have loaded Cone bolts at Big Bell there is only one documented case where a Cone bolt had failed. The grout mix was changed to reduce the strength. The superplastiser was cut from the mix to increase the water demand, and hence reduce the strength of the grout, while at the same time the low slump properties were retained.

Fig. 5 Load-displacement curves for Cone bolts using original grout mix
