## Use of Cone Bolts in Ground Prone to Rockburst

## USE OF CONE BOLTS IN GROUND PRONE TO ROCKBURST

Ron McKenzie<sup>1</sup>

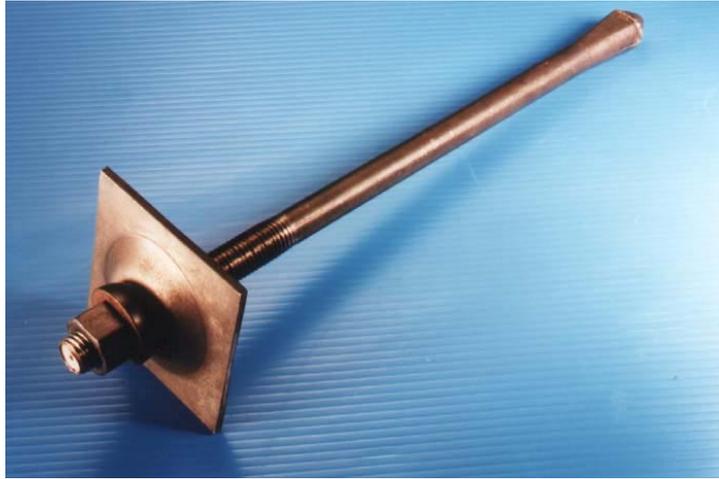
The toe end of the bolt has a forged conical enlargement. The collar end is threaded like a conventional roof/rock bolt or may have a 'Shepherd's Crook' eye to facilitate cable lacing. The entire length of the bolt is coated with a debonding agent to reduce the resistance caused by the bond between the grout and the bolt. Both types of bolt are used with a bearing plate and in the case of the threaded bolt, a nut and hemispherical washer is also used (Fig. 2).

The bolt chosen for Big Bell had a diameter of 22mm, a cone diameter of 32mm and an M24 thread. The bolt has a yield strength of 22 tonne.

**Fig. 2 Threaded Cone Bolt**
