Use of Cone Bolts in Ground Prone to Rockburst

R. McKenzie

This conference paper was originally published as McKenzie, R, Use of Cone Bolts in Ground Prone to Rockburst, in Aziz, N (ed), Coal 2002: Coal Operators' Conference, University of Wollongong & the Australasian Institute of Mining and Metallurgy, 2002, 169-175.

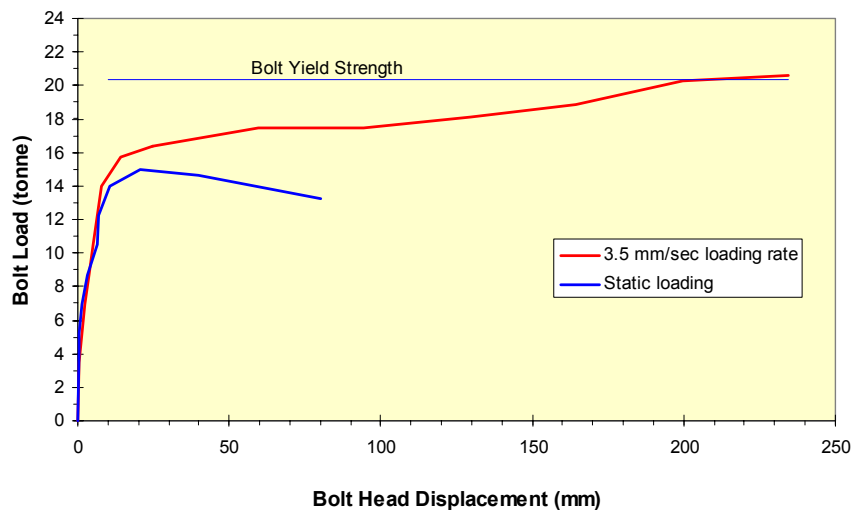
Fig. 5 Load-displacement curves for Cone bolts using original grout mix

Fig. 5 shows the results of pull tests on a three metre Cone bolt for static testing and quasi-dynamic testing. The static test was the standard pull test where the rate of loading of the bolt is low (less than one tonne per minute) and displacement readings are taken only after stabilisation. The quasi-dynamic test involved loading the bolt at the maximum rate of the testing equipment, 3.5 mm/sec, and recording the maximum load reached during each extension of the ram.

The results from the latter test showed that the bolt was reaching loads approaching the yield strength of the bolt. Numerous UCS tests on the grout mixes gave varying results but tended to be on the high side, that is, greater than 50MPa. However from a number of seismic events that have loaded Cone bolts at Big Bell there is only one documented case where a Cone bolt had failed. The grout mix was changed to reduce the strength. The superplastiser was cut from the mix to increase the water demand, and hence reduce the strength of the grout, while at the same time the low slump properties were retained.
