STRATA MANAGEMENT AT THE GOONYELLA EXPLORATION ADIT PROJECT

Ross Seedsman¹, Peter Brisbane² and Guy Mitchell³

ABSTRACT: The Goonyella Exploration Adit is a three heading development into the highwall at Ramp 4 at Goonyella Riverside Mine that was driven between September 1999 and November 2000. The principal was BHP Billiton Mitsubishi Alliance (BMA) and the contractor was Allied Mining Australia. Strata management began at the pre-tender phase and evolved as greater knowledge of the ground became available.

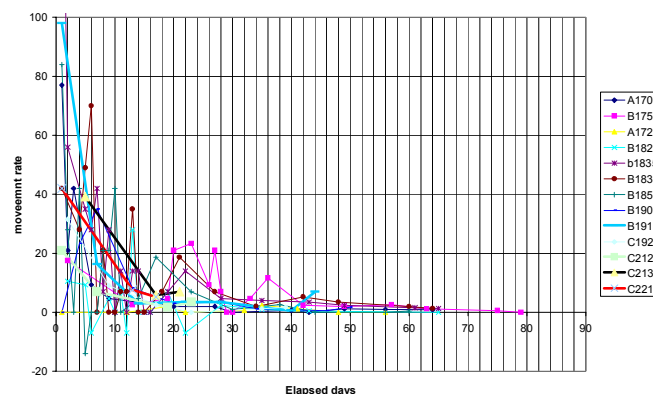
Fig.3 Examples of tell-tale measurements - movements in mm/week

The coal beam analysis gave an allowable movement of 10mm and in unstructured areas this was never exceeded. In the more structured areas, additional movement was recorded and in most cases this reduced to very low rates within ten days (Fig. 3).

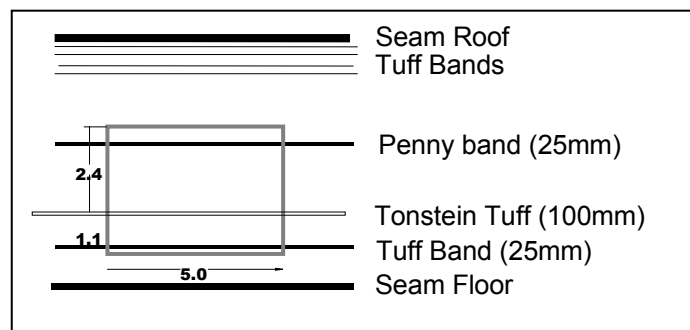
Fig. 4 Horizon control for typical ground

Typical ground was defined as that part of the driveage having a massive immediate coal roof. To achieve this, horizon control was essential and it was instilled into the work force. They all carried the simple diagram shown in Fig. 4 which was an idea copied from Moranbah North. Since Ply 2 is about 2m thick and only 0.5m had to be left, normal faults with throws of up to 1.0m to 1.5m could be traversed (so long as the fault plane itself was supported).

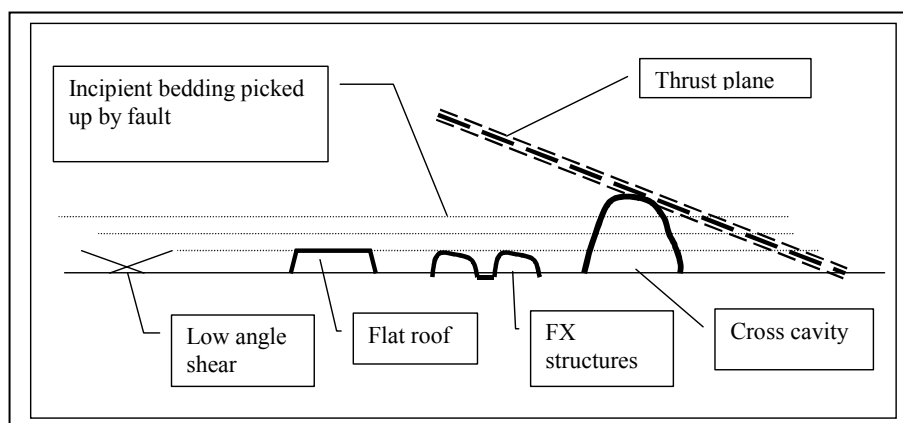
Fig. 5 Roof conditions on the footwall of thrust faults

Back analyses of the roof conditions as the thrust faults were approached from the footwall (downthrown) side allowed the formulation of a predictive model for the proximity to such faults (Fig. 5). The shallow, flat-topped roof falls began about 20m - 30m prior to the thrust plane being intersected. This model successfully identified all subsequent thrust faults and complemented the surface exploration: 3 D seismic survey were invaluable as a planning tool and was found to be accurate for faults greater than 3m, but less than 50% for smaller throws for which the observational model was essential.

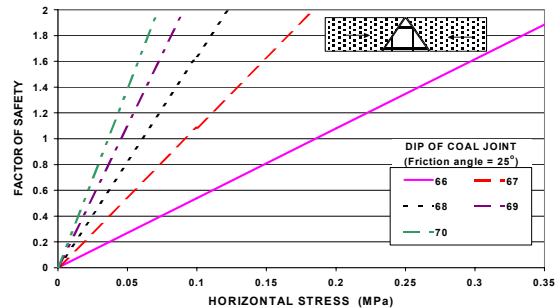
Fig. 8 Wedge analysis for coal roof with low horizontal stresses

The falls were interpreted as being the result of low horizontal stresses acting on wedges of coal defined by the horst grabens. The low horizontal stresses resulted from the interplay of the roadway shape with a low magnitude stress field where the major principal stress is vertical. Simple wedge analysis indicated that falls were likely for discontinuities dipping at between 70° and 65°, and inevitable for surfaces dipping at less than 65° (Figure 8). The height of the falls was controlled by the onset of a more compressive regime higher in the roof.
