Coal Operators' Conference

Stress corrosion cracking of rock bolts

Stress Corrosion Cracking of Rock Bolts

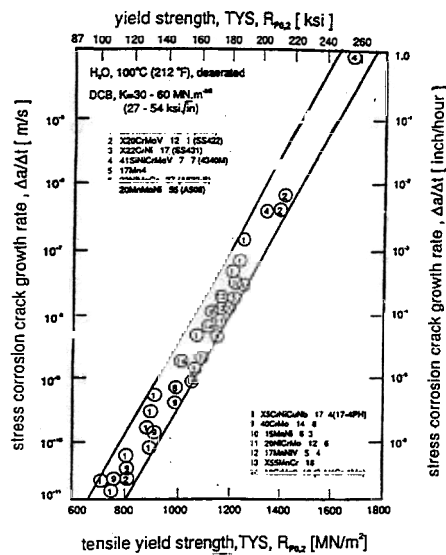
Fig. 1 - SCC growth rate vs tensile strength for high strength steels (after Atrens & Wang, Ref.1)

Figure 1 indicates that SCC can occur in a wide range of steel types (after Atrens, Ref.1). However, Figure 1 also shows that higher strength steels are generally more susceptible to SCC than lower strength steels. It can be seen that the crack growth rate is approximately 10^{-6} m/sec for steels with an ultimate tensile strength (UTS) of 1400 MPa, compared to a crack growth rate of only 10^{-11} m/sec for steels with a UTS of 600 MPa (Ref 1).

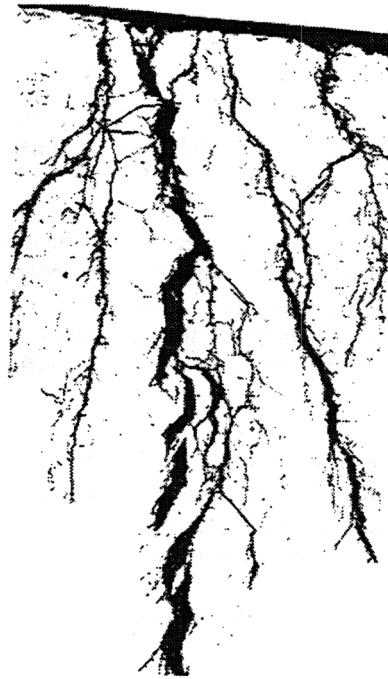
Fig. 2 - A polished and etched metallographic cross section showing typical transgranular SCC in stainless steel

SCC is a complex phenomenon and no one mechanism can explain all cases of SCC failures, but it is known to occur in many metals and alloys including Aluminium, Titanium, Brass, Steel and Stainless Steel (see Figure 2).

One form of SCC is often called Hydrogen Embrittlement (HE). When high strength steels are stressed and are also exposed to environments that release hydrogen, HE cracking can occur. Cross Section (Figure 2) see cracks in Stainless Steel.

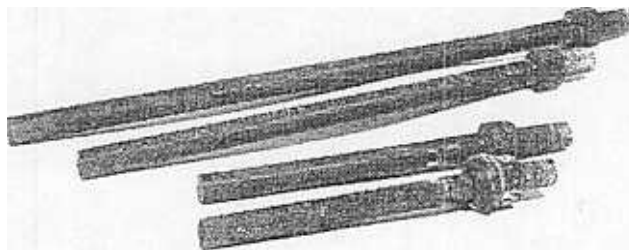
An SCC failure of a rock bolt typically appears to be a brittle failure. An SCC failure surface is normally a fracture plane at right angles to the axis of the bolt (the direction of the axial force), and there is no necking of bolt adjacent to the fracture surface. The fracture surface is frequently located at the end of the exposed free length of the bolt immediately below the resin encapsulation.

Fig. 3 - Typical SCC rock bolt failures

A typical SCC failure of a rock bolt is shown in Figure 3.

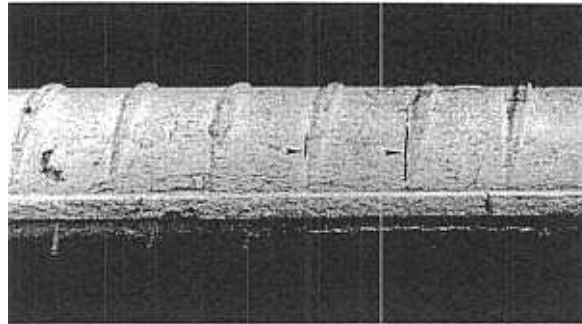
Detailed investigation of SCC failures using Magnetic Particle Impregnation (MPI) techniques reveals that many small SCC cracks develop in the bolt adjacent to the ultimate fracture surface. These small cracks frequently develop at the base of the rib profile where there is a sharp change in angle on the longitudinal section of the bolt, and this creates a “stress raiser” in the bolt (see Figure 4).

Fig. 4 - SCC at the base of the ribs on a rock bolt

Finally, the design of the ribs on the rock bolt has some influence on its susceptibility to SCC. On a conventional rock bolt, the rib projects from the core size of the rock bolt at a sharp angle (approximately between 60 and 90 degrees). This sharp angle creates a "stress raiser" in the bar when the bar is subjected to a tensile force, and consequently SCC cracks frequently occur at this point (see Figure 4). Rock bolts which therefore minimise this sharp angle and reduce the "stress raiser effect", are therefore preferable to ordinary rock bolts. In addition, all stress raisers in a rock bolt or cable bolt are to be avoided (eg cuts, grooves etc).

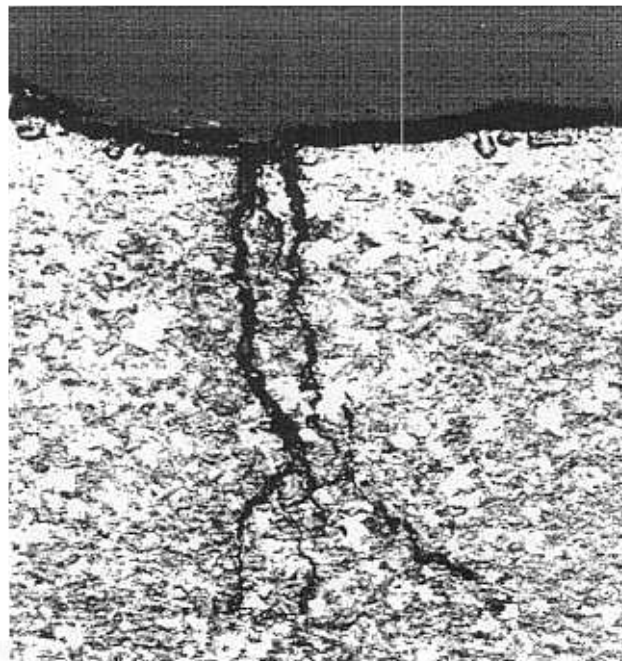
SCC cracks are usually less than 1mm deep, and are dendritic in section (see Figure 5). The crack which initiates SCC failure can be located by the fracture lines which radiate out from it as shown in Figure 6, and this crack is less than 1mm deep.

Fig. 5 - Dendritic nature of SCC at the base of the rib profile

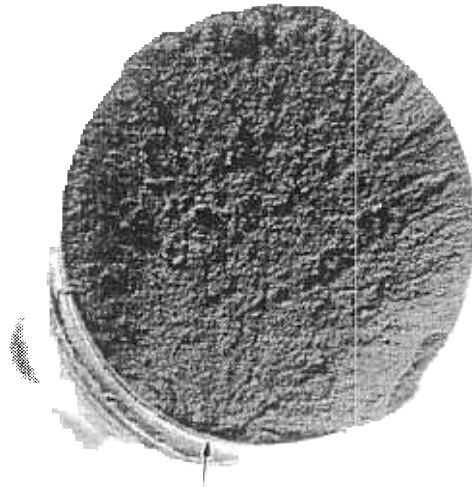
Fig. 6 - Fracture face of an SCC failure. Arrow shows the crack which initiated failure
