Coal Operators' Conference

Non destructive integrity testing of rock reinforcement elements in Australian mines

NON DESTRUCTIVE INTEGRITY TESTING OF ROCK REINFORCEMENT ELEMENTS IN AUSTRALIAN MINES

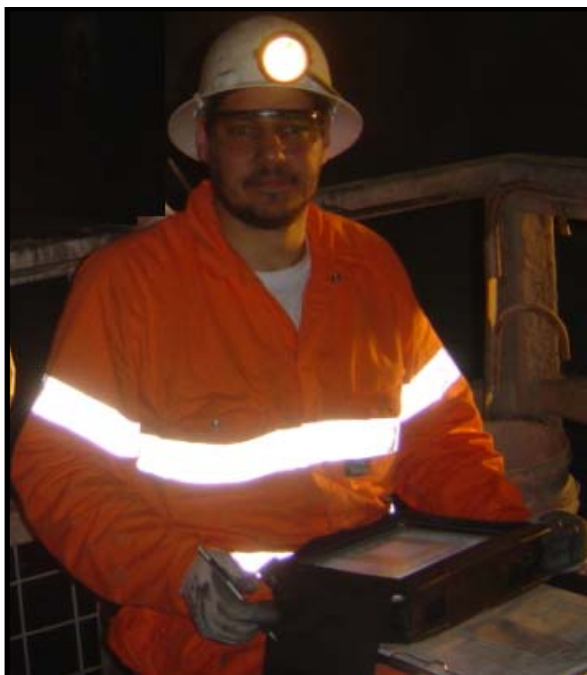
1. **A Toughbook / Notebook** - this is used to collect data and providing power via a USB cable for the (see Figure 1).

Figure 1 - Notebook in operation (by Wouter Hartman) at the Fosterville Underground Gold Mine

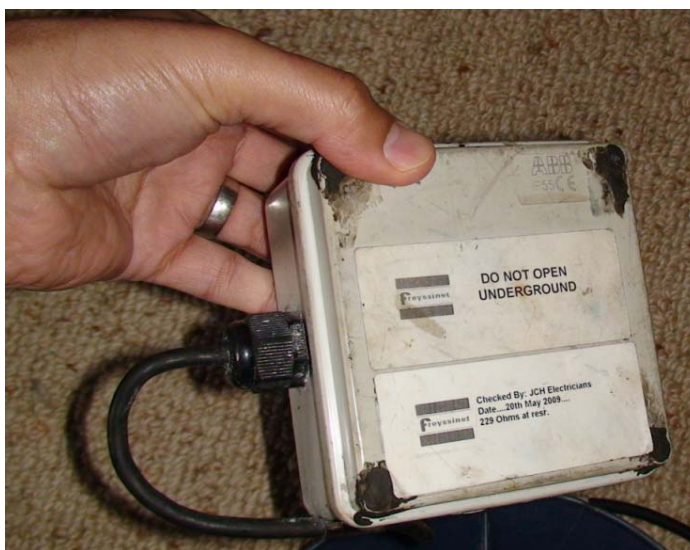
2. **Analogue/Digital Converter encased in closed unit** - this converts the signal from the transducer into a digital format. The converter is soft wired to the transducer (see Figure 2).

Figure 2 - Analogue/Digital Converter encased in closed unit for coal mine operations

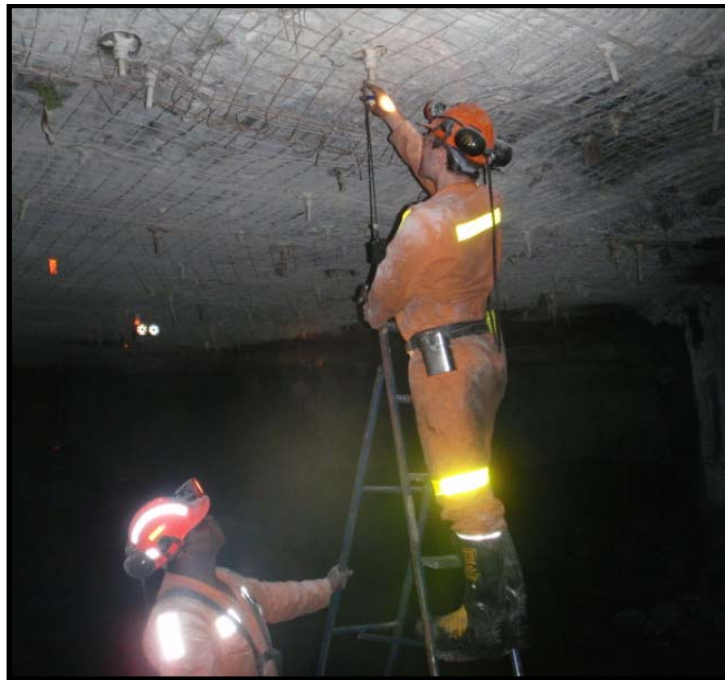
3. **Transducer** – which is held at the end of bolt (i.e. collar of hole – see Figure 3) during the test. A signal / pulse is obtained, which is generated by a small hammer.

Figure 3 - Photo showing transducer (vertical) held at the end of bolt (i.e. collar of hole) at Manadalong Coal Mine

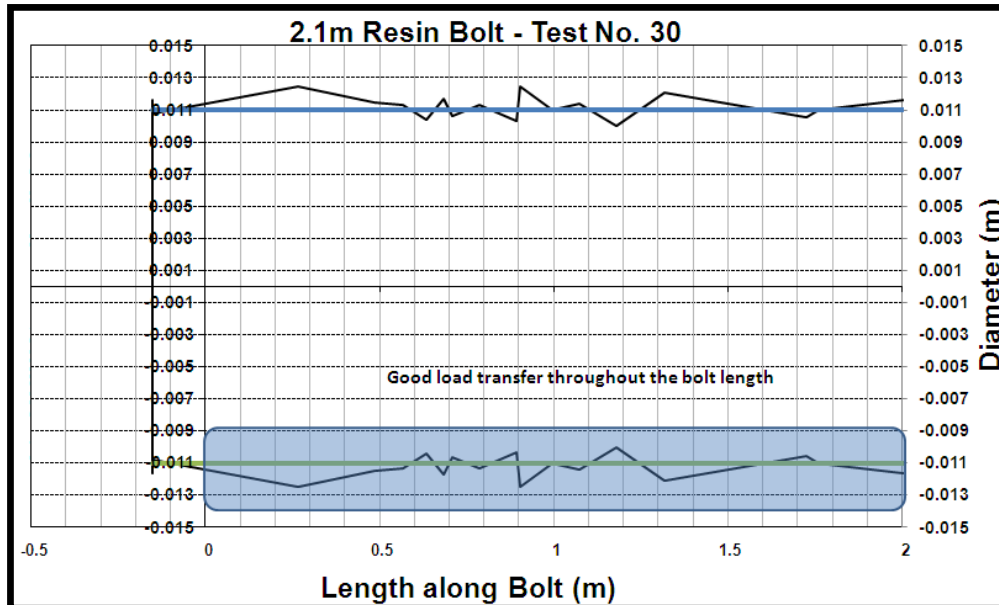
Test completed at Mandalong Coal Mine shows that the resin installation practices at Mandalong appear to be of good quality when interpreting the two dimensional graphs (see Figure 8 below) and calculated load. Figure 8 indicates good embedment (structural stiffness) along the length of the resin bolt.

Table 8 - Two dimensional graph showing good embedment achieved along the length of the 2.1 m resin anchor installation
