Coal Operators' Conference

# Non destructive integrity testing of rock reinforcement elements in Australian mines

This conference paper was originally published as Hartman, W, Lecinq, B, Higgs, J and Tongue, D, Non destructive integrity testing of rock reinforcement elements in Australian mines, in Aziz, N (ed), 10th Underground Coal Operators' Conference, University of Wollongong & the Australasian Institute of Mining and Metallurgy, 2010, 161-170.

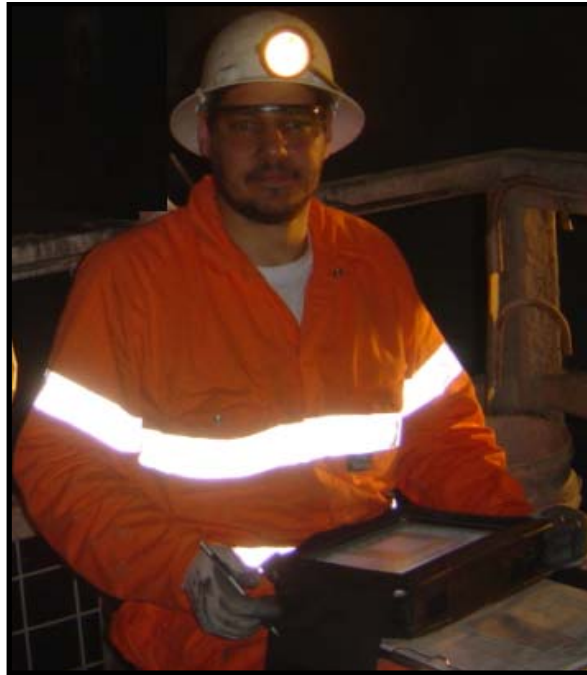
1. **A Toughbook / Notebook** - this is used to collect data and providing power via a USB cable for the (see Figure 1).

Figure 1 - Notebook in operation (by Wouter Hartman) at the Fosterville Underground Gold Mine

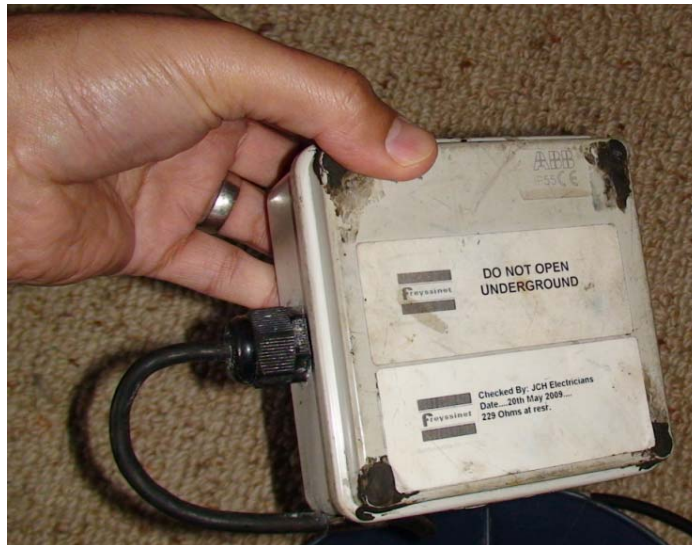
2. **Analogue/Digital Converter encased in closed unit** - this converts the signal from the transducer into a digital format. The converter is soft wired to the transducer (see Figure 2).

Figure 2 - Analogue/Digital Converter encased in closed unit for coal mine operations

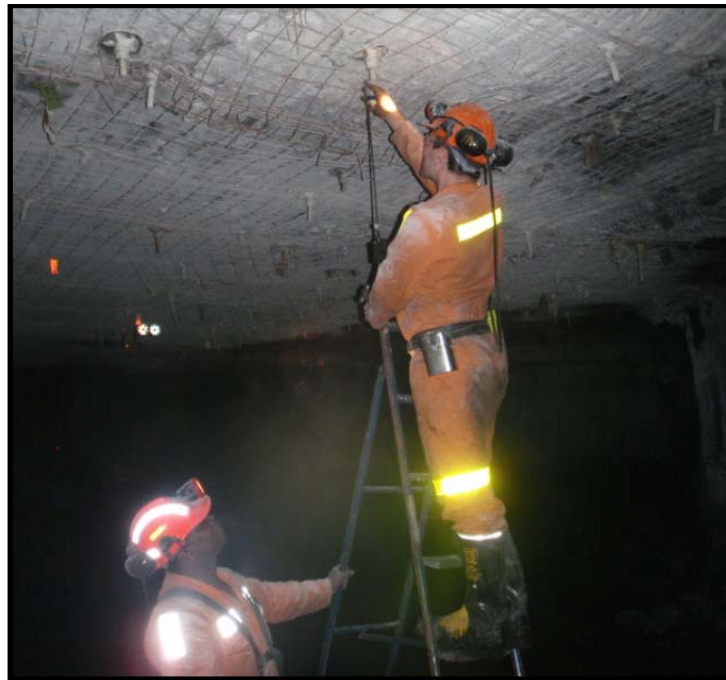
3. **Transducer** – which is held at the end of bolt (i.e. collar of hole – see Figure 3) during the test. A signal / pulse is obtained, which is generated by a small hammer.

Figure 3 - Photo showing transducer (vertical) held at the end of bolt (i.e. collar of hole) at Manadalong Coal Mine

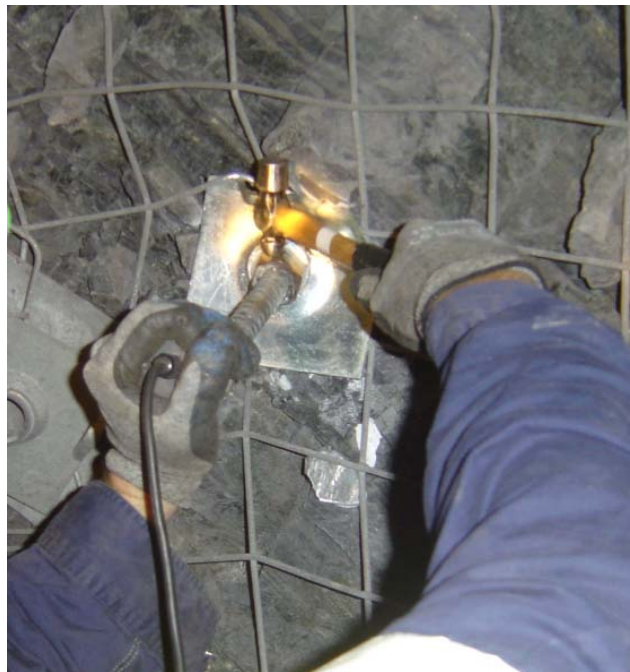
4. **A small hammer or tapping device** (see Figure 4) - This has to make contact against the plate or nut of the bolt during the test.

Figure 4 - Photo showing tapping device that is used to make contact with the nut of resin bolt

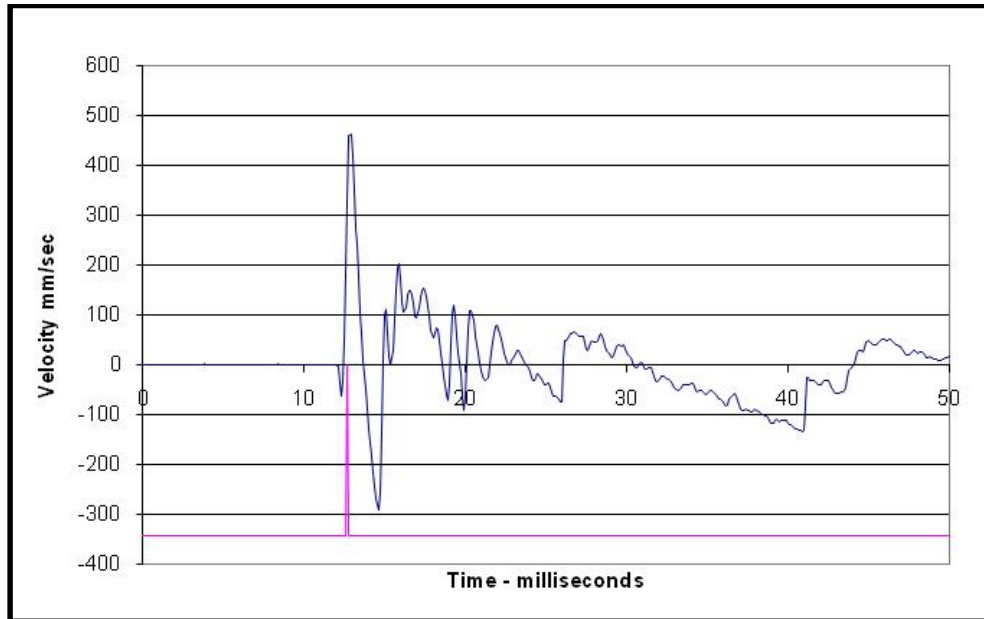
A valid seismic signal (see Figure 5) is obtained through the Modshock system and is one of the main criteria by which a test is accepted or rejected. The graph displays velocity on the vertical axis and time on the horizontal axis. The blue line represents the seismic signal; whereas the pink line represents the commencement of element analysis.

**Table 5 - Diagram showing valid seismic signal obtained by transducer (geophone)**

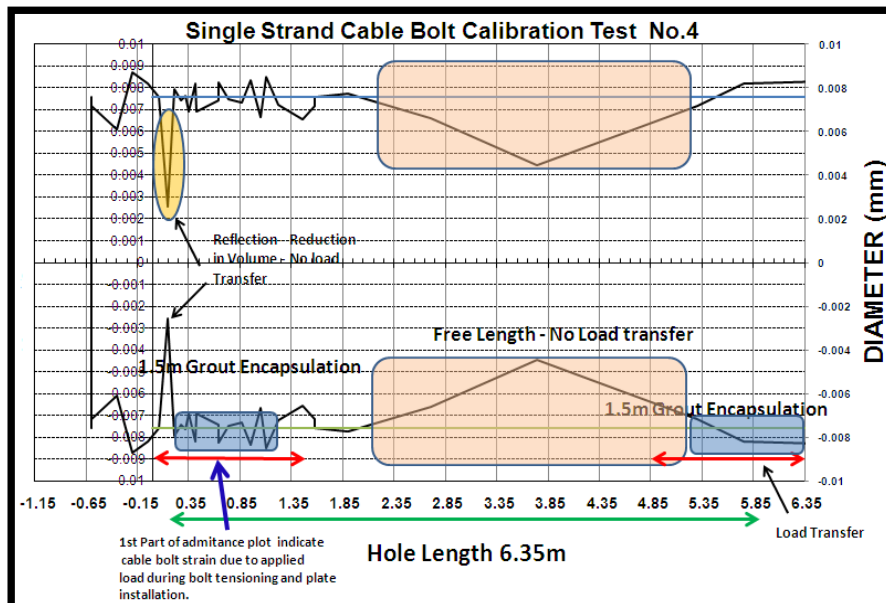
The operator in the field can at the time of testing identify which element (bolt) are serviceable and then concentrate on the rock reinforcement elements that have shown anomalies. For the elements with anomalies a two-dimensional graph of the test can be obtained and presented after the analysis has been carried out (see Figure 6).

**Table 6 - Two dimensional graph showing structural stiffness of rock reinforcement element with diameter used as a guide**

The two opposing curved black lines on the graph represent structural stiffness through good embedment or load transfer. The top (blue) and bottom (green) horizontal lines in the graph collectively represent the element's full diameter. The structural stiffness presented in the two dimensional plot together with the element's diameter are used to indicate whether any disturbance (i.e. bolt necking, bolt volume reduction through corrosion, bolt shearing (Hartman, 2003) and/or ineffective grout or resin embedment) or reflection point can be detected during testing. The graph is an example of disturbance (reflection) where grouting was deliberately placed towards the toe end of the bolt as part of a calibration program at the Sunrise Dam Mine (WA). The graph clearly shows good load transfer or embedment towards the toe end of the bolt.

Both Figure 6 and 7 above are prime examples of poor grouting. Figure 6 is an example of a calibration bolt with known grouting embedment at the toe and collar. Figure 7 is a two-dimensional graph of a “full column grouted” twin strand cable bolt tested at the Fosterville Gold Mine showing clear signs of a defect (i.e. grout deficiency) between 3 m and 4 m. In addition, this graph also shows that the cable bolt length to be 6 m instead of 8 m.

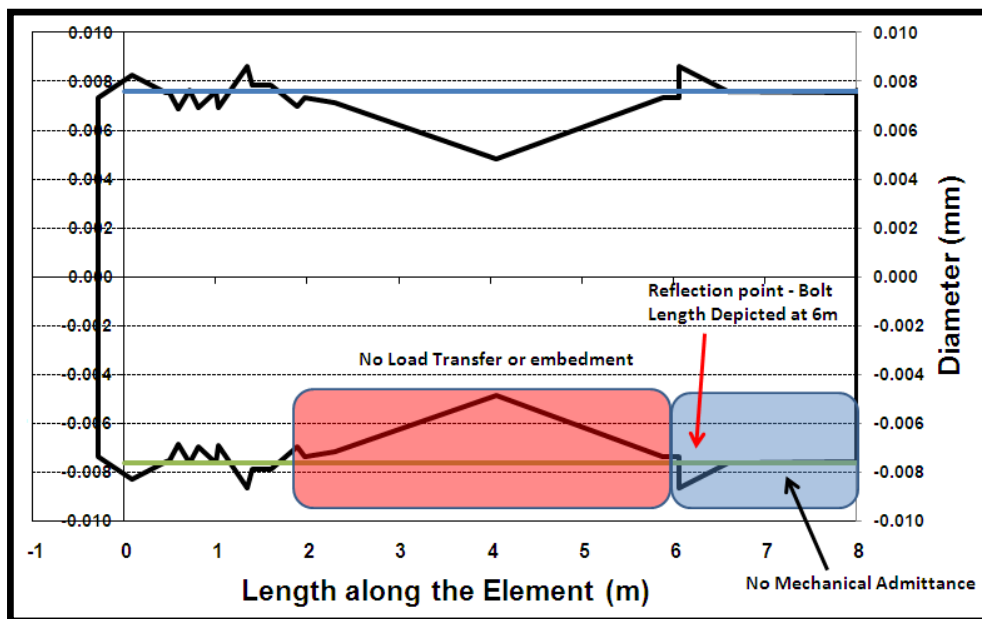
In a recent test at the Fosterville Gold Mine cable bolt lengths were accurately depicted following confirmation from the mine. The test set-up incorporated 10 m and 8 m lengths as input parameters for the cable bolt testing. Most of the bolts were confirmed to be either 8 m or 6 m in length (see below Figure 7 for final interpretation of two dimensional structural stiffness plot).

**Table 7 - Two dimensional graph showing confirmation of twin stand cable bolt 6m length following initial 8m input parameter**

The above graph clearly shows bolt length to be around 6 m following test input parameter set to 8 m. The bolt length was later confirmed by the mine to be a 6 m twin strand cable bolt.

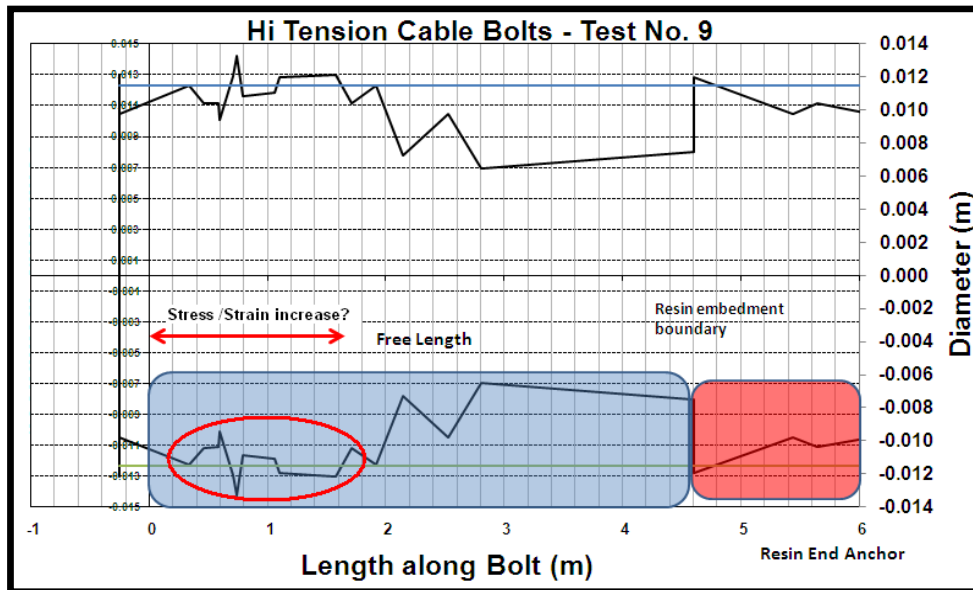
The Hi-Tens cable bolts are installed using a 1 200 mm long slow set resin which is inserted into the hole using a conduit to push it right to the back of the hole. The Hi-Tens tendon is inserted into the hole until it reaches the base of the resin. The bolt is spun through the resin for about 30 seconds to activate the quick set resin. The plate, barrel and wedge are installed with a tensioner to 20 tonnes. Tests conducted on the Hi-Tens tendon showed an interesting two dimensional graph where the resin installation is limited to the toe area of the bolt / hole as per design. A free anchor length of around 4.2m is maintained with the 2D plot showing either signs of stress increase or noise close to the collar. We have reason to believe that it could be related to an increase in stiffness / strain in the bolt as this was previously noticed when testing cable bolts at the Sunrise Dam Gold Mine and other mines. This phenomena relates to the first part of the two dimensional graph (see below Figure 9 – Hi Tension tendon – Test No. 9 – Mandalong Coal).

Table 9 - Two dimensional graph showing confirmation of end anchor resin embedment and possible stress / strain increase in close proximity of hole collar

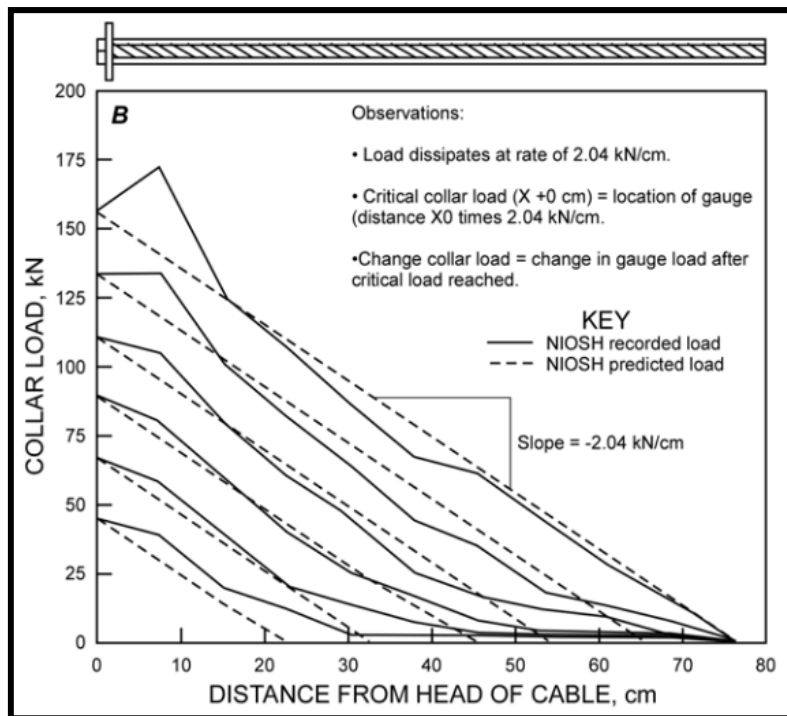
In 2004 Martin *et al.* showed that a critical load is required before the cable bolt, at a given location, would sense any load. This was done through instrumented cable bolts loaded at the collar and plotted against recorded microstrain at individual gauge locations (see below in Figure 10 the load profile along the length of the cable at different collar loads). This implied that a gauge positioned 25.4 cm from the collar would sense load only when the collar load exceeds  $25.4 \times 2\,043$  N/cm.

Table 10 - Collar load plotted against A, microstrain (load profile curve) and B, distance from head of cable (load correlation curve, Martin et al.(2004))

Figure 10 shows some similarity to the load vs dissipation rate graph of a collaborative investigation, conducted in 2004, into the behaviour of cable bolts. The collaborative work was carried out at the University of Saskatchewan, Saskatoon; Itasca Consulting Group, Inc., Minneapolis; University of British Columbia, Vancouver (BC) and the National Institute for Occupational Safety and Health (NIOSH). The study provided valuable information regarding their loading and strain behaviour. The above phenomenon, however, would need to be confirmed with strain gauged cable bolts. The cable bolts could then potentially be subjected to various loads and simultaneously tested using the Modshock system to compare actual loads with analysed elastic loads for correlation.
