Rock bolt corrosion - an experimental study

N. Aziz, P. Craig, J. Nemcik and F. Hai, Rock bolt corrosion - an experimental study, 13th Coal Operators' Conference, University of Wollongong, The Australasian Institute of Mining and Metallurgy & Mine Managers Association of Australia, 2013, 144-151.

ROCK BOLT CORROSION - AN EXPERIMENTAL STUDY

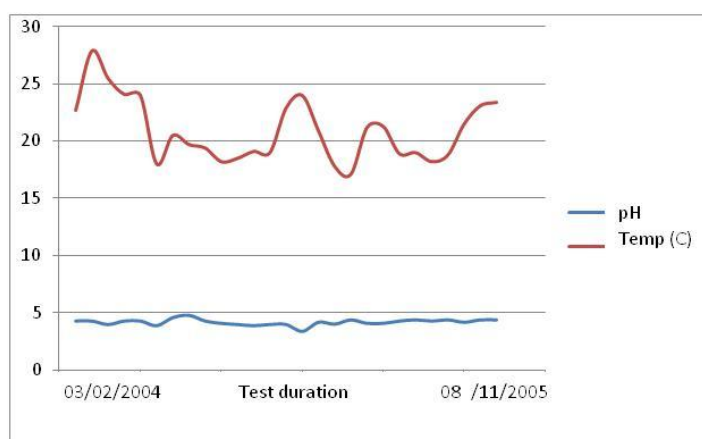
Figure 4 - Laboratory room temperature fluctuation and water Ph value

4 show the graph of PH level variations with time. Table 2 shows four water samples chemical analysis. Samples one to three were collected form Shoalhaven River inlet while sample four was from water from a local mine.

Table 2 shows the analysis of the water quality from Shoalhaven River and water quality of mine water collected from one mine in the southern coal field of Sydney Basin. It is clear from Table 2 and graphs in Figure 4, that the test water from Shoalhaven River was an aggressive solution that was suited to corrosion reactions in comparison from a typical mine water sample shown in Table 2. High concentrations of chloride ions as well as low pH level suggest that the solution was acidic. The large proportions of sulphates reinforced the weathering of the pyrite from the water origin, which assisted in decreasing any resistance to corrosion such as the formation of oxide layers. The sample solutions also show that the water had low dissolved oxygen content, which is not favoured in corrosive reactions;

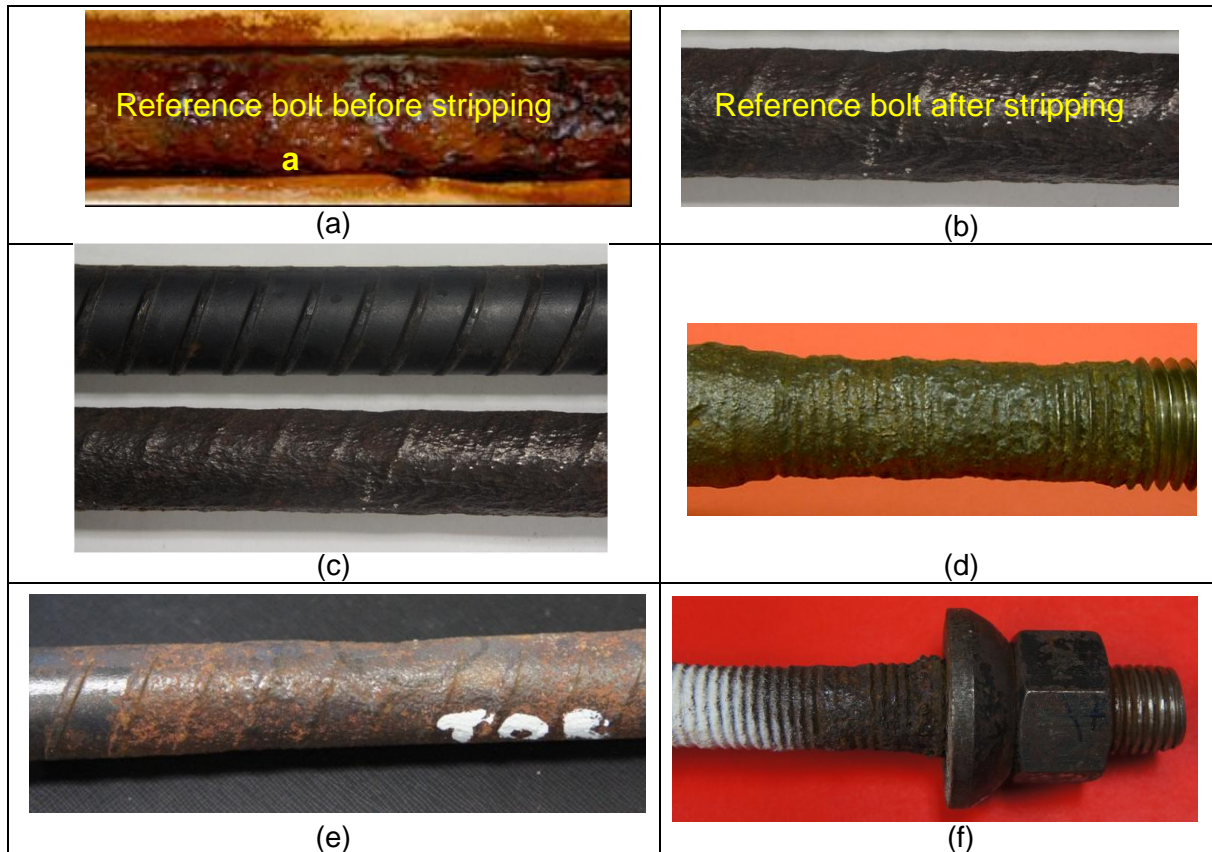
Figure 5 shows pictures of various sections of pre and post-tested bolts. It is clear that there were some variations in the post-testing diameters along the length of each bolt. A noticeable and excessive corrosion occurred on the threaded bolt-ends section and at the sections of the bolts passing through the steel PFC end plate holes. These two sections were outside the direct water dripping zones. The threaded side of the bolt with maximum corrosion were for the purpose of bolt tensioning on the loading

frame sides. Figure 5 d, e and f show corroded bolt surfaces located in the vicinity of the PFC bolt tightening hole. This type of crevice corrosion is most likely to be the result of differential aeration mechanism.

Figure 5 - Photos of parts of various corroded bolt sections compared with un- corroded section. Section (e) shows the evidence of crevice corrosion due to aeration at bolt end

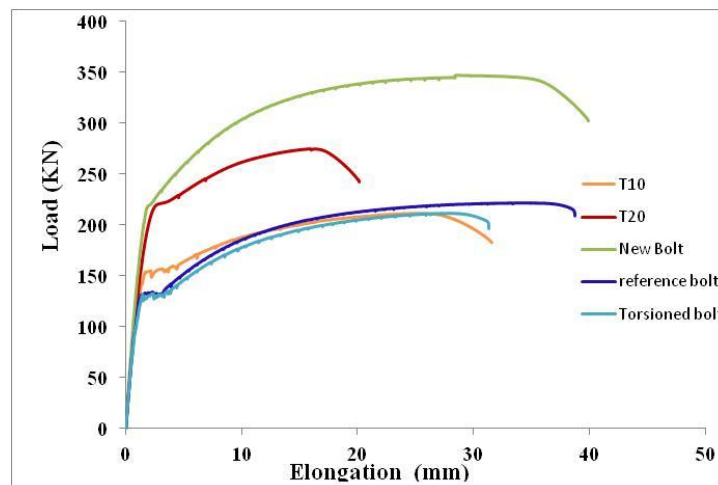
Figure 6 - Load displacement profiles of various bolts

Figure 6 shows the load-displacement graphs of various corrosion tested bolts as well as a new bolt, which was not subjected to the corrosion test. Table 4 shows the various bolts load-displacement values at yield as well as the ultimate strength values as seen in column six in Table 4.

One of the noticeable profiles of the load displacement graph was that the strength value of the 20 t tensioned bolt (T_{20}), was relatively greater than the other three bolts in the test. The peak load of P_{20} bolt was in the order of 274 kN (27.94 t). This level represented a reduction of around 21% in strength with

respect to the failure strength of a similar new bolt with its tensile strength failure load of 347 kN (35.38 t). The 10 t (T_{10}) tensioned bolt achieved 39% reduction in strength, and the reduction in strength of the torsion bolt (P_t) was 39% and the reference bolt (T_r) was 36%. The unusually lower percentage reduction in the failure load of the 20 t bolt as compared to other corroded bolts is likely to be attributed to the steel composition of the bolt as shown in Table 4. It is clear that the carbon and manganese content of the T_{20} bolt was greater than with other three bolts.
