INVESTIGATIONS INTO PREMATURE ROCK BOLT FAILURES IN THE AUSTRALIAN COAL MINING INDUSTRY

ABSTRACT: An ACARP project was initiated in 1999 to address the observed phenomenon of premature failure of rock bolts in a number of Australian coal mines, and with a particular focus on the problem of Stress Corrosion Cracking (SCC) in rock bolts. This paper briefly outlines the findings of this study.

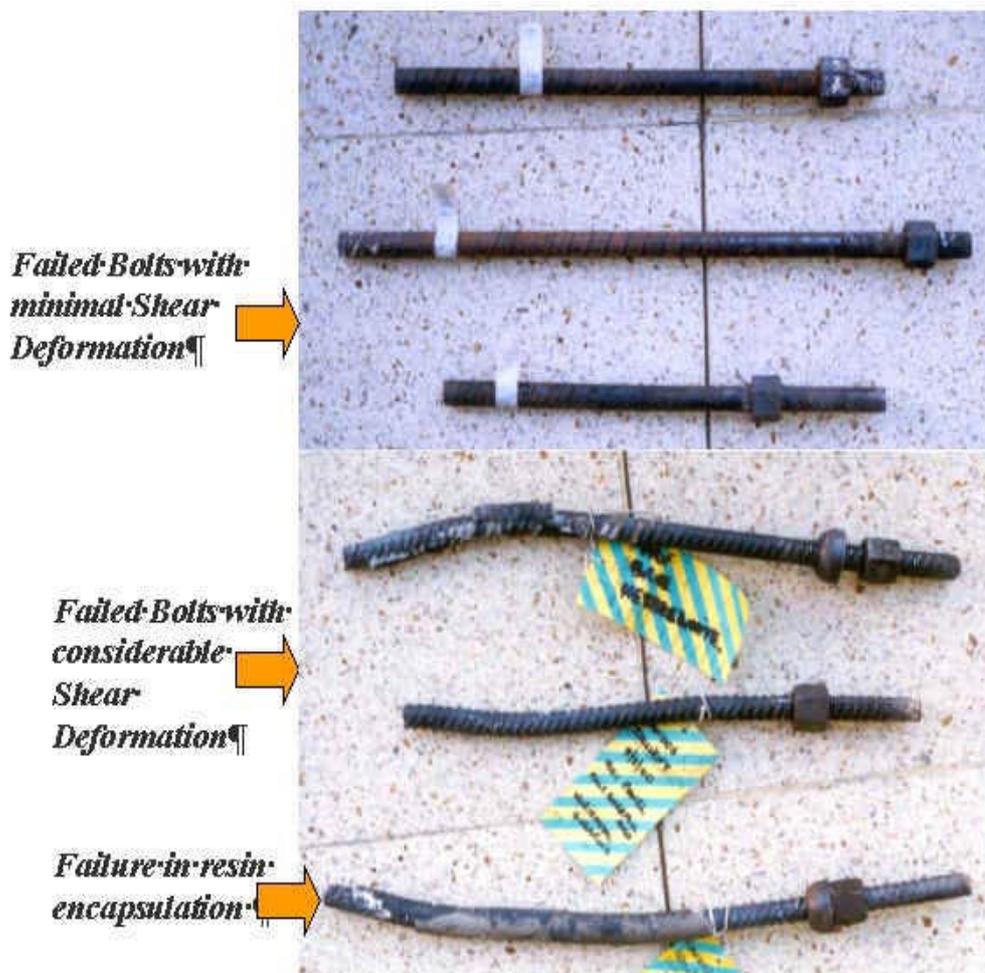
Examples of SCC brittle failures in rock bolts are shown in Figure 2.

FIG. 2 - SCC Brittle Failures of Rock Bolts

- traditional stress corrosion cracking failures caused by corrosion cracks or pits propagating until ultimate brittle failure occurs as shown in Figure 1;*
- brittle failures within the encapsulated section of the bolt without any visible corrosion see bottom bolt in Figure 2;*
- existing cracks or pits in the steel which propagate and are the trigger mechanism for ultimate failure as shown in Figure 3;*
- failures within the threaded section of the bolt typically across the root diameter of the thread as shown in the right hand bolt of Figure 4).*

Most failed bolts that were recovered from the mines were substantially straight, see Figure 2, but this is considered to be simply caused by biased sampling because straight bolts are less likely to be locked into the roof. In fact, some shear loading mechanism is probably required to explain bolt failures, below the level of encapsulation, with very low tensile collar loads.

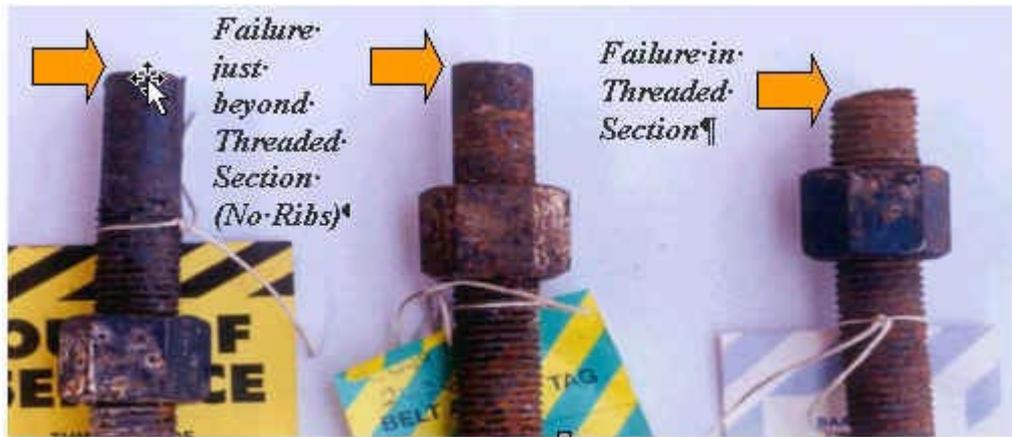
FIG. 4 - SCC Brittle failures of Rock Bolts near the collar – the two bolts on the left have failed through the bar-peeled or swaged section of the bolt, whereas the bolt on the right has failed through the root diameter of the thread.
