Stress corrosion cracking of rock bolts

Stress Corrosion Cracking of Rock Bolts

P Gray¹

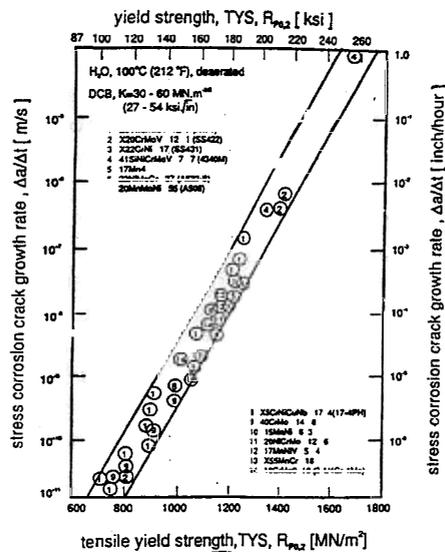
Fig. 1 - SCC growth rate vs tensile strength for high strength steels (after Atrens & Wang, Ref.1)

Figure 1 indicates that SCC can occur in a wide range of steel types (after Atrens, Ref.1). However, Figure 1 also shows that higher strength steels are generally more susceptible to SCC than lower strength steels. It can be seen that the crack growth rate is approximately 10^{-6} m/sec for steels with an ultimate tensile strength (UTS) of 1400 MPa, compared to a crack growth rate of only 10^{-11} m/sec for steels with a UTS of 600 MPa (Ref 1).

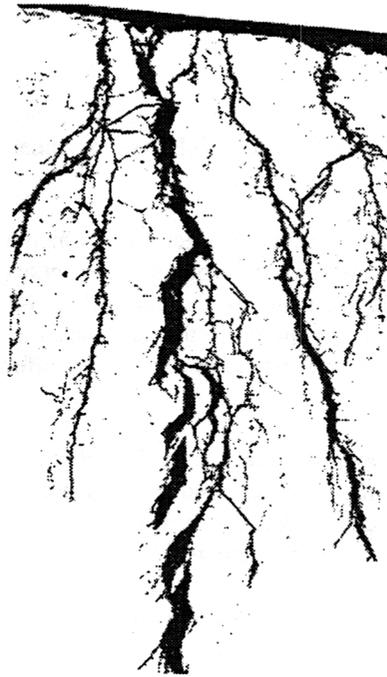
Fig. 2 - A polished and etched metallographic cross section showing typical transgranular SCC in stainless steel

SCC is a complex phenomenon and no one mechanism can explain all cases of SCC failures, but it is known to occur in many metals and alloys including Aluminium, Titanium, Brass, Steel and Stainless Steel (see Figure 2).

One form of SCC is often called Hydrogen Embrittlement (HE). When high strength steels are stressed and are also exposed to environments that release hydrogen, HE cracking can occur. Cross Section (Figure 2) see cracks in Stainless Steel.

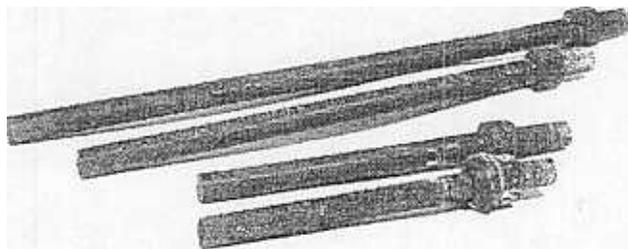
An SCC failure of a rock bolt typically appears to be a brittle failure. An SCC failure surface is normally a fracture plane at right angles to the axis of the bolt (the direction of the axial force), and there is no necking of bolt adjacent to the fracture surface. The fracture surface is frequently located at the end of the exposed free length of the bolt immediately below the resin encapsulation.

Fig. 3 - Typical SCC rock bolt failures

The surface condition of the bolt often does not show significant surface corrosion, and the end bearing plate commonly indicates that the maximum axial force on the bolt was less than the yield strength of the bolt.

A typical SCC failure of a rock bolt is shown in Figure 3.

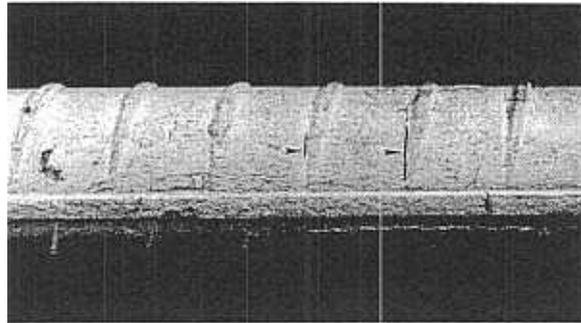
Detailed investigation of SCC failures using Magnetic Particle Impregnation (MPI) techniques reveals that many small SCC cracks develop in the bolt adjacent to the ultimate fracture surface. These small cracks frequently develop at the base of the rib profile where there is a sharp change in angle on the longitudinal section of the bolt, and this creates a “stress raiser” in the bolt (see Figure 4).

Fig. 4 - SCC at the base of the ribs on a rock bolt

Finally, the design of the ribs on the rock bolt has some influence on its susceptibility to SCC. On a conventional rock bolt, the rib projects from the core size of the rock bolt at a sharp angle (approximately between 60 and 90 degrees). This sharp angle creates a "stress raiser" in the bar when the bar is subjected to a tensile force, and consequently SCC cracks frequently occur at this point (see Figure 4). Rock bolts which therefore minimise this sharp angle and reduce the "stress raiser effect", are therefore preferable to ordinary rock bolts. In addition, all stress raisers in a rock bolt or cable bolt are to be avoided (eg cuts, grooves etc).

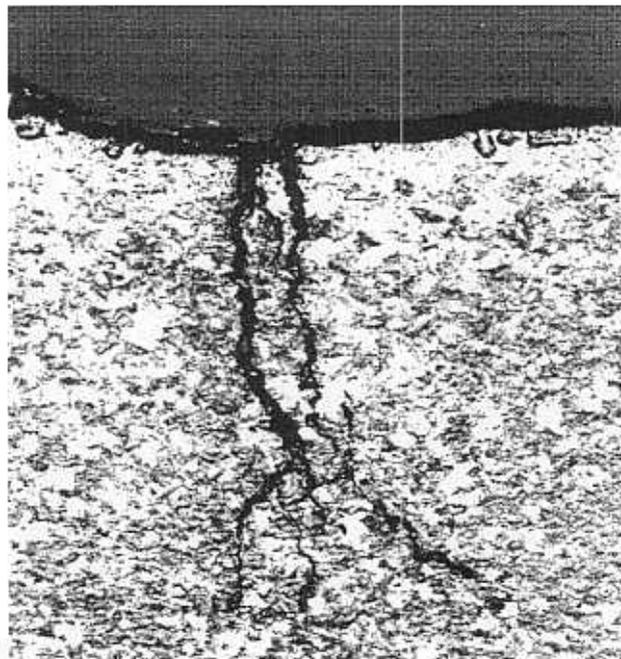
SCC cracks are usually less than 1mm deep, and are dendritic in section (see Figure 5). The crack which initiates SCC failure can be located by the fracture lines which radiate out from it as shown in Figure 6, and this crack is less than 1mm deep.

Fig. 5 - Dendritic nature of SCC at the base of the rib profile

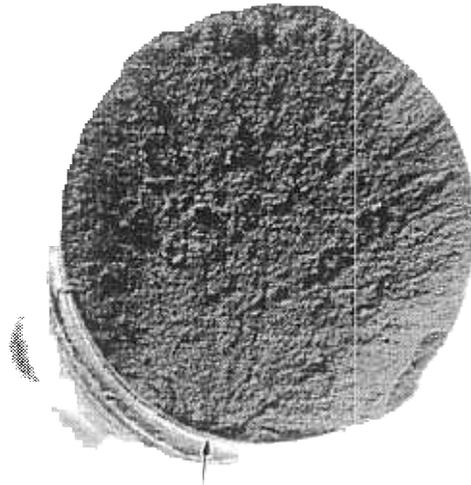
Fig. 6 - Fracture face of an SCC failure. Arrow shows the crack which initiated failure
