Naj Aziz, Ali Mirzaghobanali, and Matthew Holden, The extent of shearing and the integrity of protective sleeve coating of cable bolts, in Naj Aziz and Bob Kininmonth (eds.), Proceedings of the 17th Coal Operators' Conference, Mining Engineering, University of Wollongong, 8-10 February 2017, 240-246.

THE EXTENT OF SHEARING AND THE INTEGRITY OF PROTECTIVE SLEEVE COATING OF CABLE BOLTS

ABSTRACT: Long term integrity of cables installed around tunnels for ground reinforcement can be influenced by ground movement. This paper reports on the laboratory study of the influence of shearing on damaging the encapsulated plastic sleeves leading to exposure of the cable surface to a hostile environment. Two experimental studies were carried out to assess the extent of shearing displacement and damage to the sleeves. Various shear displacement tests were carried out. In the first test a sleeved cable was encapsulated in a plastic tube and single sheared up to 43 mm vertical displacement and the same procedure was repeated with the second sleeved cable being subjected to double shearing using a double shear testing Machine MKII. In both tests it was found that the corrugated plastic sleeves star

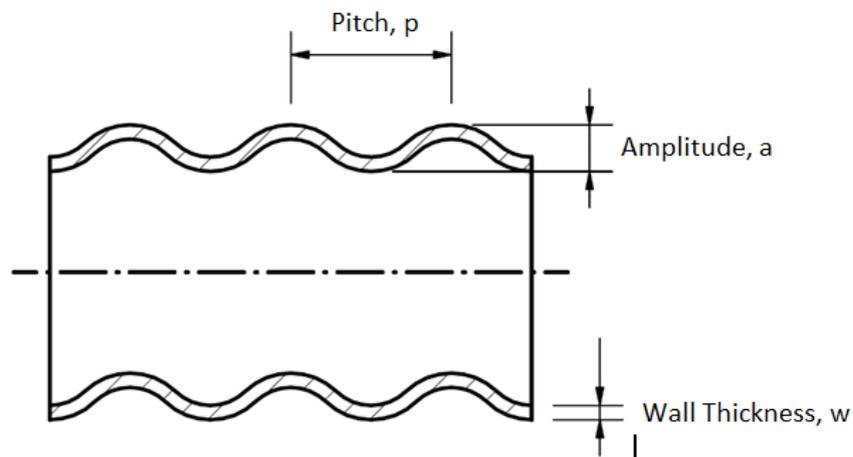
Figure 1: Cross-section of corrugated plastic sleeve

cable with corrugated plastic sheathing. The corrugated plastic sheath is manufactured from High Density Polyethylene (HDPE) with a wall thickness of 2.0 mm, pitch of 22 mm and amplitude of 6 mm (refer to Figure 1). A close up view of the cable and corrugated plastic sleeve is shown in Figure 3.

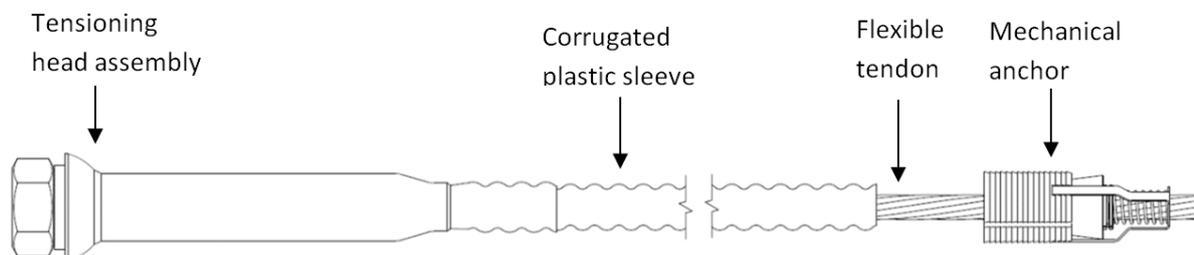
Figure 2: Typical flexible corrosion protected ground anchor

A challenge associated with incorporating a protective plastic sleeve over the reinforcing tendon is ensuring effective load transference between the tendon, the grout annuli and the ground. A smooth plastic sleeve relies heavily on the skin friction between the sleeve and the grout annuli to transfer load from ground movement to the tendon and ultimately reduces the load transference capacity of the system. To overcome this, many ground support standards and guidelines specify that the geometric profile of the sleeve should be corrugated and sinusoidal in shape. For instance, the British standard code of practice for ground anchorages, BS 8081: 1989, as well as the Roads and Maritime Services (RMS) quality assurance specification for soil nailing (R64) both specify sinusoidal corrugations with a pitch between six and twelve times the sleeve wall thickness and amplitude not less than three times the wall thickness as shown in Figure 1. The idea is to create a mechanical interlock between the inner and outer grout annuli through the geometric interference introduced by the corrugations in the plastic sleeve. This relies on the shear strength of the cement grout as opposed to the mechanical properties of the plastic sleeve. Figure 2 shows a typical flexible corrosion protected ground anchor which incorporates the protective plastic sleeve.

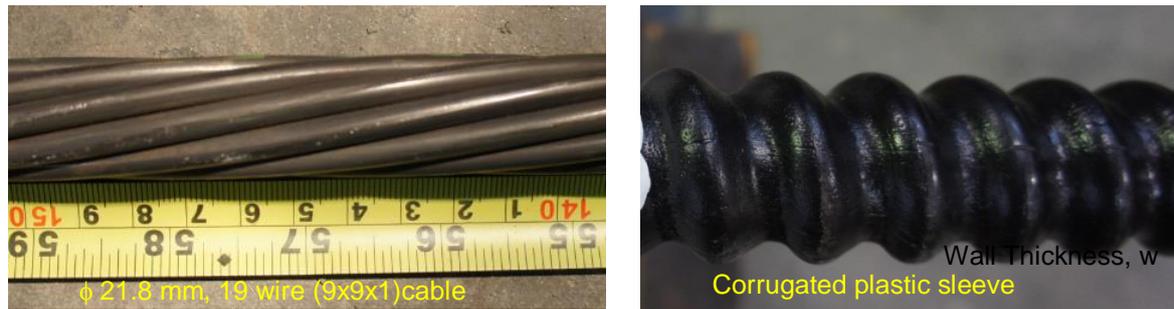
Figure 3: A close up view of the 21.7 mm diameter steel cable and corrugated plastic sleeve

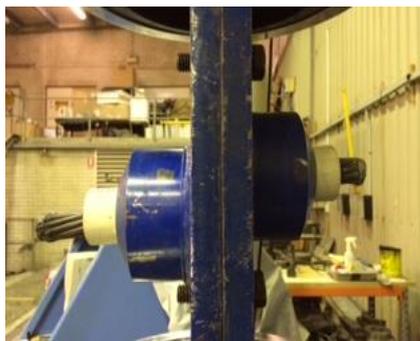
Figure 4a: Single shear apparatus:

A guillotine type single shear apparatus as shown in Figure 4a was used to carry out the preliminary shear tests. The encapsulated cable was grouted in a 5 mm thick smooth wall plastic tube using a cementitious grout to act as the outside protection layer. A 12 mm ring strip of the plastic cover was removed from mid-section of the encapsulated cable section to expose the corrugated tube, shown in Figure 4b, to allow the bare corrugated plastic sleeve to be visually inspected when sheared. Shearing of the cable was carried out in four displacement steps, until cracks appear in the corrugated sleeve.

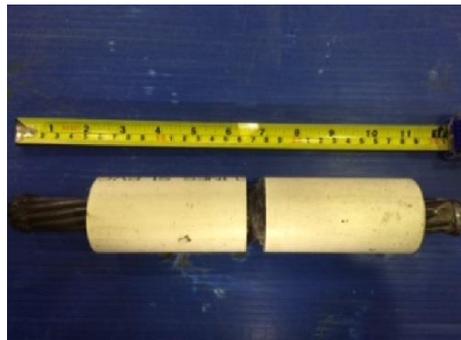
Figure 4b: Cable section with corrugated sleeve installed in 45 mm plastic tube

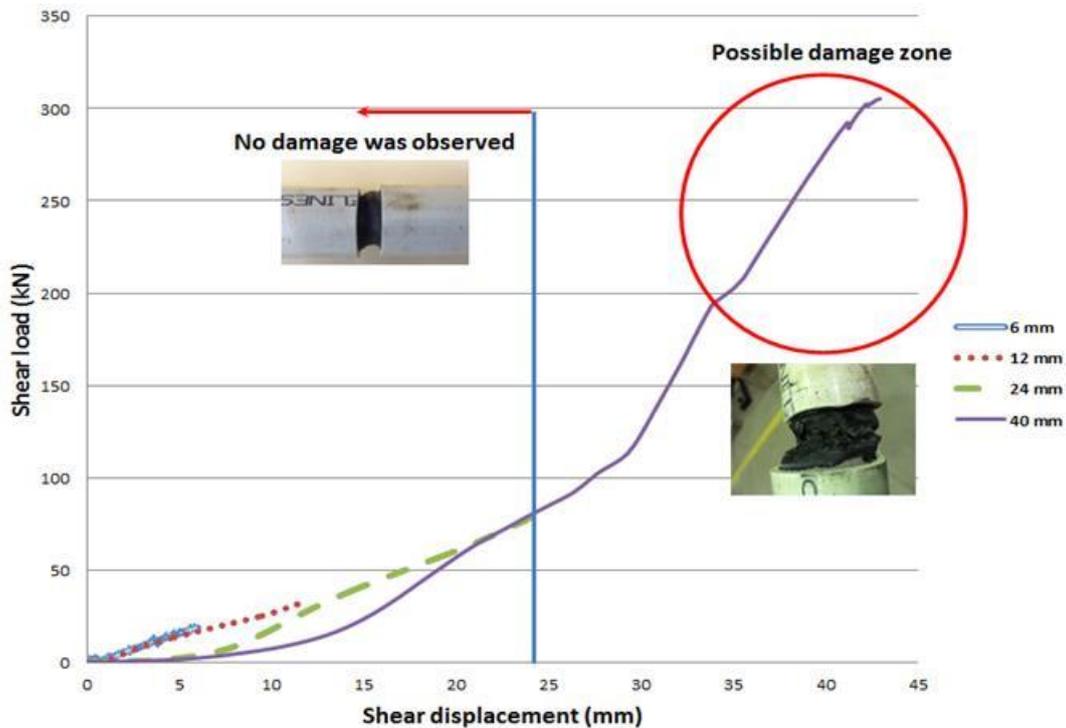
Figure 5: Shear load and displacement graphs

Figure 5 shows the shear load and shear displacement of four tests. The final test was terminated at shear displacement of 43 mm. The test was stopped at the end of each predetermined displacement step shown in the graph and the cable sleeve was physically examined for any damage. Four shear displacement step ranges were made. They were 6, 12, 24, and 40 mm ranges. As seen in Figure 5 the displacements range step of 24 mm represented, the critical shear travel for plastic sleeve failure. The shear displacement of the cable after 6 and 12 mm was recovered once the sheared load was taken off the cable. Figure 6 shows the ultimate cable shear travel and the condition of the damaged sleeve respectively. The final view of the damaged sleeve may have occurred, when the shear displacement was beyond 24 mm. An audible cracking sound was heard at the vertical displacement of around 33 mm. Therefore it is reasonable to suggest that cracking of the corrugated sleeve occurred at the vertical shearing movement of 33 mm.

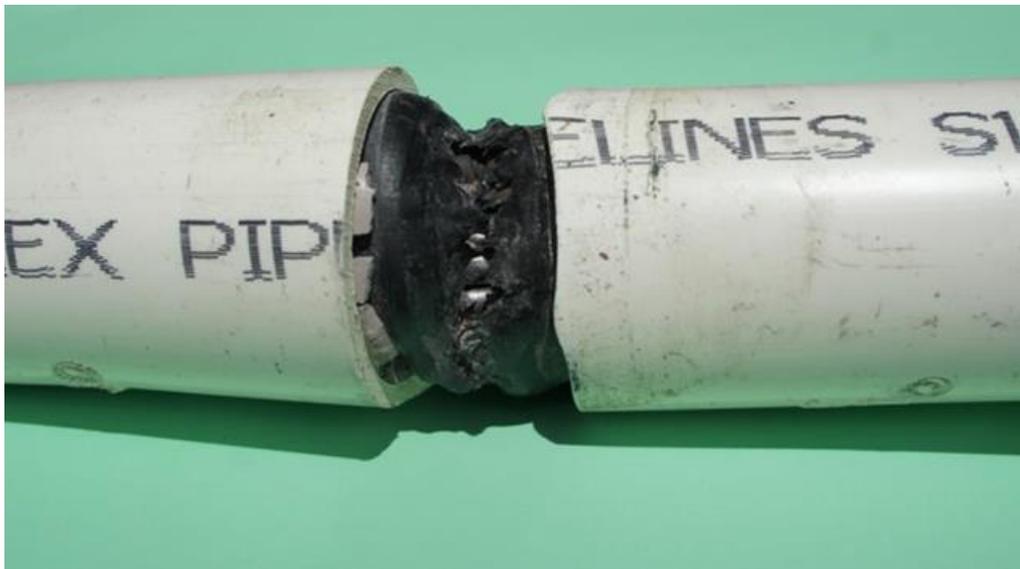
Figure 6: Damaged corrugated sleeve at the end of the shearing test

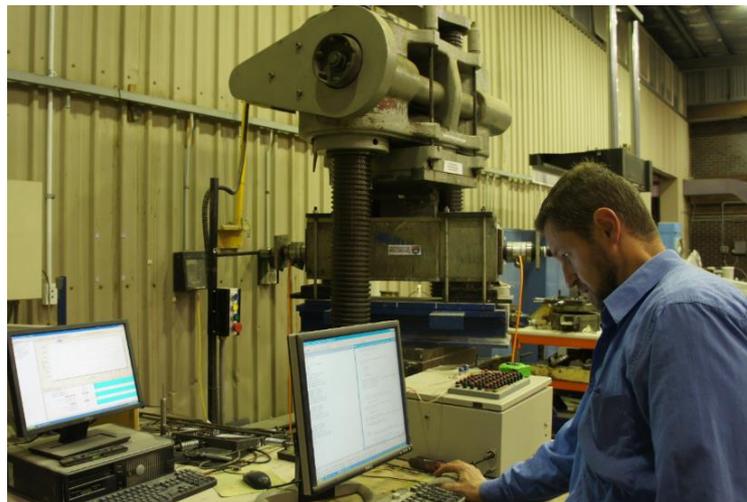
Figure 7: Double shear testing apparatus in 500 t compression testing machine

The cured blocks were then mounted in the double shear confining steel frames and the sleeved cable bolt specimen was inserted into the borehole. The annulus section between the sheath and cable was grouted and left for setting prior to cable bolt installation. Two 100 t load cells were inserted onto each end of the cable followed by the typical cable bolt end fitting. The load cells were connected to the data logger during tensioning. Once the cable was pretensioned for 5 t of axial load as specified, the grout was injected into the annulus between the cable and borehole through the intersecting small holes on top of the block. The whole assembly was then left undisturbed for the duration of seven days for the grout to cure. 50 mm cube samples were cast from the same grout as used for encapsulation and then tested for strength, yielding 45 MPa of UCS after seven days of curing. The top of the concrete blocks were covered by the bolted steel plates and the whole assembly was then mounted on the carried base platform. The whole double shear assembly and the base frame was then positioned on to the 500 t compression testing machine for shearing process at the rate of 1 mm/min as shown in Figure 7.

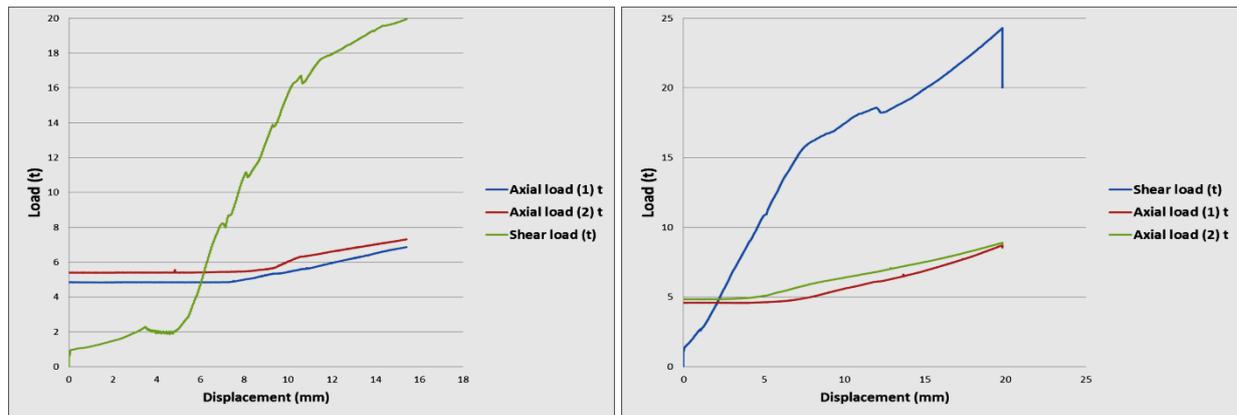
Figure 8: Shear and axial load profiles against shear displacement, left at 15 mm of shear displacement and right at 20 mm of shear displacement

Figure 8 shows the shear load and axial load profiles against shear displacement for two tests conducted in this study. The maximum values of shear load attained during double shearing, were 20 t and 24.3 t for 15 mm and 20 mm of shear displacement respectively. These correspond to maximum axial load of 7.3 t and 8.9 t. At the end of the test, the double shear assembly was dismantled and the tested cable was extracted and examined for the extent of damage to the protective sheath. Figure 8 shows pictures that were captured once the concrete blocks were gently dismantled.

For 15 mm of shear displacement;

- No damage was observed cable bolt sheath ,
- Deformation shear displacement of the cable bolt was recovered once the sample was dismantled,
- Cracks were observed on top of the concrete blocks once the steel cap was opened.

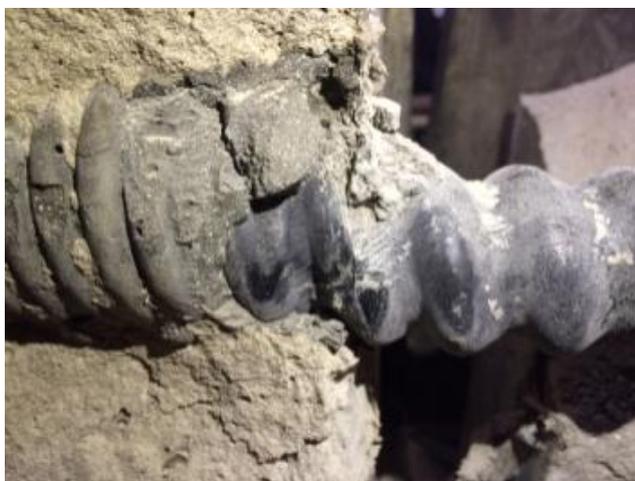
Figure 9: Post-test pictures of double shearing for 20 mm of shear displacement

Figure 9 shows post-test picture of the second test where the maximum shear displacement set to 20 mm. The following main conclusions were obtained:

- No damage on sheath of cable bolt was observed,
- Permanent deformation of the sheathed cable was noted once the sample was dismantled,
- Cracks were observed on the top and side of the concrete blocks once the steel box was opened.

Clearly the vertical shear displacement of 20 mm appeared not to have caused any detrimental damage to the sheath, which entails that the enclosed cable inside the plastic sheath would not be exposed to an adverse environment. Triggering of the plastic deformation and cracking would be likely to occur at shear displacement beyond 25 mm as indicated from the initial single shear testing.
