# Why the peak shear load of indented cables increases with increased wire failures?

Guanyu Yang, Saman Khaleghparast, Naj Aziz, Jan Nemcik and Travis Marshall, Why the peak shear load of indented cables increases with increased wire failures?, in Naj Aziz and Bob Kininmonth (eds.), Proceedings of the 2019 Coal Operators Conference, Mining Engineering, University of Wollongong, 18-20 February 2019, 162-170.

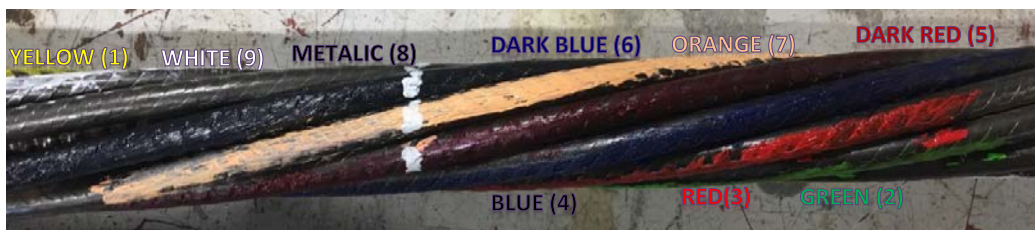
4a: Colour painted on cable bolt

Figure 4 location of strand wires at the shearing zones across joint planes

To obtain reliable results on the location of the early wire failure and their identification, all wires of the cable strand periphery were painted with different colours, using oil-based paints as shown in Figure 4a. The orientation of each wire in the sheared joint areas was clearly marked. Then one strain gauge was installed on each strand wire and the wires were numbered and marked for identification in relation to wire location in the perimeter of the strand and the shear force direction. The application of the strain gauges required a clean and flat surface on each wire, which was achieved by sanding a small area of the wire surface, located some distance away from the sheared section so that the glued strain gauge will not be affected by changes in the wire cross section area. The area was polished and wiped clean with an alcohol based cleaner to ensure any impurities on the wire surface were removed. All strain gauges were subsequently checked for functioning and line continuity prior to start of shear loading. The profile of the cable wires, location at both sheared joint faces were identified and drawn as shown in Figure 4b. The strain gauge wires were carefully coursed out of the circular MKIV double shear box in such a way that all wires were not damaged during assembling and subsequent shearing. Figure 5 shows the assembled and instrumented Naj Aziz double shear box mounted on a 500 t compression testing machine.

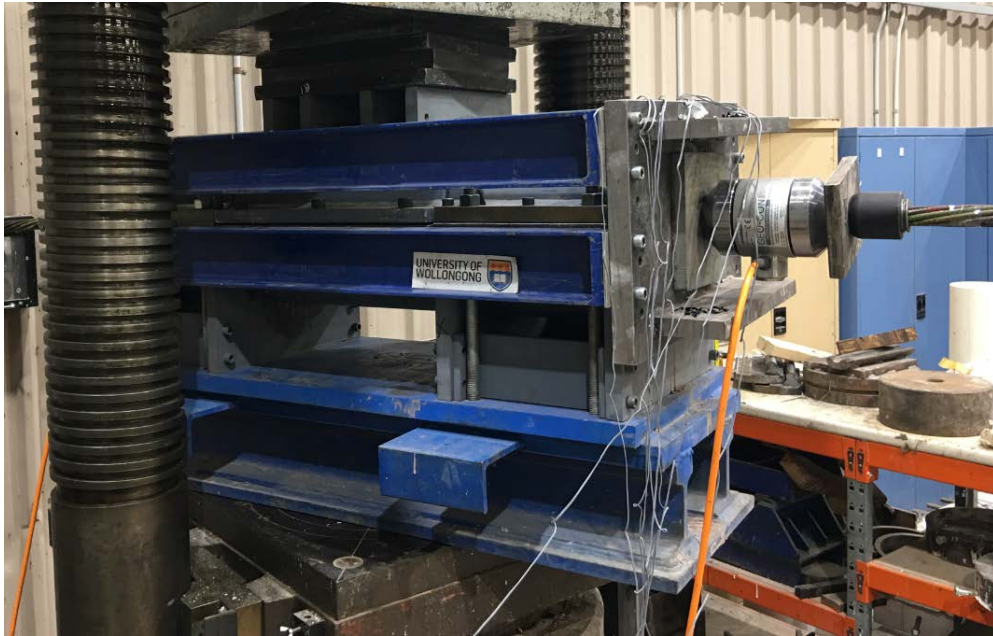
Figure 5: test sample installation and strain gauges connecting monitor channels

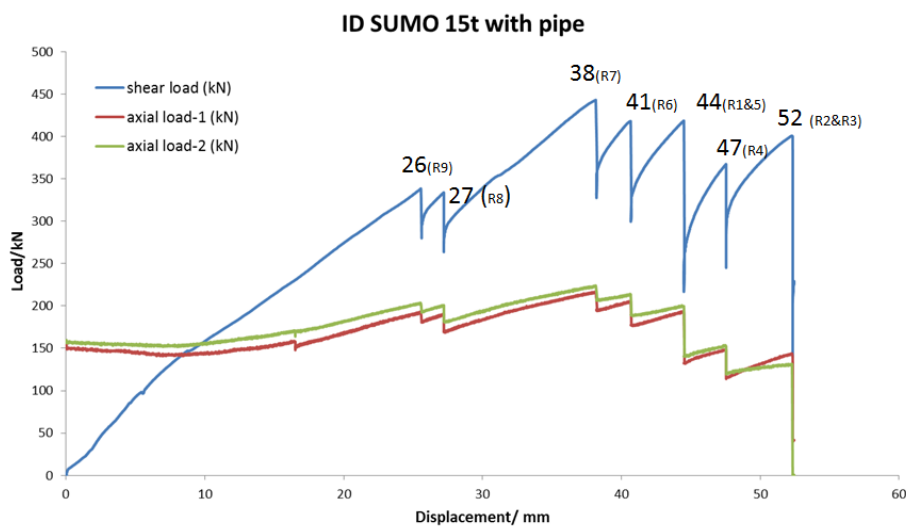
Figure 6: shear/ axial load vs displacement

Figure 6 shows the load-displacement graph of the instrumented cable under shear and Figure 7 shows the individual strain gauge readings from different wires. The first wire (R9) in the strand snapped at 25.6 mm of displacement, at shear load of 338.4 kN and occurred on the right side (R side) of the double shear testing joint face area. This was followed by the failure of the second wire (R8) at 27 mm displacement. However, the maximum shear load of 443.1 kN of R7 was reached before failure of R7 wire occurred at 38.2 mm displacement. This is followed by erratic loads failures, occurring in indented wire strand and is contrary to the past test results from plain cables as reported by Aziz, *et al.*, (2015, 2016, and 2017). In plain wire strand the peak load decreases gradually with each subsequent wire failure, as shown in Figure 2a.
