# WHY THE PEAK SHEAR LOAD OF INDENTED CABLES INCREASES WITH INCREASED WIRE FAILURES?

**ABSTRACT:** In shear testing of indented cables it has been found that indented cables peak share load failures behave contrary to the normal failure behaviour. The gradual strength loss with each individual wire failure in an indented cable strand may not lead to subsequent peak shear failure of the remaining strands in decline. This failure behaviour is characteristic of indented cables and occurs irrespective of the test method used (single shear or double shear test). Accordingly in this study all wires in a tested cable strand were instrumented with strain gauges. Each instrumented wire was individually colour coded to assist in determining the location of the wires in the strand circumference with respect to the direction of shear. The location of wires in the perimeter was identified at the sheared joint surface areas. During testing of the cable using a circular MKIV double shear apparatus (Naj Aziz DS Box) the initialisation of wire failure was identified by the strain gauge readings. This data found that the wires failing early were located on the upper segment of the bent strand durin

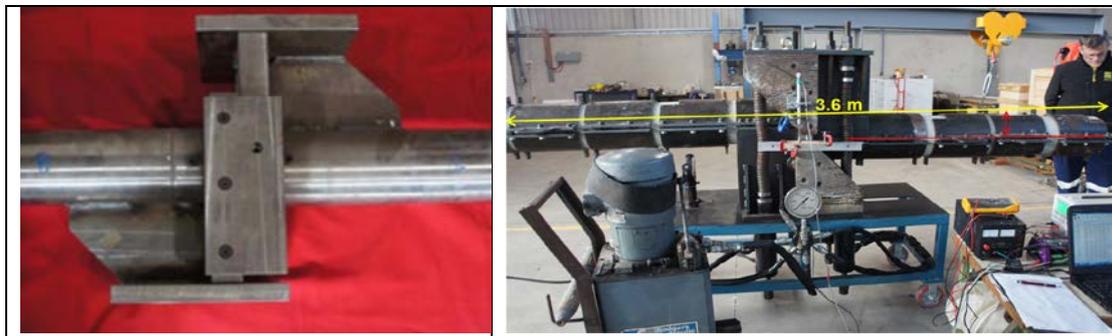
**Figure 1: Single shear apparatus; (a) British standard based single shear and (b) Megabolt single shear apparatus**

The conventional guillotine type apparatus based on British Stand BS 8761-part 2 (2009) and Megabolt single shear apparatus are methods for shear testing of tendons. The Megabolt single shear apparatus (McKenzie and King, 2015) is an integrated system that incorporated 120 t compression testing machine to the system and is also capable of evaluating bonding and debonding characteristics of tendon with respect to surface roughness. The performance of both types of rigs for testing cable bolts, as shown in Figure 1, are also reported by Aziz, *et al* in (2015 and 2018 a, b) and Mirzaghobanali, *et al.*, 2017 respectively.

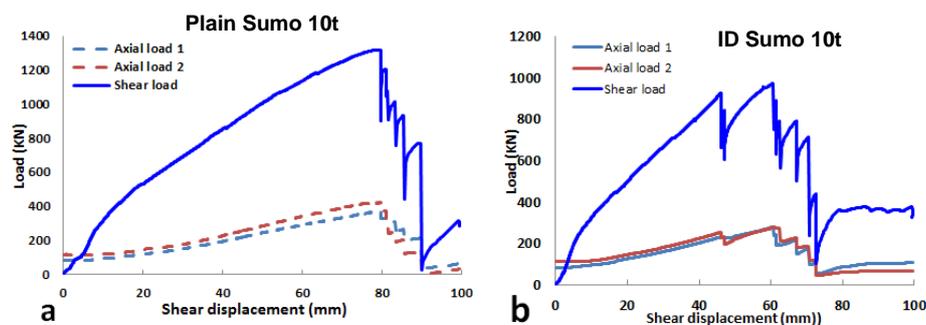
**Figure 2: Shear testing of (a) plain and (b) indented cable bolts in 40 MPa concrete subjected to 10 t pretension load**

Several cables tested in shear using various types of the UOW double shear boxes have resulted in different failure behaviours of strand wires. The variance in failure pattern is related to the surface condition of smooth or indented wires as shown in load – displacement in Figure 2. The peak failure load of a cable bolt would normally be the maximum load and occur as the first wire failed with each subsequent wire failure continuing to shed load. Some indented wires appear to fail in an abnormal fashion, particularly when compared with smooth wire type, in which its peak failure load is lower than the smooth wired cables and may not be reached when the first wire fails. The subsequent wire failures may lead to increased peak shear load with the failure of indented wires. No abnormal failures were found in plain/ smooth wire cables with the first wire failure always being the peak load. Abnormal load failures in indented wire cables may also lead lower ultimate peak load failures.

Figure 6 shows the load-displacement graph of the instrumented cable under shear and Figure 7 shows the individual strain gauge readings from different wires. The first wire (R9) in the strand snapped at 25.6 mm of displacement, at shear load of 338.4 kN and occurred on the right side (R side) of the double shear testing joint face area. This was followed by the failure of the second wire (R8) at 27 mm displacement. However, the maximum shear load of 443.1 kN of R7 was reached before failure of R7 wire occurred at 38.2 mm displacement. This is followed by erratic loads failures, occurring in indented wire strand and is contrary to the past test results from plain cables as reported by Aziz, *et al.*, (2015, 2016, and 2017). In plain wire strand the peak load decreases gradually with each subsequent wire failure, as shown in Figure 2a.

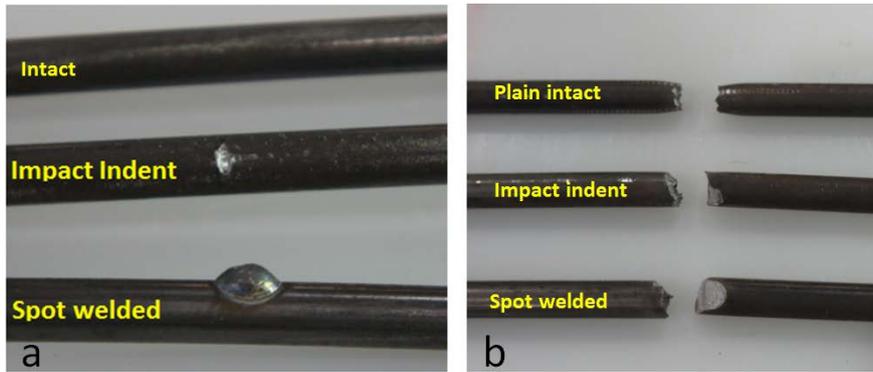
Figure 3: Impact free and stressed wires

To demonstrate the strength performance behaviour under different test environments, three 400 mm long sections of the same cable bolt wire were cut and subjected to various forms of stress environments, as described above. Figure 3a shows three wires with one wire subjected to impact punch, the second was spot welded and the third one was intact. All three wires were then pull tested to failure using 50 t capacity Instron universal testing machine. The tested wires are shown in Figure 3b. The peak failure load of the intact wire was 69 kN, the failure load of punched wire was 67 kN and spot welded wire was 51 kN. All tested wires were from Sumo cable strand. This finding demonstrated clearly that failure of wires varies with respect to test wire conditions and that excessively stressed wire fails prematurely.

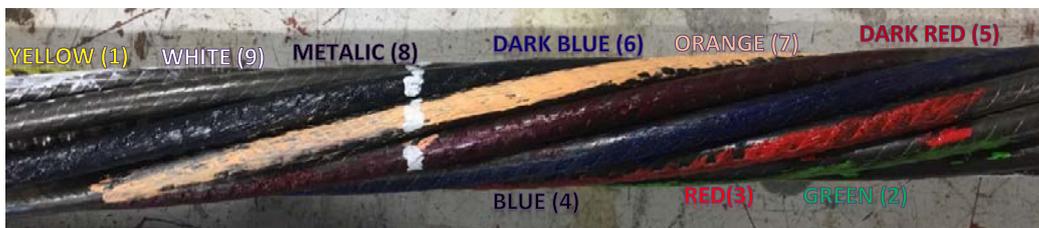
4a: Colour painted on cable bolt

Figure 4 location of strand wires at the shearing zones across joint planes

To obtain reliable results on the location of the early wire failure and their identification, all wires of the cable strand periphery were painted with different colours, using oil-based paints as shown in Figure 4a. The orientation of each wire in the sheared joint areas was clearly marked. Then one strain gauge was installed on each strand wire and the wires were numbered and marked for identification in relation to wire location in the perimeter of the strand and the shear force direction. The application of the strain gauges required a clean and flat surface on each wire, which was achieved by sanding a small area of the wire surface, located some distance away from the sheared section so that the glued strain gauge will not be affected by changes in the wire cross section area. The area was polished and wiped clean with an alcohol based cleaner to ensure any impurities on the wire surface were removed. All strain gauges were subsequently checked for functioning and line continuity prior to start of shear loading. The profile of the cable wires, location at both sheared joint faces were identified and drawn as shown in Figure 4b. The strain gauge wires were carefully coursed out of the circular MKIV double shear box in such a way that all wires were not damaged during assembling and subsequent shearing. Figure 5 shows the assembled and instrumented Naj Aziz double shear box mounted on a 500 t compression testing machine.

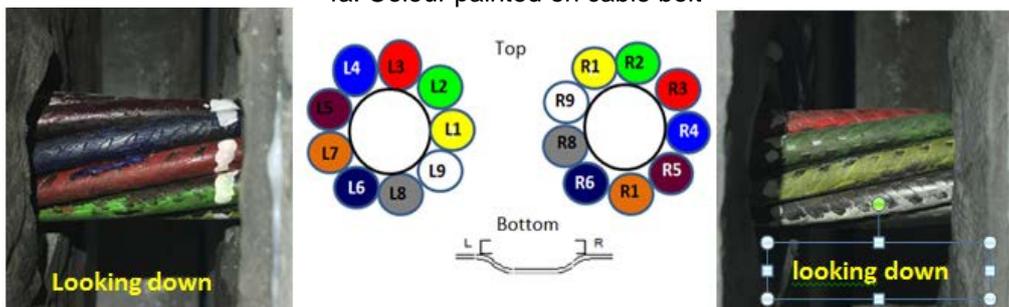
4b: wires orientation at both Lift and right joint planes zones

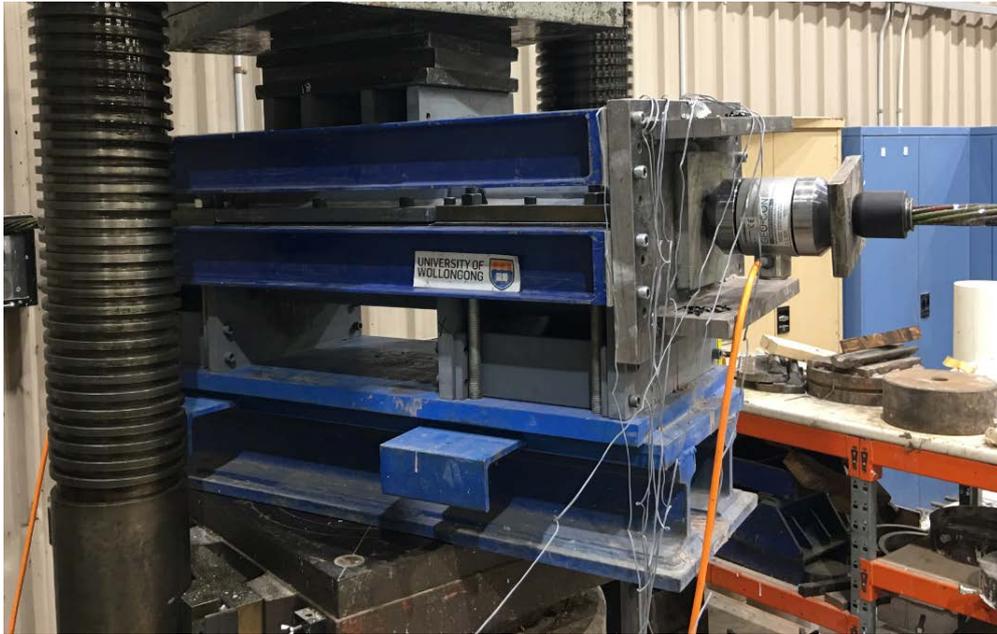
Figure 5: test sample installation and strain gauges connecting monitor channels

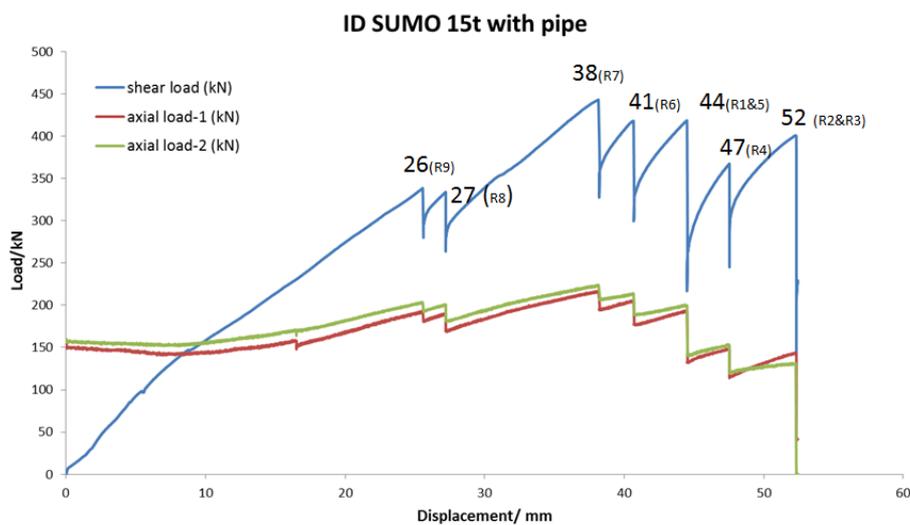
Figure 6: shear/ axial load vs displacement

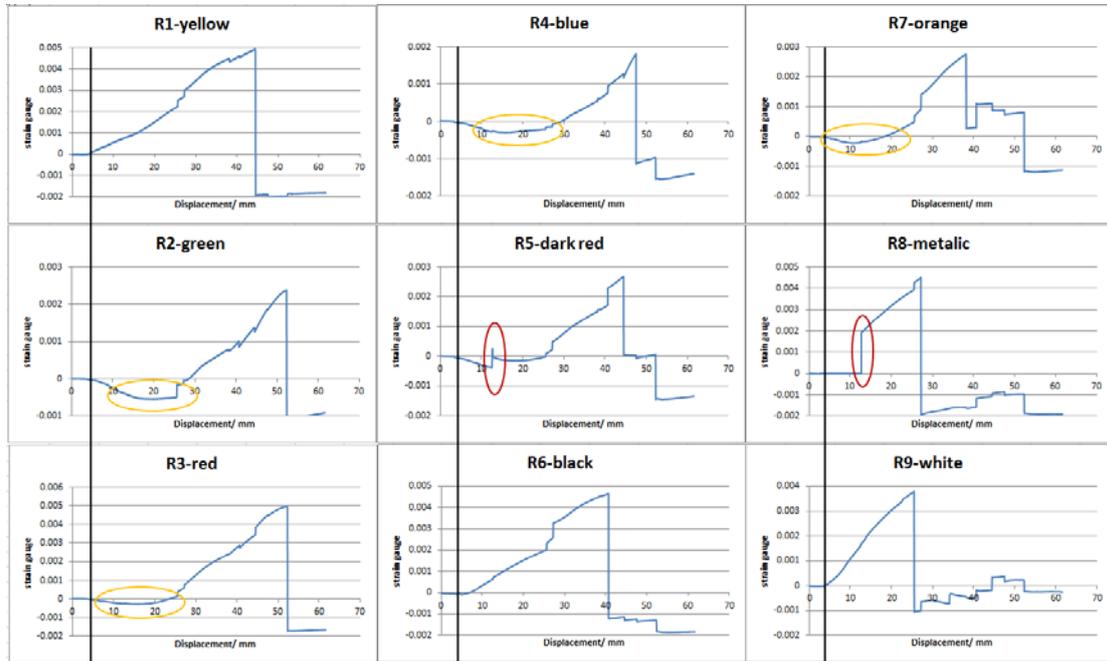
Figure 7: Strain vs displacement of instrumented wires during shearing

During the early stage of shearing process some cable strand wires, namely Green (R2), Red (R3), Blue (R4), Black (R5), orange (R7), were subjected to early negative strain of shear load-

displacements as shown in Figure 7, while others Yellow (R1), Dark Blue (R6), Metallic (R8) and White (R9) recorded positive strains right from the start of shearing, This suggests that those wires with positive strain were subjected to tensile and shear failure and they were mostly located on the top side (upper side)of the strand with respect to the vertical shear direction. The failed wires are characteristically either in tensile shear or in tension with cone and cup as shown in Figure 8. These failure patterns are documented in Table 1.

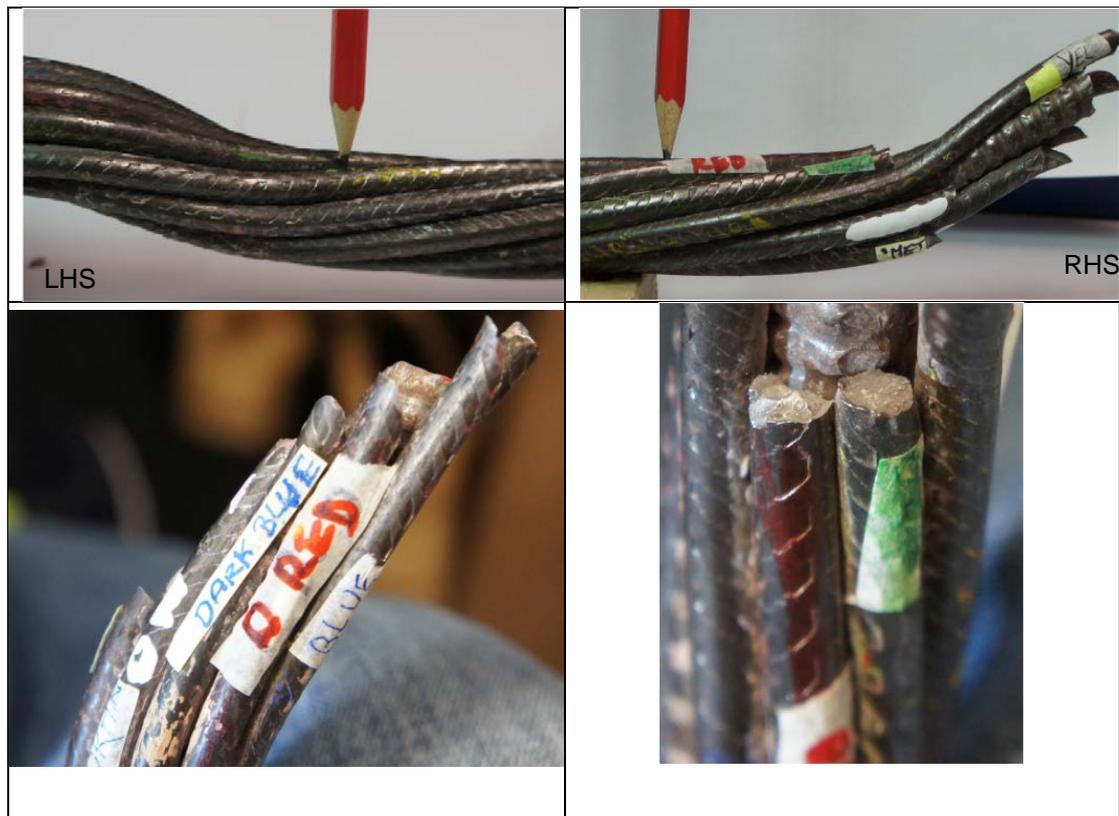
RHS- Sheared Cross section

**Figure 8: failure pattern of wires during shearing (right side of sheared cable in double shear test)**
