LABORATORY STUDY ON ROCKBOLT CORROSION

*N Aziz¹ P Craig² and J Nemcik¹
¹*University of Wollongong,
North Fields Avenue, Kieraville,
Wollongong, NSW, Australia, 2522,*
(*Corresponding Author: naj@uow.edu.au)

The effect of long term exposure of full size bolts to corrosive environments is presented. A special test rig was used to test four bolts under different loading conditions. Four, X-grade identical profile bolts, each of 21.7 mm core diameters (23.7 mm full diameter) were subjected to prolonged corrosion testing using acid sulphate water. The pH value of the circulated water varied between 3.4 and 4.3. The corrosion exposure test period lasted three and half years. Two bolts were axially loaded to 10 and 20 tonnes force respectively, the third bolt was subjected to a 360 Nm torsion load and the fourth bolt was left unstressed to act as a reference bolt. After the test period ended, the bolts were stripped of their corroded coatings and weighted for weight loss. The diameter of each bolt was subsequently measured, and the loaded bolt samples were first tested non-destructively for tensile cracks and then tested for tensile failure. No cracks were found on post corrosion bolts

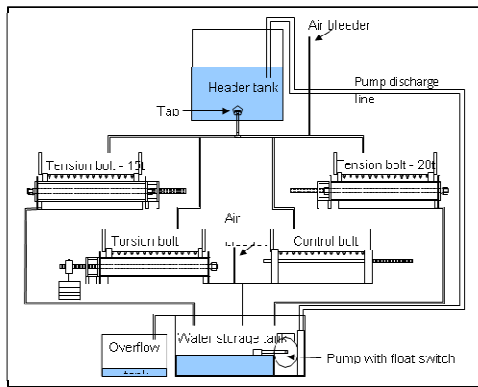
Figure 1 – The general layout of the bolt corrosion rig

The corrosion testing apparatus consisted of a header tank which fed water to all test bolts as shown schematically in Figure 1. Figure 2 shows the laboratory experimental test rig. The dispersion of water on each tested bolt used 13 drippers spaced at 40 mm along a 720 mm long 100 mm diameter PVC manifold tubing, giving each bolt a wetting exposure length of between 520 and 540 mm. Water in the PVC manifold tubes was supplied from the main reservoir tank, placed about 500 mm above the PVC water manifold tubings. The length of each bolt loading frame was 770 mm. The dripped water was collected in plastic drip trays placed beneath each tested bolt and returned to the header tank for recirculation.

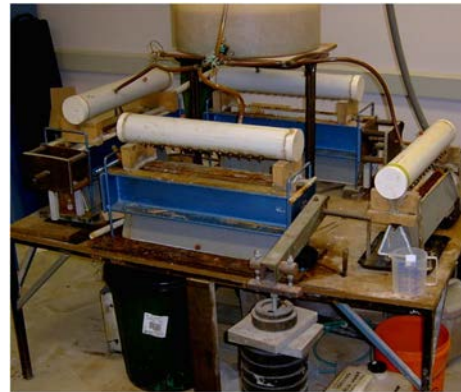
Figure 2 – Corrosion testing rig

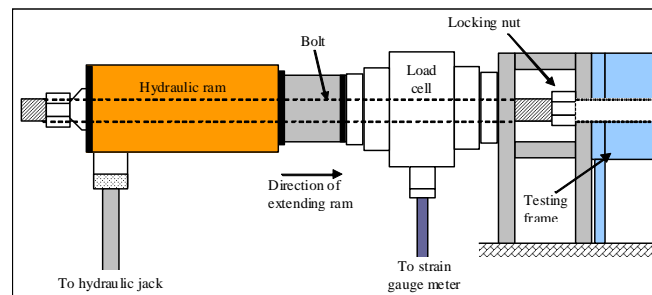
Figure 3 – Axial tensioning of bolts installed in the tension rig of Figure 2

Bolt tensioning was carried out using three strong Parallel Flanged Channel (PFC) steel frames, which allowed axial loading of two bolts to the predetermined loads of 10 and 20 tonnes, and torsion of the third bolt. The 9.5 mm thick steel tensioning PFC frames consisted of two 150 mm x 75 mm sections. Two 150 mm square, 10 mm steel plates welded the two PFC steel channels together and were painted to protect and prevent them from influencing the bolt corrosion. The end-plates were drilled with 25 mm diameter holes to allow the bolt to pass through and sit between the beams spaced at 50 mm. The strength of the end-plates allowed the applied tension to be held by an interlocking nut against the sides of the frames as shown in the Figure 2 inset. The PFC section frames were designed to allow the water, that drip on to the bolts, to be collected in plastic trays placed underneath bolt mounted rigs. The reference bolt (non-tensioned) rested on top of the plastic drip tray, and the dripper tube was supported on a small plastic stand, just above the bolt. Figure 3 shows the procedure adopted for tensioning the bolt axially.

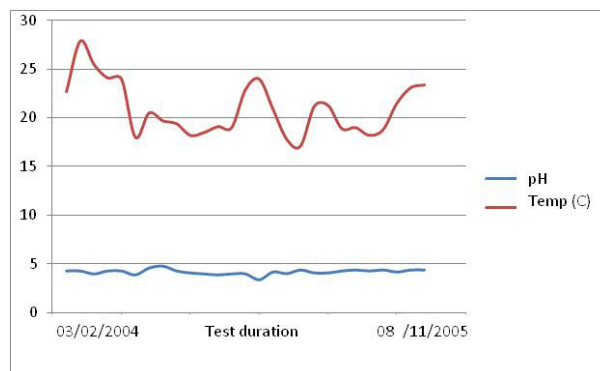
Figure 4 – Laboratory room temperature fluctuation and water Ph value

Table 2 shows the analysis of the water quality from Shoalhaven River and water quality of mine water collected from one mine in the southern coal field of Sydney Basin. It is clear from Table 2 and graphs in Figure 4, that the test water from Shoalhaven River was an aggressive solution that was suited to corrosion reactions in comparison from a typical mine water sample shown in Table 2. High concentrations of chloride ions as well as low pH level suggest that the solution was acidic. The large proportions of sulphates reinforced the weathering of the pyrite from the water origin, which assisted in decreasing any resistance to corrosion such as the formation of oxide layers. The sample solutions also show that the water had low dissolved oxygen content, which is not favoured in corrosive reactions; however this was not

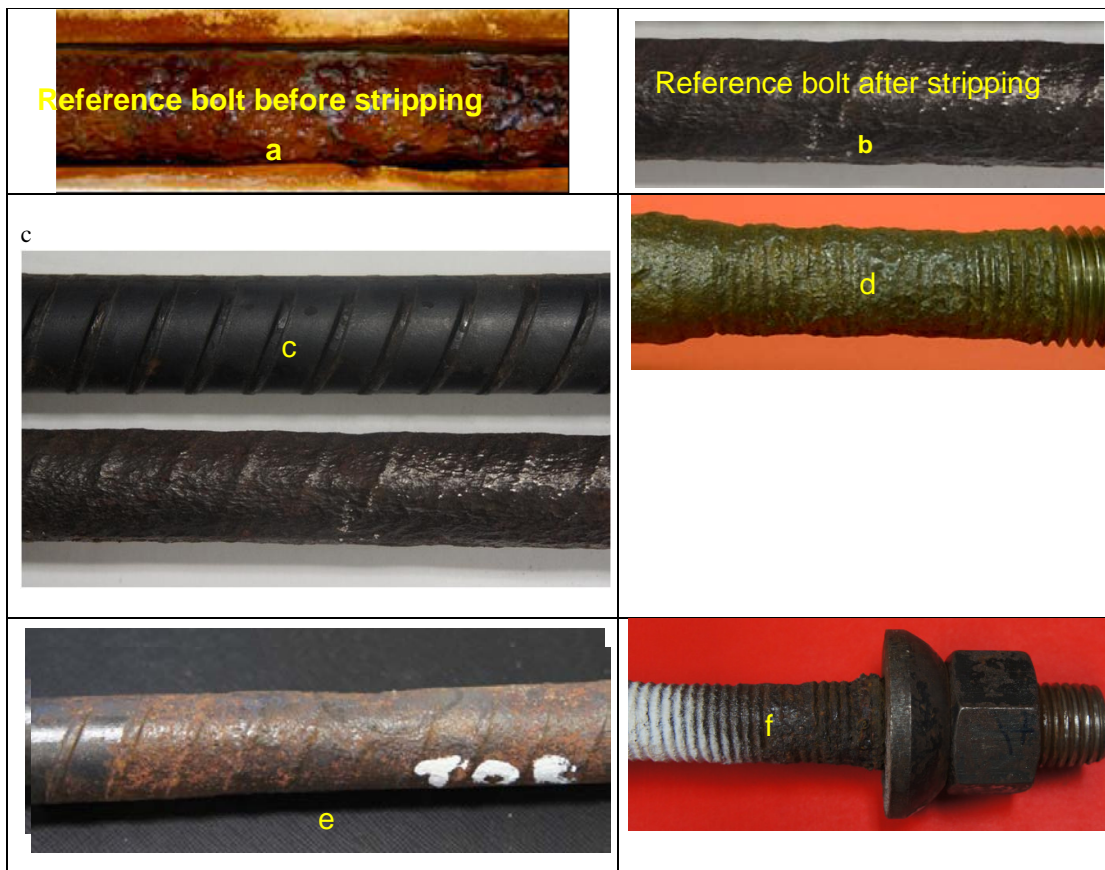
Figure 5 – Photos of parts of various corroded bolt sections compared with un- corroded section. Section (e) shows the evidence of crevice corrosion due to aeration at bolt end

Figure 5 shows pictures of various sections of pre and post-tested bolts. It is clear that there were some variations in the post-testing diameters along the length of each bolt. A noticeable and excessive corrosion occurred on the threaded bolt-ends section and at the sections of the bolts passing through the steel PFC end plate holes. These two sections were outside the direct water dripping zones. The threaded side of the bolt with maximum corrosion were for the purpose of bolt tensioning on the loading frame sides. Figure 5d, e and f show corroded bolt surfaces located in the vicinity of the PFC bolt tightening hole. This type of crevice corrosion is most likely to be the result of differential aeration mechanism.

The weight loss measurement, before and after the test, could not be related solely to the designated wetted section of the bolt. There was some further corrosion at the bolt ends that anchored the bolt ends to the PFC steel loading frame. Thus, two forms of corrosion were identified in this experimental study, pitting and crevice corrosion. Pitting corrosion was evident in the mid-sections of the bolt directly along the dripping zone as seen in Figure 5 a, b and c. Crevice corrosion on the other hand occurred at the

bolt ends as demonstrated in Figure 5 d, e and f. The mounting of the torsion bolt on the PFC tension frame also generated crevice corrosion as one side of the bolt required no direct axial loading, just torsion, thus leaving a free flow of air through the bolt surface as shown in Figure 5e. Normally crevice corrosion occurs in the confined space as a result of differential aeration mechanism. Also the excessively crevice corroded zone shown in Figure 5e was not in direct contact with the dripper waters as the last drip nozzle was some 60-70 mm away from either side of the rig side holes housing the bolt ends. This type of corrosion is most likely to be observed underground at the collar of the installed bolt in a hole with less encapsulation, thus leading to the onset of stress corrosion cracking, particularly when the protruding bolt end is subjected to external shear loading or impact. According to Gray (2006) this type of corrosion was often found in their field observations particularly at Angus Place Mine, NSW, with severe corrosion taking place along the free length of the bolt, even though there was no apparent free water. A damp corrosive atmosphere is sufficient to cause corrosion and perhaps this is because of the greater presence of free oxygen in air rather than under water. In addition, the excessive surface area of the threaded section of the bolt also has an influence.

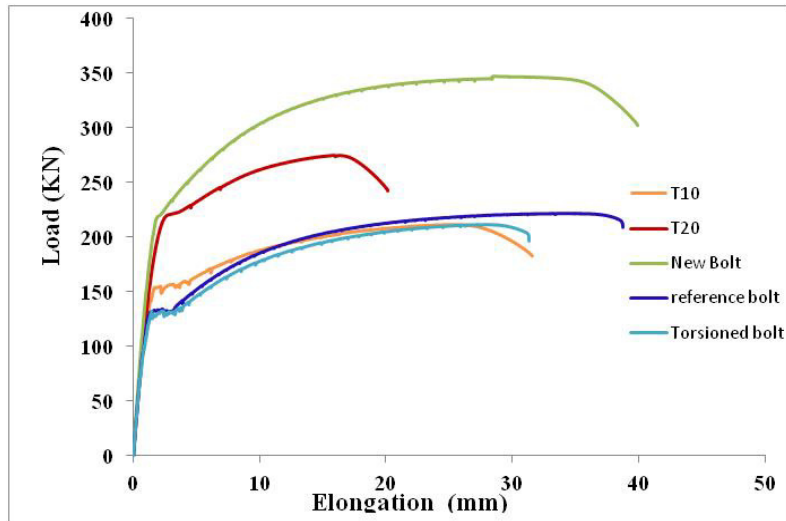
Figure 6 – Load displacement profiles of various bolts

Figure 6 shows the load-displacement graphs of various corrosion tested bolts as well as a new bolt, which was not subjected to the corrosion test. Table 4 shows the various bolts load-displacement values at yield as well as the ultimate strength values as seen in column six in Table 4.

One of the noticeable profiles of the load displacement graph was that the strength value of the 20 t tensioned bolt (T_{20}), was relatively greater than the other three bolts in the test. The peak load of P_{20} bolt was in the order of 274 kN (27.94 t). This level represented a reduction of around 21% in strength with respect to the failure strength of a similar new bolt with its tensile strength failure load of 347 kN (35.38 t). The 10 t (T_{10}) tensioned bolt achieved 39% reduction in strength, and the reduction in strength of the torsion bolt (P_t) was 39% and the reference bolt (T_r) was 36%. The unusually lower percentage reduction in the failure load of the 20 t bolt as compared to other corroded bolts is likely to be attributed to the steel composition of the bolt as shown in Table 4. It is clear that the carbon and manganese content of the T_{20} bolt was greater than with other three bolts.
