Aziz, N., Craig, P. & Nemcik, J. Anton. (2013). Laboratory study on rockbolt corrosion. 23rd World Mining Congress (pp. 1-10). United States: CIM.

LABORATORY STUDY ON ROCKBOLT CORROSION

The effect of long term exposure of full size bolts to corrosive environments is presented. A special test rig was used to test four bolts under different loading conditions. Four, X-grade identical profile bolts, each of 21.7 mm core diameters (23.7 mm full diameter) were subjected to prolonged corrosion testing using acid sulphate water. The pH value of the circulated water varied between 3.4 and 4.3. The corrosion exposure test period lasted three and half years. Two bolts were axially loaded to 10 and 20 tonnes force respectively, the third bolt was subjected to a 360 Nm torsion load and the fourth bolt was left unstressed to act as a reference bolt. After the test period ended, the bolts were stripped of their corroded coatings and weighted for weight loss. The diameter of each bolt was subsequently measured, and the loaded bolt samples were first tested non-destructively for tensile cracks and then tested for tensile failure. No cracks were found on post corrosion bolts tested non-destructiv

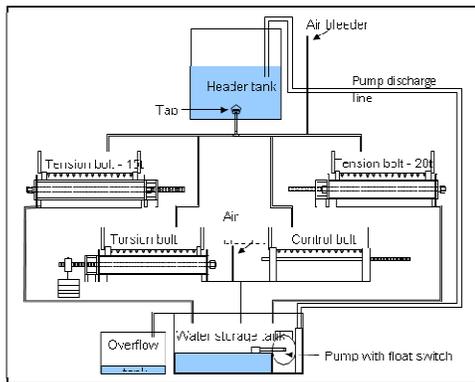
Figure 1 – The general layout of the bolt corrosion rig

The corrosion testing apparatus consisted of a header tank which fed water to all test bolts as shown schematically in Figure 1. Figure 2 shows the laboratory experimental test rig. The dispersion of water on each tested bolt used 13 drippers spaced at 40 mm along a 720 mm long 100 mm diameter PVC manifold tubing, giving each bolt a wetting exposure length of between 520 and 540 mm. Water in the PVC manifold tubes was supplied from the main reservoir tank, placed about 500 mm above the PVC water manifold tubings. The length of each bolt loading frame was 770 mm. The dripped water was collected in plastic drip trays placed beneath each tested bolt and returned to the header tank for recirculation.

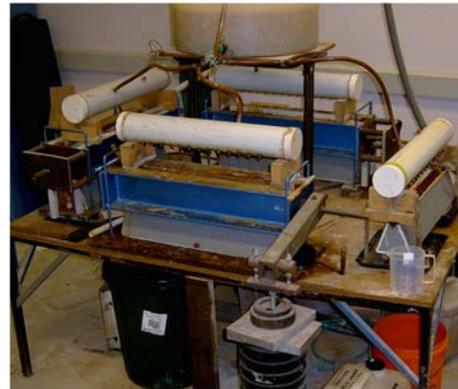
Figure 2 – Corrosion testing rig

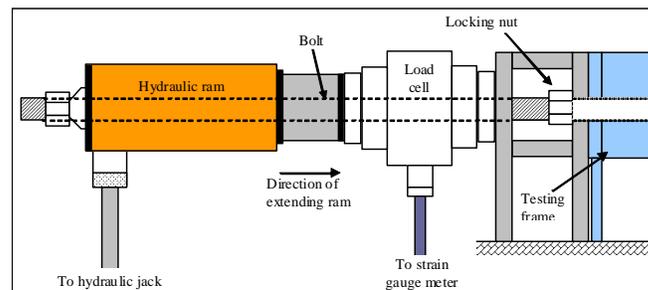
Figure 3 – Axial tensioning of bolts installed in the tension rig of Figure 2

Bolt tensioning was carried out using three strong Parallel Flanged Channel (PFC) steel frames, which allowed axial loading of two bolts to the predetermined loads of 10 and 20 tonnes, and torsion of the third bolt. The 9.5 mm thick steel tensioning PFC frames consisted of two 150 mm x 75 mm sections. Two 150 mm square, 10 mm steel plates welded the two PFC steel channels together and were painted to protect and prevent them from influencing the bolt corrosion. The end-plates were drilled with 25 mm diameter holes to allow the bolt to pass through and sit between the beams spaced at 50 mm. The strength of the end-plates allowed the applied tension to be held by an interlocking nut against the sides of the frames as shown in the Figure 2 inset. The PFC section frames were designed to allow the water, that drip on to the bolts, to be collected in plastic trays placed underneath bolt mounted rigs. The reference bolt (non-tensioned) rested on top of the plastic drip tray, and the dripper tube was supported on a small plastic stand, just above the bolt. Figure 3 shows the procedure adopted for tensioning the bolt axially.

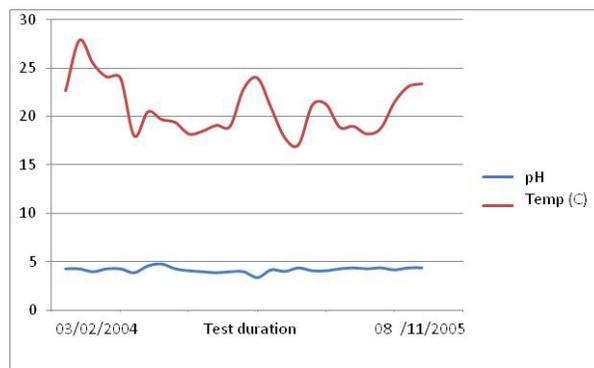
Figure 4 – Laboratory room temperature fluctuation and water Ph value

Table 2 shows the analysis of the water quality from Shoalhaven River and water quality of mine water collected from one mine in the southern coal field of Sydney Basin. It is clear from Table 2 and graphs in Figure 4, that the test water from Shoalhaven River was an aggressive solution that was suited to corrosion reactions in comparison from a typical mine water sample shown in Table 2. High concentrations of chloride ions as well as low pH level suggest that the solution was acidic. The large proportions of sulphates reinforced the weathering of the pyrite from the water origin, which assisted in decreasing any resistance to corrosion such as the formation of oxide layers. The sample solutions also show that the water had low dissolved oxygen content, which is not favoured in corrosive reactions; however this was not

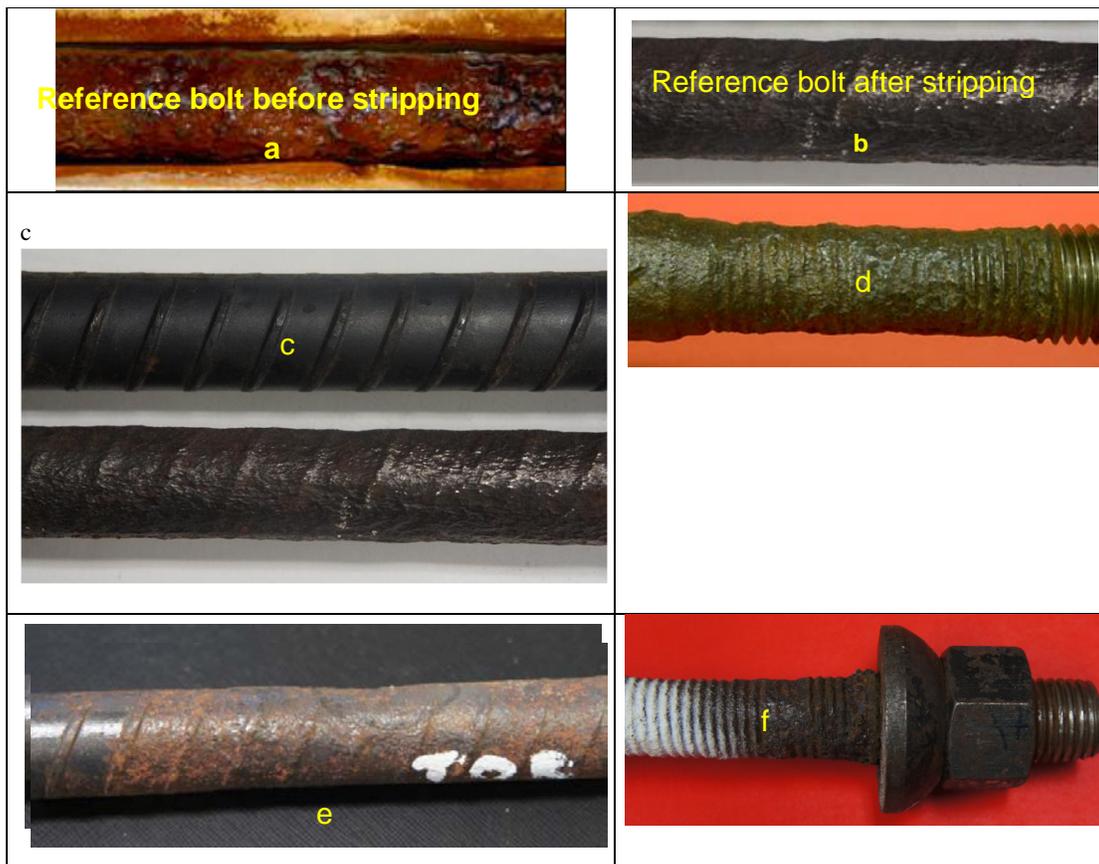
Figure 5 – Photos of parts of various corroded bolt sections compared with un- corroded section. Section (e) shows the evidence of crevice corrosion due to aeration at bolt end

Figure 5 shows pictures of various sections of pre and post-tested bolts. It is clear that there were some variations in the post-testing diameters along the length of each bolt. A noticeable and excessive corrosion occurred on the threaded bolt-ends section and at the sections of the bolts passing through the steel PFC end plate holes. These two sections were outside the direct water dripping zones. The threaded side of the bolt with maximum corrosion were for the purpose of bolt tensioning on the loading frame sides. Figure 5d, e and f show corroded bolt surfaces located in the vicinity of the PFC bolt tightening hole. This type of crevice corrosion is most likely to be the result of differential aeration mechanism.

The weight loss measurement, before and after the test, could not be related solely to the designated wetted section of the bolt. There was some further corrosion at the bolt ends that anchored the bolt ends to the PFC steel loading frame. Thus, two forms of corrosion were identified in this experimental study, pitting and crevice corrosion. Pitting corrosion was evident in the mid-sections of the bolt directly along the dripping zone as seen in Figure 5 a, b and c. Crevice corrosion on the other hand occurred at the

bolt ends as demonstrated in Figure 5 d, e and f. The mounting of the torsion bolt on the PFC tension frame also generated crevice corrosion as one side of the bolt required no direct axial loading, just torsion, thus leaving a free flow of air through the bolt surface as shown in Figure 5e. Normally crevice corrosion occurs in the confined space as a result of differential aeration mechanism. Also the excessively crevice corroded zone shown in Figure 5e was not in direct contact with the dripper waters as the last drip nozzle was some 60-70 mm away from either side of the rig side holes housing the bolt ends. This type of corrosion is most likely to be observed underground at the collar of the installed bolt in a hole with less encapsulation, thus leading to the onset of stress corrosion cracking, particularly when the protruding bolt end is subjected to external shear loading or impact. According to Gray (2006) this type of corrosion was often found in their field observations particularly at Angus Place Mine, NSW, with severe corrosion taking place along the free length of the bolt, even though there was no apparent free water. A damp corrosive atmosphere is sufficient to cause corrosion and perhaps this is because of the greater presence of free oxygen in air rather than under water. In addition, the excessive surface area of the threaded section of the bolt also has an influence.

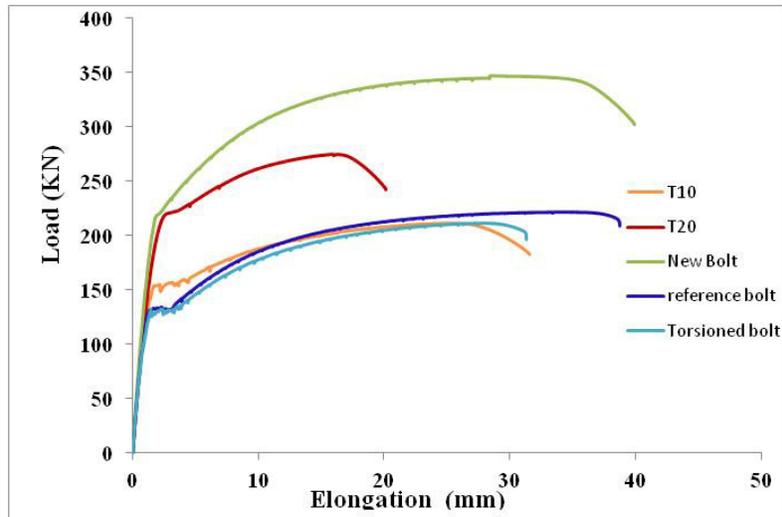
Figure 6 – Load displacement profiles of various bolts

Figure 6 shows the load-displacement graphs of various corrosion tested bolts as well as a new bolt, which was not subjected to the corrosion test. Table 4 shows the various bolts load-displacement values at yield as well as the ultimate strength values as seen in column six in Table 4.

One of the noticeable profiles of the load displacement graph was that the strength value of the 20 t tensioned bolt (T_{20}), was relatively greater than the other three bolts in the test. The peak load of P_{20} bolt was in the order of 274 kN (27.94 t). This level represented a reduction of around 21% in strength with respect to the failure strength of a similar new bolt with its tensile strength failure load of 347 kN (35.38 t). The 10 t (T_{10}) tensioned bolt achieved 39% reduction in strength, and the reduction in strength of the torsion bolt (P_t) was 39% and the reference bolt (T_r) was 36%. The unusually lower percentage reduction in the failure load of the 20 t bolt as compared to other corroded bolts is likely to be attributed to the steel composition of the bolt as shown in Table 4. It is clear that the carbon and manganese content of the T_{20} bolt was greater than with other three bolts.
