Experimental study on the effectiveness of CFRP strengthening of shear-deficient reinforced concrete beams under impact loading

Goldston, M., Remennikov, A. & Sheikh, M. Neaz. (2014). Experimental study on the effectiveness of CFRP strengthening of shear-deficient reinforced concrete beams under impact loading. Australasian Conference on the Mechanics of Structures and Materials (pp. 427-434). Lismore, Australia: Southern Cross University.

EXPERIMENTAL STUDY ON THE EFFECTIVENESS OF CFRP STRENGTHENING OF SHEAR-DEFICIENT REINFORCED CONCRETE BEAMS UNDER IMPACT LOADING

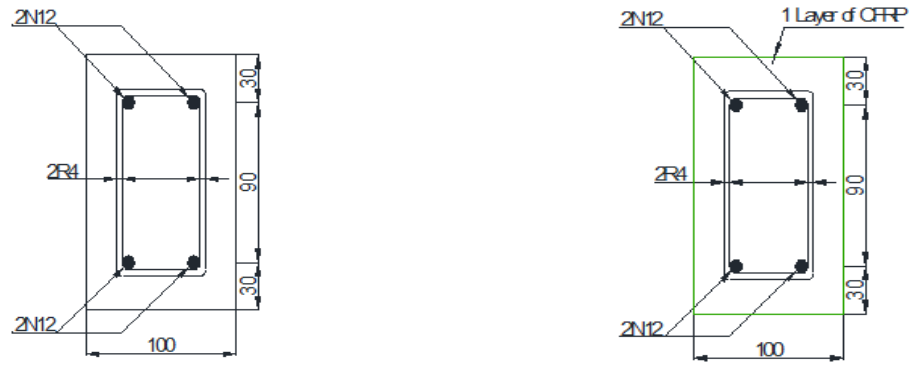
(a) Type A Beams (No CFRP) (b) Type B Beams (With CFRP)
 Figure 1. Cross sectional dimensions and reinforcement details of tested beams

This section includes the examination of two sets of RC beams with varying shear reinforcement denoted by Group's A and B, see Figure 1. Description of each beam is shown in Table 1. Type A beams were designed to be under-reinforced with varying percentage of shear reinforcement and similar longitudinal reinforcement. They were designed to fail in shear. Group B beams were similar to Type A beams, having identical properties but were continuously wrapped with one layer of CFRP. One of the limitations associated with this type of wrapping is the impracticable and unrealistic approach in engineering applications. This is because in engineering structures, the beam is supported on top by a concrete slab, and thus only a U- configuration or side wrapping is achievable. This type of wrapping is more suitable for other concrete structures, such as circular columns. The corners of the beams were grinded down, for a smooth finish before wrapping. This was to prevent stress concentrations at the edges. The fibres were positioned perpendicular to the longitudinal reinforcement to enhance the shear strength. Group A were the controlled specimens for Group B's beams. Also, beams A1 and B1 were tested under static conditions in a three point loading method, with the four remaining beams tested under the drop hammer to allow for comparisons to be established between the two loading systems.

According to the Australian Standards for concrete structures, AS 3600 (2009), the maximum shear reinforcement spacing is the effective depth of the cross section. With the specimens experimentally tested, this spacing doesn't satisfy code requirement. This was achieved to ensure group A beams were shear deficient and to show that this requirement is not critical for RC beams enhanced with CFRP external reinforcement.

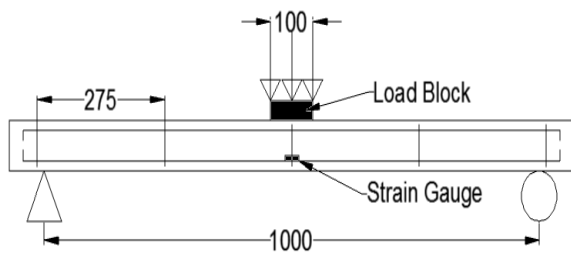
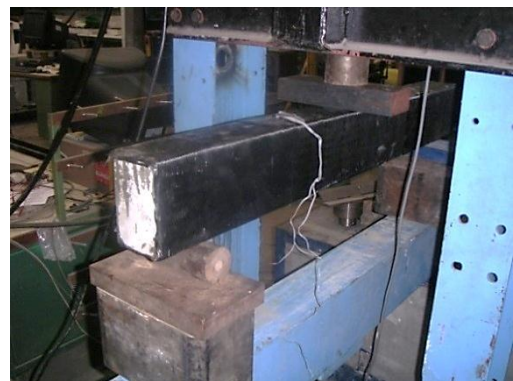
(a) FBD of Static Beams (b) Experimental Static Testing
 Figure 2. Static Testing of CFRP Strengthened Beam B1

The static test setup involved testing two beams A1 and B1 and measuring their responses to a monotonically increasing load as seen in Figure 2. The reasons for testing beams A1 and B1 under these conditions included: collecting data involving the load-deformation behaviour, analysis of energy absorption capacities at failure and use as control specimens for the RC beams subjected to impact loading. The beams were simply supported in a three point loading configuration using a roller and pin, producing an effective span of 1000 mm. The steel plate with dimensions 100 mm x 280 mm x 50 mm was placed at the midspan of each beam to distribute the applied concentrated load. The beams were tested using a hydraulic jack to deflect the beams at a constant rate. The loading rate was initially 1 mm/min and was gradually modified to a rate of 2 mm/min for each beam. This was done to provide the sufficient time for the beams to deflect before failing. Strain measurements of the tensile reinforcement were recorded through the data logger and program Strain Smart 5000.

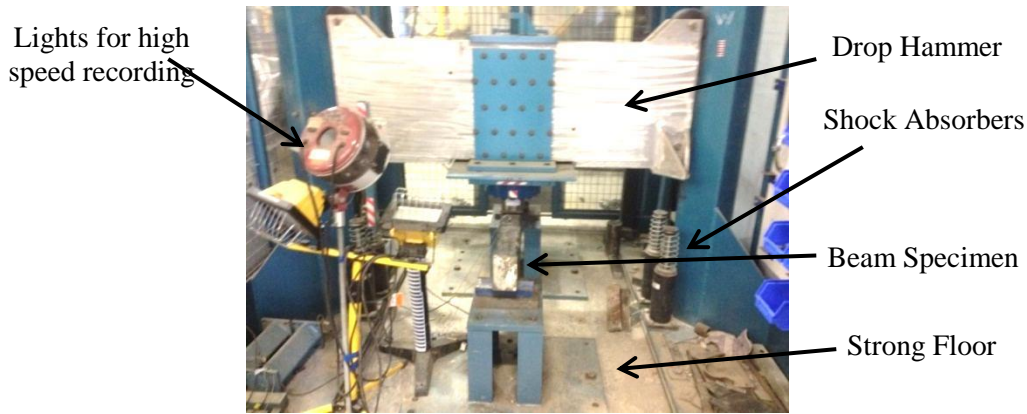
Figure 3. Impact testing of CFRP Strengthened Beam in Drop Hammer Facility

The specimens for impact testing in this research program were designed as detailed in Table 1 and tested using the High Capacity Impact Testing Machine, see Figure 3. The impact height was calculated using energy principles, by equating the area under the load – deflection graph from the static results to the potential energy of the drop hammer. One drop-weight was utilised in this test program: weight of 590 kg. The load was measured via the load cell attached to the drop hammer with the strain recorded by the data logger from the tensile reinforcement. Deflection was analysed using a high speed camera situated within the cage with the footage being examined using computer software Image Pro Plus. The data logger recorded results at a rate of 50,000/sec with the high speed camera measuring 1000 frames/sec.

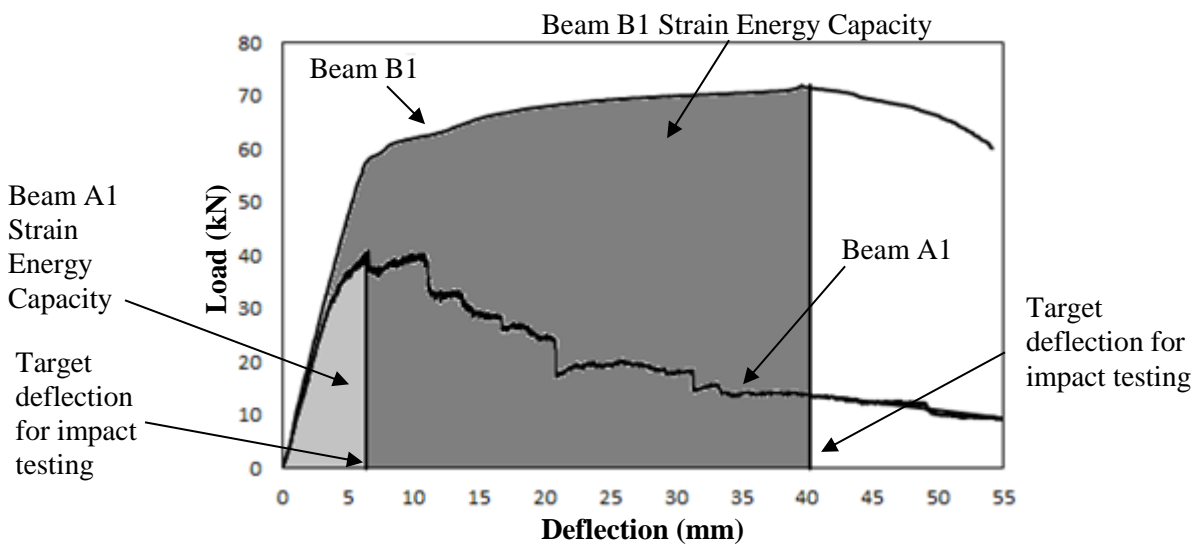
Figure 4. Load-deformation behaviour of test specimens A1 and B1 under quasi-static loading

Specimen A1 initially exhibited a linear elastic response, showing signs of residual strength and integrity as the load increased. This linear response began to deteriorate around 30 kN load capacity, where the beam began to show signs of minor cracks. The initial formation of shear cracks occurred at a peak load of 41.0 kN with critical diagonal shear cracks at 45° propagating from the supports to the midspan of the RC beam, see Figure 5(a). This indicated the beam had an insufficient amount of shear reinforcement to resist shear forces. The secondary peak as seen in Figure 4 indicated critical shear cracks, ultimately causing shear failure of the RC beam at a load of 39.5 kN and deflection of 11.5 mm. This resulted in a major reduction in the load carrying capacity of the RC beam. Additional web shear cracks formed, causing large sections of the concrete to separate from the compression fibres.

Specimen B1 showed that the strengthening process of the CFRP significantly increased the load carrying capacity and shear capacity of the beam, with a maximum load of 72.0 kN being measured at a deflection of 42.0 mm. The beam initially performed up to a load of approximately 55 kN before starting to yield and plastically deform, showing signs of ductility based on the curvature (Sheikh et al. 2010) as seen in Figure 4. By positioning the carbon fibres parallel to the transverse reinforcement, the RC beam failed in a flexural response, completely resisting shear cracks. The fibre assisted in carrying the load by the static weight, thus preventing shear cracks propagating from the supports. There was one major flexural crack localised under the loading plate which propagated from the tensile fibres

From Figure 4, a target deflection was chosen for each specimen, defined as the point in where the beams began to shown signs of failure under the load. This target deflection was chosen based on how the beam behaved under a monotonically increased load. Thus for the purposes of being able to compare the results with the beams under impact loading, the deflection was chosen for Beam A1 when the specimen had begun to show signs of structural deficiency and experience its first critical shear crack (Peak 1) in Figure 4. This resulted in a target deflection of 6 mm chosen for this beam. A target deflection limit was chosen to be 42.0 mm for Beam B1 because this is when the RC beam began to fail under the static loading and it was the specimen’s maximum deformation capacity before failure. An energy absorption capacity was calculated as 296 J by estimating the area under the load-deflection curve for Beam A1 and 2422J for Beam B2. The carbon fibre external reinforcement enhanced the energy capacity of the RC by approximately 8 times compared to the controlled specimen. See Table 2 for a summary of the static results and energy absorption capacities of the test specimens.

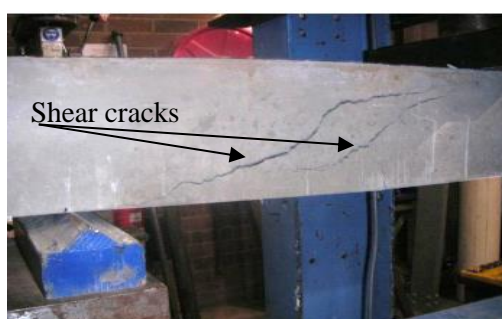
(a) Beam A1

Figure 5. Damage patterns of tested specimens under static loading

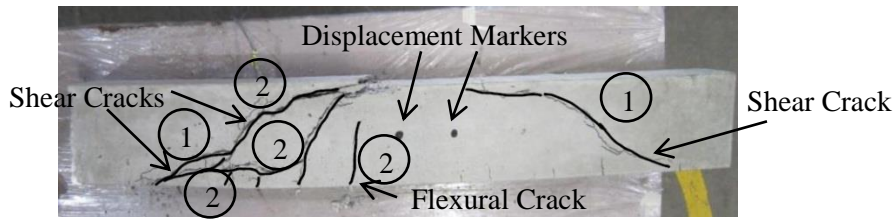
Figure 6. Beam A2 Test 2 crack pattern after impact loading

Beams A2 and A3 were tested twice due to malfunctions with the data acquisition equipment. The initial drop for beam A2 displayed two distinct shear cracks propagating from the roller and pin supports to the midspan as shown in Figure 6 by (1). Minor tensile cracks were observed within the shear span of the beam. The second drop caused the beam to sustain more damage, with the critical shear crack expanding in width from the pin support as seen in Figure 6. Smaller shear cracks also extended from the left support (pin) with additional tensile cracks being developed as shown by (2). The high increase in the tensile cracks expanding from the tensile face suggested some flexural behaviour occurring despite the beam failing in shear. The second drop didn’t cause any major shear cracks within the beam.

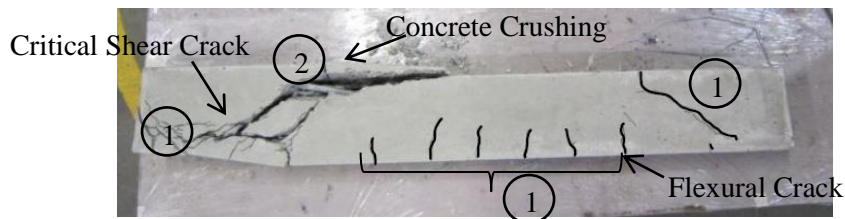
Figure 7. Beam A3 Test 2 crack pattern after impact testing

Beam A3 experienced severe shear cracking from the pin support after the initial drop as shown by (1) in Figure 7. A minor web shear crack developed at the roller support with a few hair width tensile fractures centralised around the left support. The additional drop showed minor differences in the pattern of the cracks throughout the beam. The changes observed between the two drops are identified with the critical shear crack from the pin support, depicted by (2). The change in width of this crack expanded considerably with severe buckling of the compressive reinforcement. This caused the top

cover concrete to separate and break off following the impact produced by the drop hammer. Extra tensile cracks formed due to the large deformation as a result of the extensive shear failure. The initial and secondary impact placed beam A3 in a more structural deficient state than beam A2, with the concrete being displaced from the compressive fibres under the loading plate with more distinct cracking.

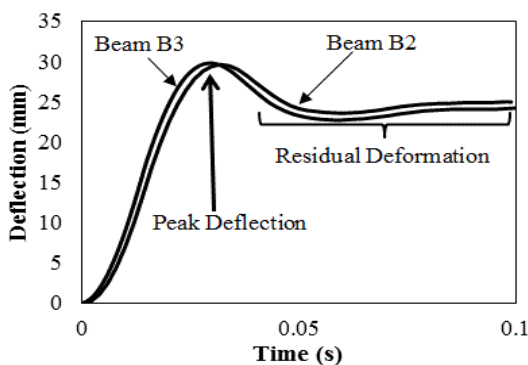
Figure 8. Deflection-time behaviour of strengthened beams under impact loading

Beam B2 underwent extensive deflection during the first 0.03 seconds after the impact as seen in Figure 8, compared to the controlled specimens. This was due to the increased shear capacity of the beam by the CFRP confinement, resulting in flexure-based failure rather than shear failure. A peak deflection of 30 mm was recorded with a residual displacement of 25 mm. This peak displacement was slightly lower than the 40mm predicted from the static tests. The reason for the differences in deformation was due to the assumption that the kinetic energy of the drop hammer is fully absorbed by the beam to cause its flexural deformation. Other energy dissipation mechanisms include friction at the supports, friction between the CFRP and concrete, contributing to the lower peak displacement. The energy based analysis ignores contribution of damping, which in the case of CFRP-wrapped concrete beams could be quite sustained.

The impact deflection response of beams B2 and B3 was similar as shown in Figure 8, regardless of the extra shear reinforcement in B2, thus indicating that the external CFRP confinement played the dominant role in providing concrete confinement with the contribution of the internal shear links significantly diminished. The deformed shape of both beams was identical to beam B1 and this was expected since all variables except for the stirrups were kept constant. The peak deformation for beam B3 was recorded as 30mm, with a residual deformation of 24mm.

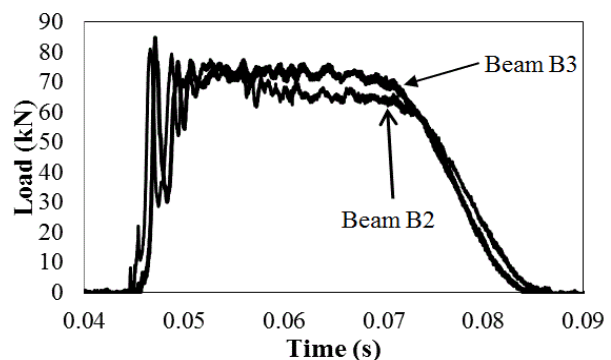
Figure 9. Load – time behaviour of strengthened beams under impact loading

Beams B2 and B3 displayed similar performances under the impact load. By analysing the high speed data acquisition results, both beams developed the same peak impact resistance of about 80 kN, see Figure 9. This impact resistance is the impact load capacity of the specimen. The impact resistance is defined as the capacity of the beam at failure under impact loading. Regardless of the height of the drop hammer, the beam will fail at the same value of the impact load considering that all other parameters of the beam are kept constant, –i.e., reinforcement ratio, concrete strength and amount of CFRP external reinforcement. Comparing the beams from the two groups, the impact loading capacity varied because of the presence of the layer of external reinforcement. The presence of external CFRP reinforcement significantly increased the the impact height. The CFRP significantly increased the ductility of the specimens which resulted in a larger increase in impact load at failure, as displayed in group B beams. The two beams sustained this resistance over a short period of 0.04 seconds, after the drop hammer struck the beams initially. From Figure 9, the beams showed signs of ductility, with the specimens being able to sustain a constant load over a period of time. The results indicate that the variations in shear reinforcement of the two specimens had minimal influence on the peak impact load.

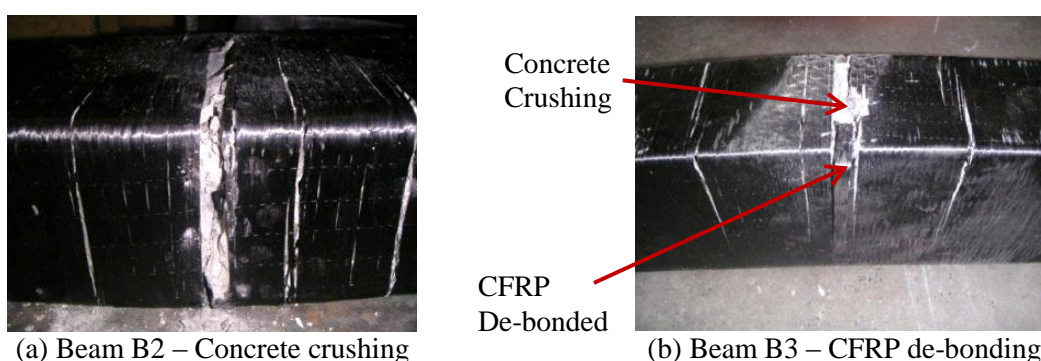
Figure 10. Failure modes of FRP strengthened beams under impact loading

Beam B2 as shown in Figure 10(a) displayed large, severe flexural cracks propagating from the tensile fibres vertically towards the compressive region. The CFRP debonded and ruptured on the underside of the RC beam due to the impact load applied at the mid-span. The concrete was fractured around the central region, with significant concrete crushing evident based on small particles flaking off. Beam B3 as depicted in Figure 10(b) had a larger percentage of transverse reinforcement and showed similar crack patterns to beam B2 under similar impact loading. By comparison, the carbon fibre ruptured with more damage and separation evident in beam B3. There was a critical flexural crack appearing in the midspan, expanding approximately two thirds up from the tensile fibres. The tensile cracks were more obvious and clear with this beam which was expected because of the extra reinforcement. See Table 3 for a summary of the impact test results for all specimens.
