Decision support system for the remediation of flexible road pavements in local government

**Decision Support System for the Remediation of Flexible Road
Pavements in Local Government**

**This thesis is presented as part of the requirement for the
Award of the Degree of Masters of Engineering (Research)**

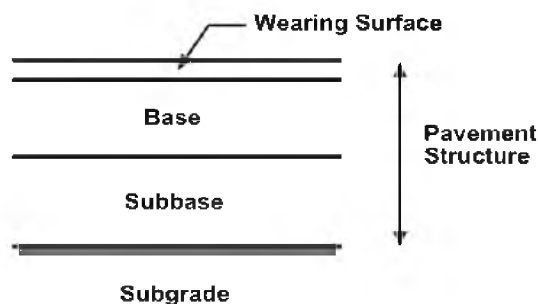
Figure 2.1 – Typical Flexible Pavement Structure (Austroads 2009)

A sealed flexible pavement is a pavement constructed from compacted, bound or stabilised granular materials that consists of essentially four common components: wearing surface (wearing course), base course, subbase and subgrade as illustrated in Figure 2.1 below. Unsealed flexible pavements mirror the structure of a sealed pavement, with the main notable differences being the exclusion of a wearing course as well as different behavioural characteristics (Austroads 2009; Austroads 2009).

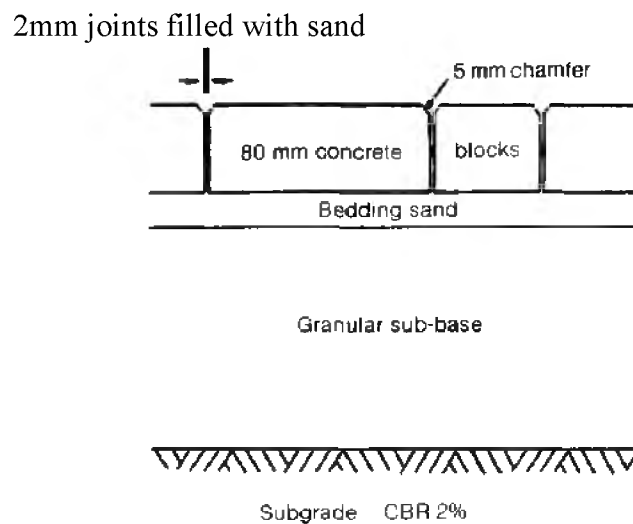
Figure 2.3 – Typical Section of Segmental Block Pavement (Barber and Knapton 1979)

Segmental block pavements are roads constructed using vitreous clay or high strength concrete pavers (segmental blocks) placed over a base/subbase/subgrade pavement structure, as illustrated in Figure 2.3; where the discontinuous nature of the block surfacing allows the structure to behave in a flexible manner (Shackel and Pearson 1991; Giummarra 1995; Austroads 2009; Fletcher 2009; Soutsos et al. 2011).

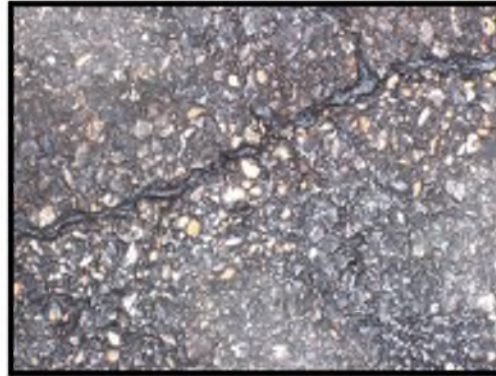
Figure 2.4 – Pavement Oxidation with Associated Cracking (RPC 2011)

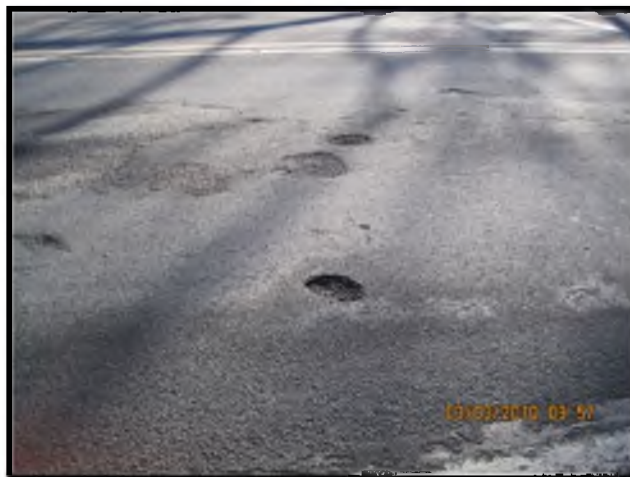
Figure 2.5 – Stripping of Asphalt Pavement under Chip Seal (Wood and Cole 2013)

Primarily an issue with sprayed seals, stripping is the loss of surface texture through the separation of aggregate from binder that leads not only to poor skid resistance, but also aggregate loss, which as illustrated in Figure 2.5 can result in further structural pavement defects such as potholes (Evans et al. 1990; Austroads 2006; Austroads 2009). The stripping affect begins from the bottom of the bituminous/asphalt layer and progresses up to the surface. When it begins at the top and progresses downward it is referred to as raveling (PavementInteractive 2007).

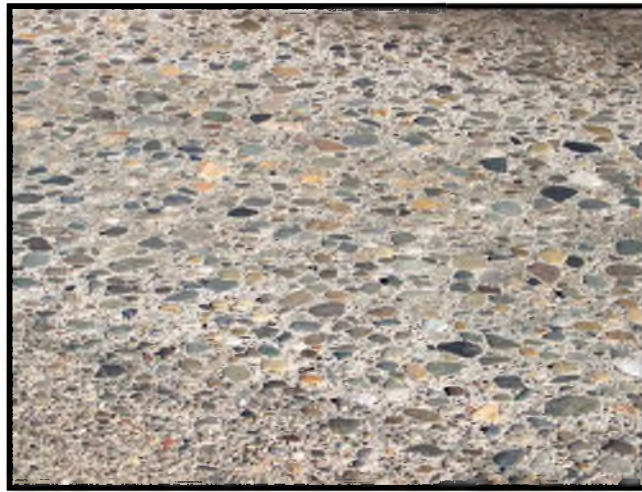
Figure 2.6 – Polished Aggregate in 40 year old Seal (PavementInteractive 2010)

Aggregate polishing has a significant impact on road user safety and skid resistance. Sometimes referred to as the loss of surface texture, it is commonly found in the wheel paths of traffic lanes, and as the name suggests, it is the smoothing and rounding of the wearing surface aggregate as shown in Figure 2.6 (Geller 1996; Austroads 2006; Ahammed and Tighe 2008; Austroads 2009; HYD 2009).

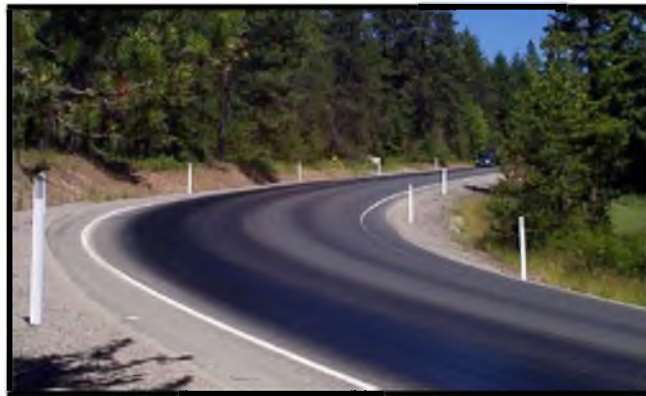
Figure 2.7 – Flushing in a Road Pavement (RoadScience 2013)

Flushing (also referred to as bleeding) is the partial (or complete) submersion of the surface aggregate into the binder mixture in a sealed pavement, resulting in a slippery surface with low macrotexture and skid resistance (Austroads 2006; Austroads 2008; HYD 2009). Flushing and aggregate polishing both share a visibly shiny surface; however, flushing is distinguished by a noticeable blackness, illustrated in Figure 2.7, which comes from the bitumen being almost completely exposed at the surface (HYD 2009; Kodippily et al. 2012).

Flushing can occur during hot weather when the bituminous binder fills the aggregate voids and then expands onto the pavement surface; and since it is not reversible during cold weather, the binder will accumulate on the pavement surface over time (Kodippily et al. 2012).

Other possible causes include excessive binder content on the surface or underlying surfaces, poor mix design, aggregate penetration into underlying low strength pavements, softening of the binder or spillages or accumulation of oil from vehicles (Austroads 2006; Austroads 2008; HYD 2009).

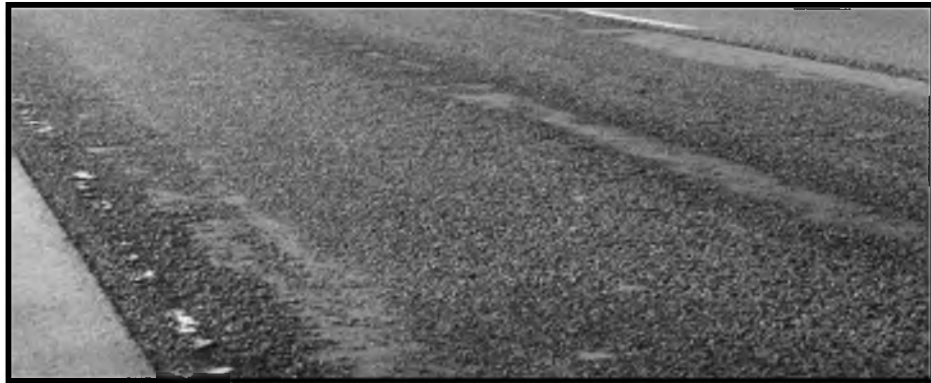
Figure 2.8 – Raveling in a Spray Sealed Asphalt Pavement (RoadScience 2013)

oxidation, traffic loading and softening of the bituminous binder due to fuel or oil accumulation – this is especially prevalent in areas where traffic is regularly stopped, such as intersections with traffic lights or stop signs (Austroads 2006; HYD 2009; PavementInteractive 2009). An example of raveling in sealed pavements is illustrated in Figure 2.8 below.

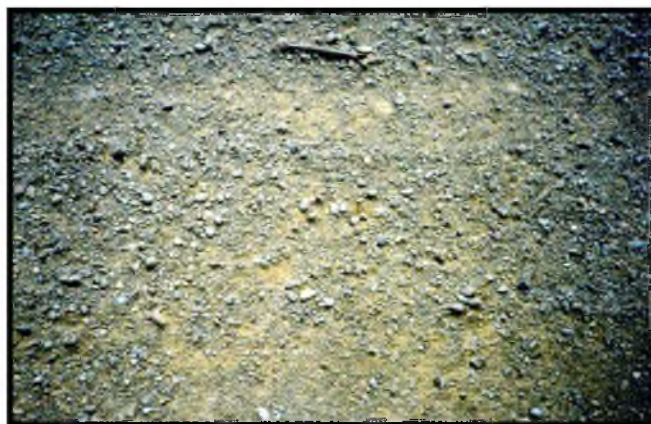
Figure 2.9 – Raveling in an Unsealed Pavement (QDMR 1999)

Raveling is associated with a loss of fines, since the fines in an unsealed pavement represent the binder of the pavement surface matrix, their loss leads to the exposure of surface aggregate which not only results in a coarse surface with increased noise, roughness and permeability, but increases the likelihood of further raveling which decreases skid resistance due to loose aggregates (ESB 1998; Jones 1999; Austroads 2009). An example of raveling in an unsealed pavement is shown in Figure 2.9 below.

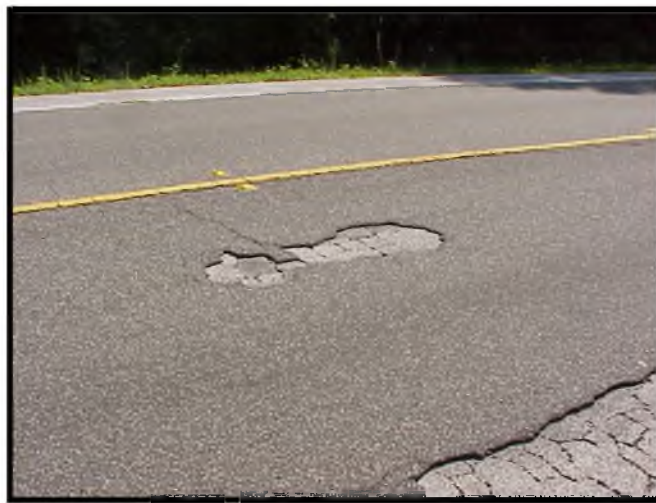
Figure 2.10 – Delamination of an Asphalt Sealed Pavement (FDOT 2014)

This surface deficiency is the loss of bond between the wearing surface and the base course layer in sealed pavements that leads to low shear resistance to traffic stresses (Austroads 2006; HYD 2009). It is the total removal, or peeling off, of areas of the asphalt wearing course, with a clear delineation between the wearing course and the pavement base course layer below which is illustrated in Figure 2.10 (Austroads 2006; FDOT 2014).

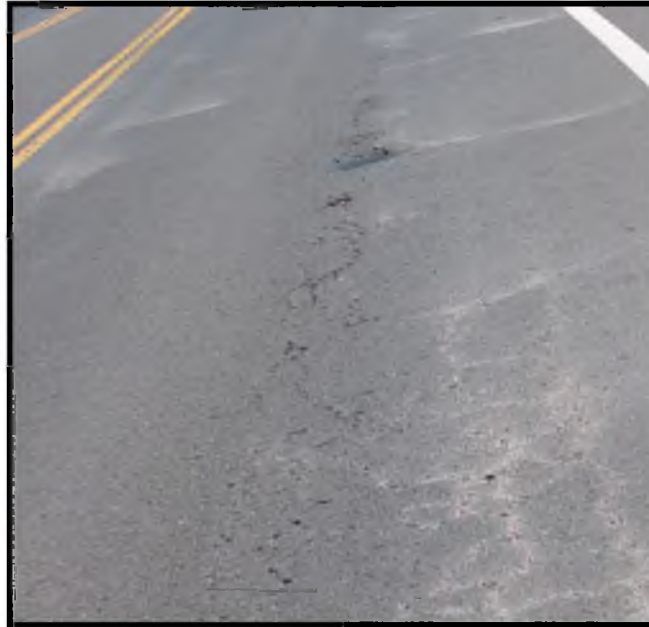
Figure 2.11 – Pavement Fines Present on Road Surface due to Pumping
(PavementInteractive 2009)

to migrate upwards towards the surface and the presence of cracking allows these fines to escape the pavement through the surface (Alobaidi and Hoare 1999).

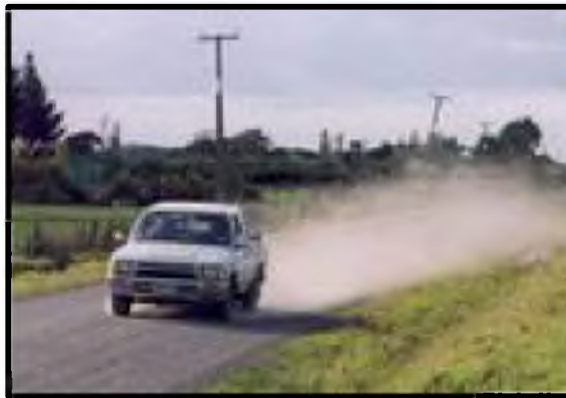
Figure 2.12 – Road Experiencing Loss of Fines (NRC 2014)

In addition to road user safety, there are number of health issues surrounding the resulting airborne dust generated from the loss of fines (Jones 1999).

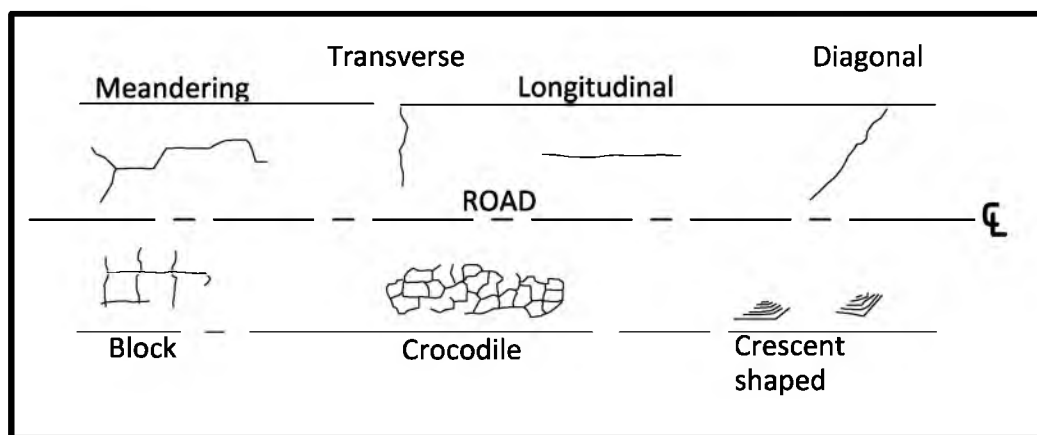
Figure 2.13 – Types of cracking defects in sealed flexible pavements (Austroads 2006)

Cracking types are identified and described by their dominant geometric structure and include block cracking, crocodile cracking, diagonal cracking, longitudinal cracking, meandering cracking, transverse cracking, and crescent-shaped cracking (Austroads 2006; Loria-Salazar 2008; HYD 2009; Peshkin et al. 2009) as illustrated in Figure 2.13 below and described in the following sections.

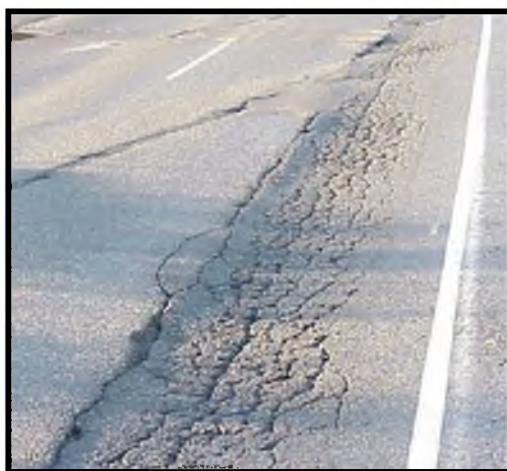
Sometimes referred to as *dry rutting*, it is prevalent in dry environments and caused by loss of material from regular or heavy traffic, but can also be due to high moisture content in the subsurface soil or base (Austroads 2009; Edvardsson 2009).

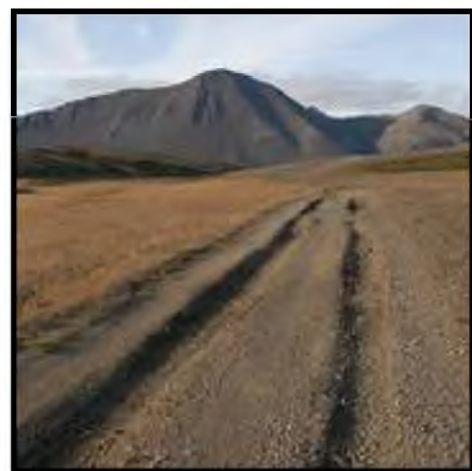
Figure 2.14 – Examples of Rutting in Sealed and Unsealed Pavements

Rutting, as illustrated in Figure 2.14, is the vertical deformation of pavement that occurs in the regular wheel paths, aligned parallel to the flow of traffic (ESB 1998; Austroads 2006; PavementInteractive 2008; HYD 2009). Rutting is considered to have a length-to-width ratio greater than 4:1 and is a measurement of the maximum

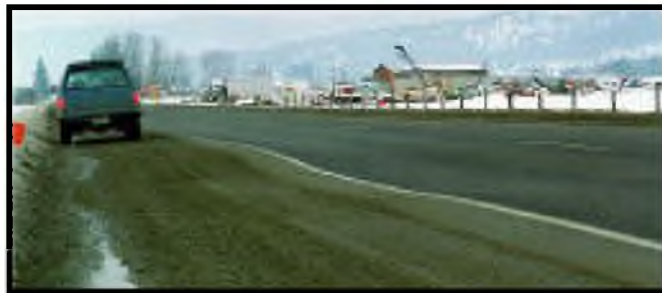
Figure 2.15 – Large Depression on a Sealed Pavement (OSU 2012)

Depressions are generally caused by a volume change in the subgrade or sub-base materials due to recent service trenches, soft and poorly compacted areas, embankment movements, change in moisture content within pavement materials or the erosion of the underlying pavement layers (ESB 1998; Austroads 2006; HYD 2009; OSU 2012).

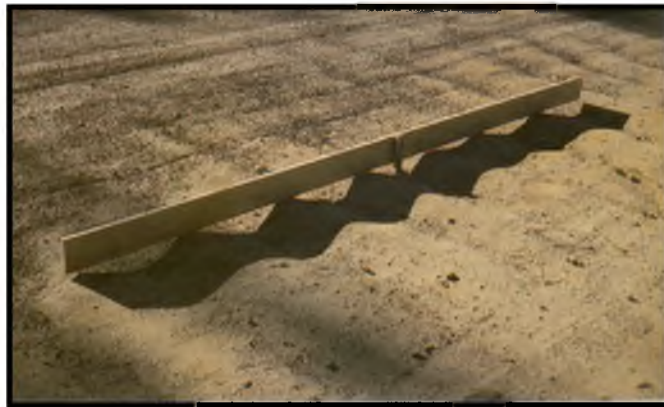
Figure 2.16 – Typical Wave-Like Deformation of Pavement Corrugations on an Unsealed Pavement (LGAM 2014)

Corrugations are a wave-like plastic deformation of the pavement surface, with distortion perpendicular to the direction of traffic flow (PavementInteractive 2006; Austroads 2009; HYD 2009). They are distinguished by regularly and closely spaced undulations, or ripples, spaced usually 500 millimetres to 1 metre apart as illustrated in Figure 2.16 below. Corrugations represent significant deformation of the pavement that can rapidly lead to failure (Austroads 2006; HYD 2009).

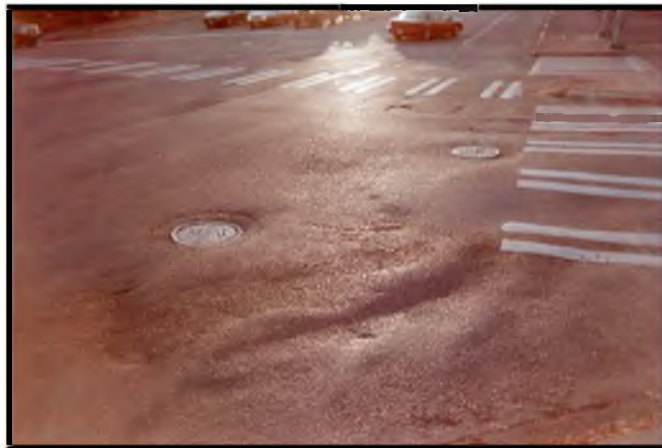
Figure 2.17 – Shoving at a Busy Intersection (PavementInteractive 2006)

Shoving primarily stems from construction or design issues, where the use of surface and base layers with unstable and poor strength characteristics are unable to perform under frequent stopping and starting of vehicles, particularly at intersections. However, in situ causes can be attributed to excessive moisture in the subgrade (Austroads 2006; PavementInteractive 2006; HYD 2009).

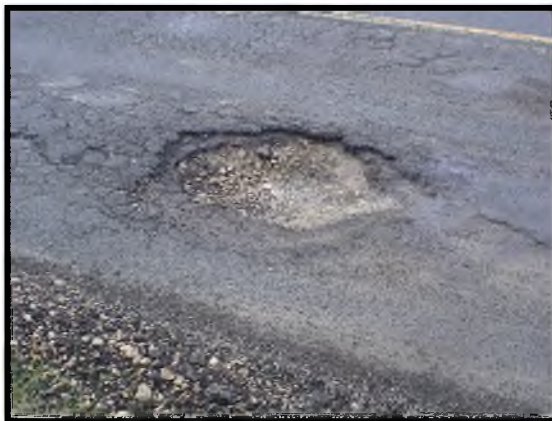
Developing after Significant Rain

Potholes in unsealed pavements are significantly accelerated in the presence of water and traffic loads, more so than that in sealed pavements which benefit from the protection of a waterproof membrane (Austroads 2009; Edvardsson 2009). Their occurrence may also be due to previous potholes that have not been repaired to sufficient depth or compaction. This results in a permanent pothole nucleus that allows future degradation (Edvardsson 2009).

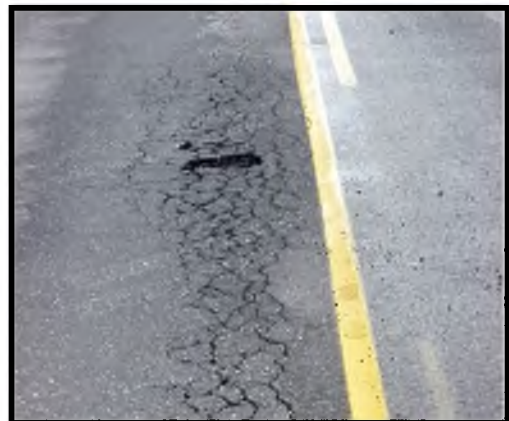
Crocodile Cracking with associated Pothole

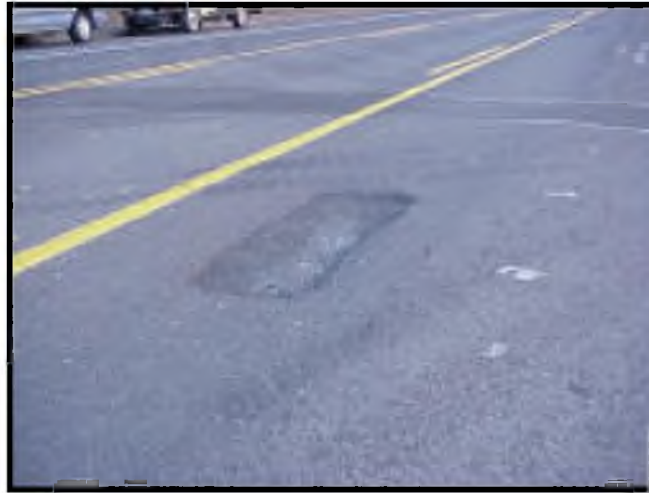
Figure 2.19 – Failing Patch Repair with Pumping (OSU 2012)

begun to deteriorate but not sufficiently to require a vehicle to reduce its speed, and it is considered to be severe when the patch has deteriorated enough to cause a driver to reduce the speed of their vehicle (ESB 1998).

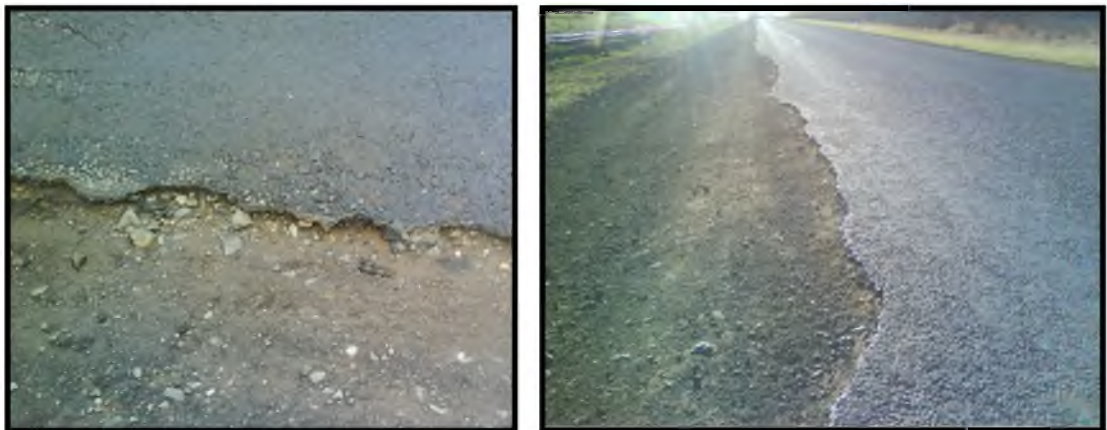
Figure 2.20 – Edge Break of a Spray Sealed Pavement (LGAM 2014)

Edge breaks occur near the shoulder of sealed pavements (the edge of the road), parallel to the direction of traffic flow as shown in Figure 2.20 (Austroads 2006). They can result in a reduction of the effective pavement width, the loss of ride quality and reduced user safety. Aligned in a longitudinal direction, the raised lip of an edge break can channel water runoff from the road, leading to erosion of the road shoulder as well as increasing the likelihood of lateral water entry into the pavement base (Austroads 2006).

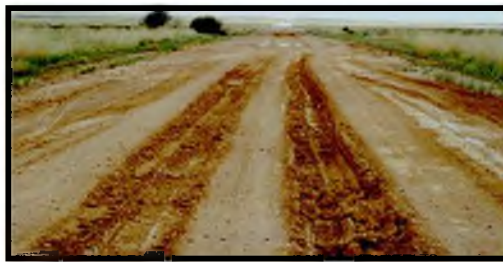
Figure 2.21 – Surface Gouging on an Unsealed Pavement (Austroads 2009)

A similar, or subset, condition called ‘surface gouging’ (see Figure 2.21) is a result of soft spots that affect a much greater area, and indeed may extend over an entire road segment. Surface gouging is associated with rutting and results in a surface that is instantly slippery in wet conditions, and if allowed to progress further will leave the road inaccessible (Austroads 2009).

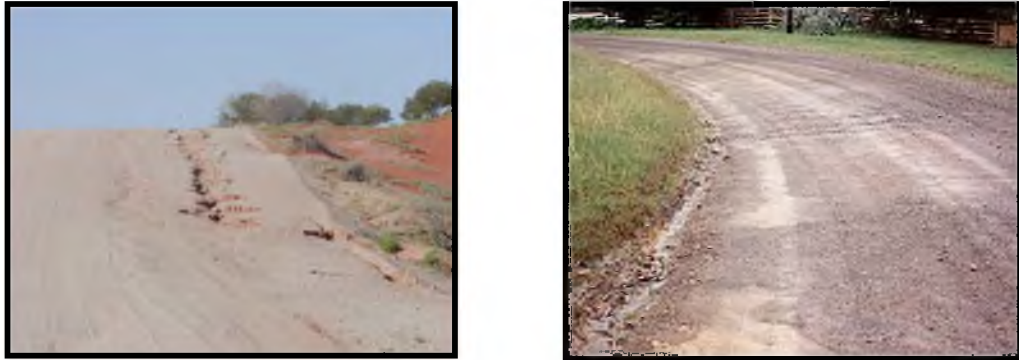
Figure 2.22 – Longitudinal and Transverse Erosion Channels on an Unsealed Pavement (Austroads 2009)

Erosion channels are more common in pavements with a high content of fines and small aggregate sizes, more so than a well-graded pavement mix containing aggregate 19 millimetres in size or larger (Austroads 2009).

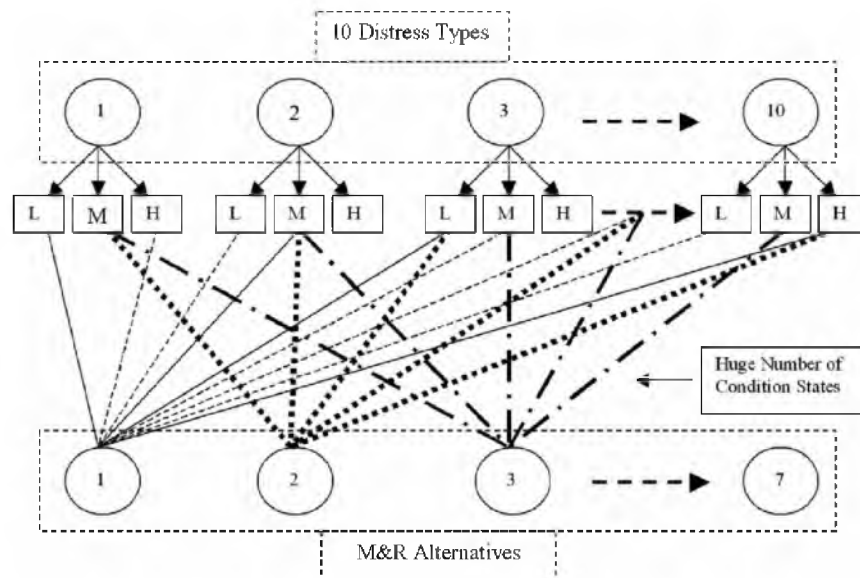
Figure 3.3 – Schematic illustration of the relationship between distress levels and maintenance alternative (Abo-Hashema and Sharaf 2009)

author from the reviewed literature presented in Sections 2.2 and 2.3 (specifically Table 2.3); while Figure 3.3 provides a decision tree analysis of the complex combinations between defects and remediation options over an Egyptian highway pavement presented by Abo-Hashema and Sharaf (2009) which also confirms Ferreira's (2002) high order quantification of the problem presented above.

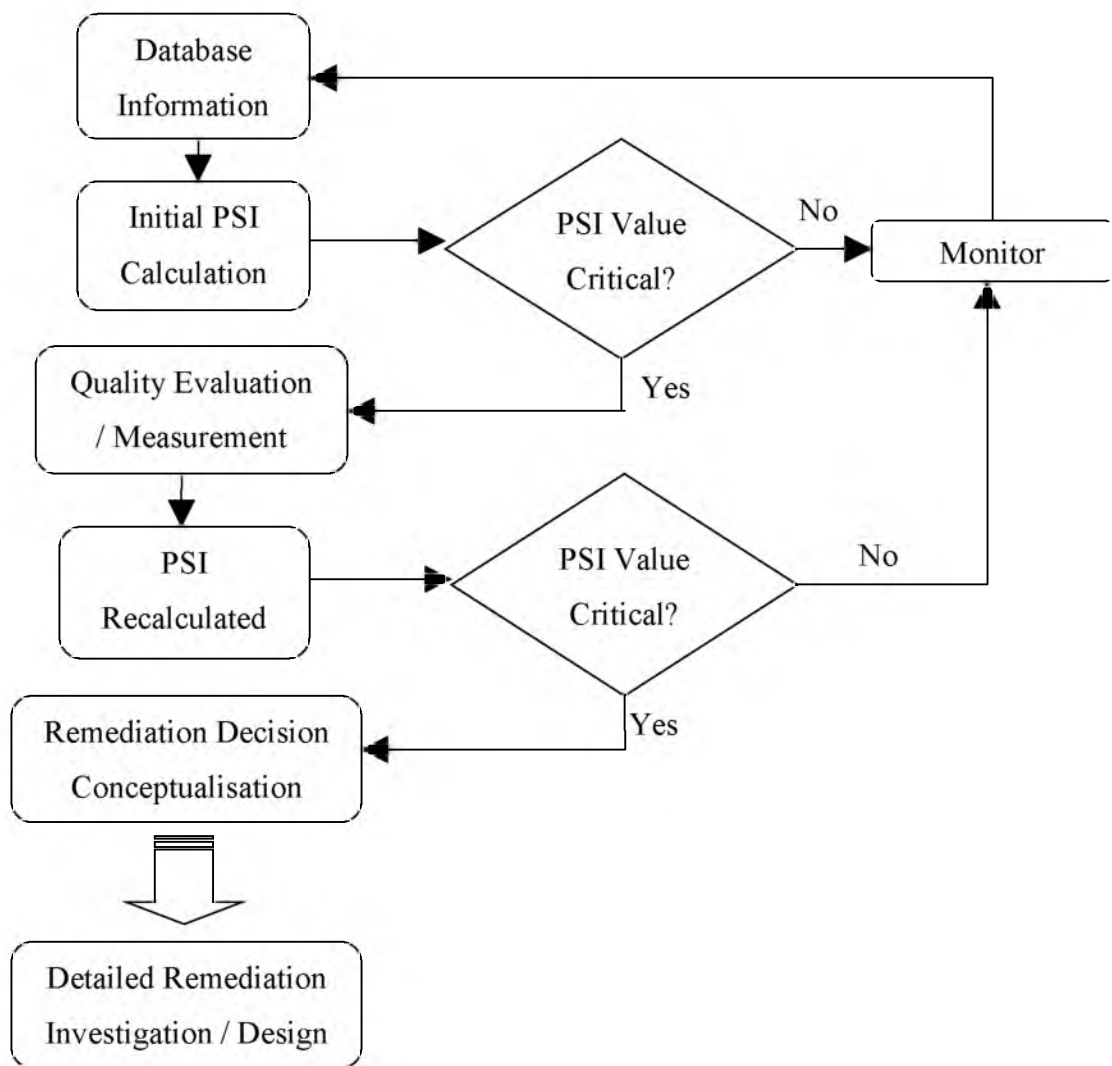
Figure 3.4 - Pavement Serviceability Evaluation Process

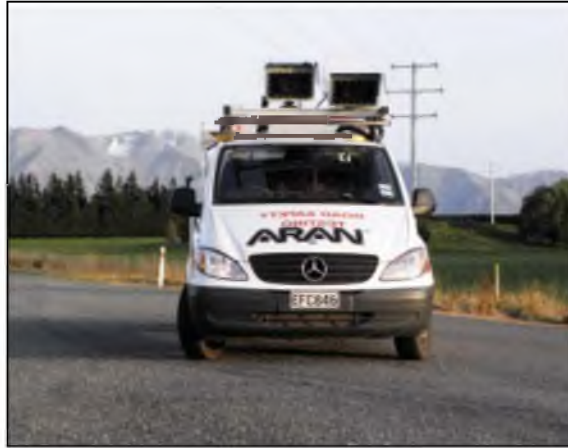
Figure 3.5 – Typical Roughness Measurement Vehicle/Apparatus (FUGRO 2012)

In Australia, the traditional NAASRA measurement of roughness was discontinued in 2007 in favour of the International Roughness Index (IRI). The IRI is a

measurement of vertical displacement of the test vehicle/apparatus (illustrated in Figure 3.5 below) in the units of metres per kilometre (Austroads 2007).

There are two predominant methods for measuring roughness, *quarter-car model* and *half-car model*, however, only the quarter-car model is endorsed in Australia (Austroads 2007). The half-car model measures the roughness of both wheel paths within a lane simultaneously, whereas the quarter-car model measures the roughness of each individual wheel path within a lane independently, then the roughness of the lane is calculated as prescribed by Austroads (2007), presented in Equation 3.2.

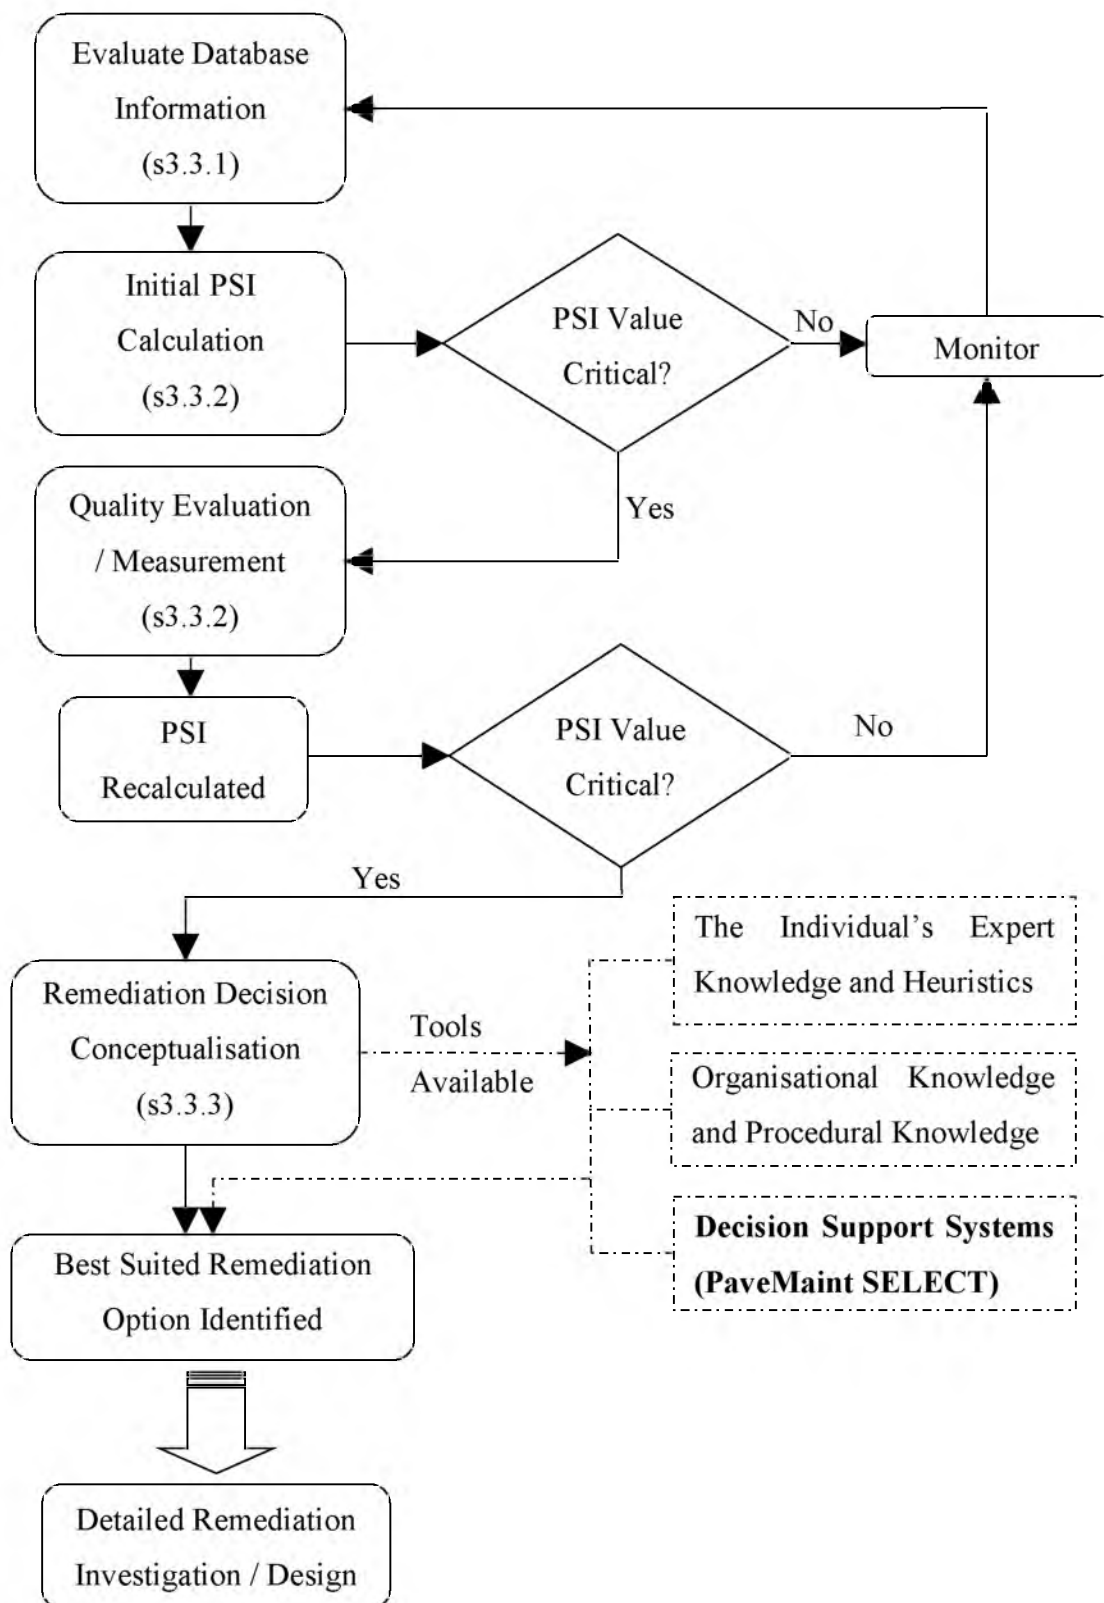
Figure 4.1 – Pavement Serviceability Evaluation Augmented with Remediation Decision Conceptualisation Tools

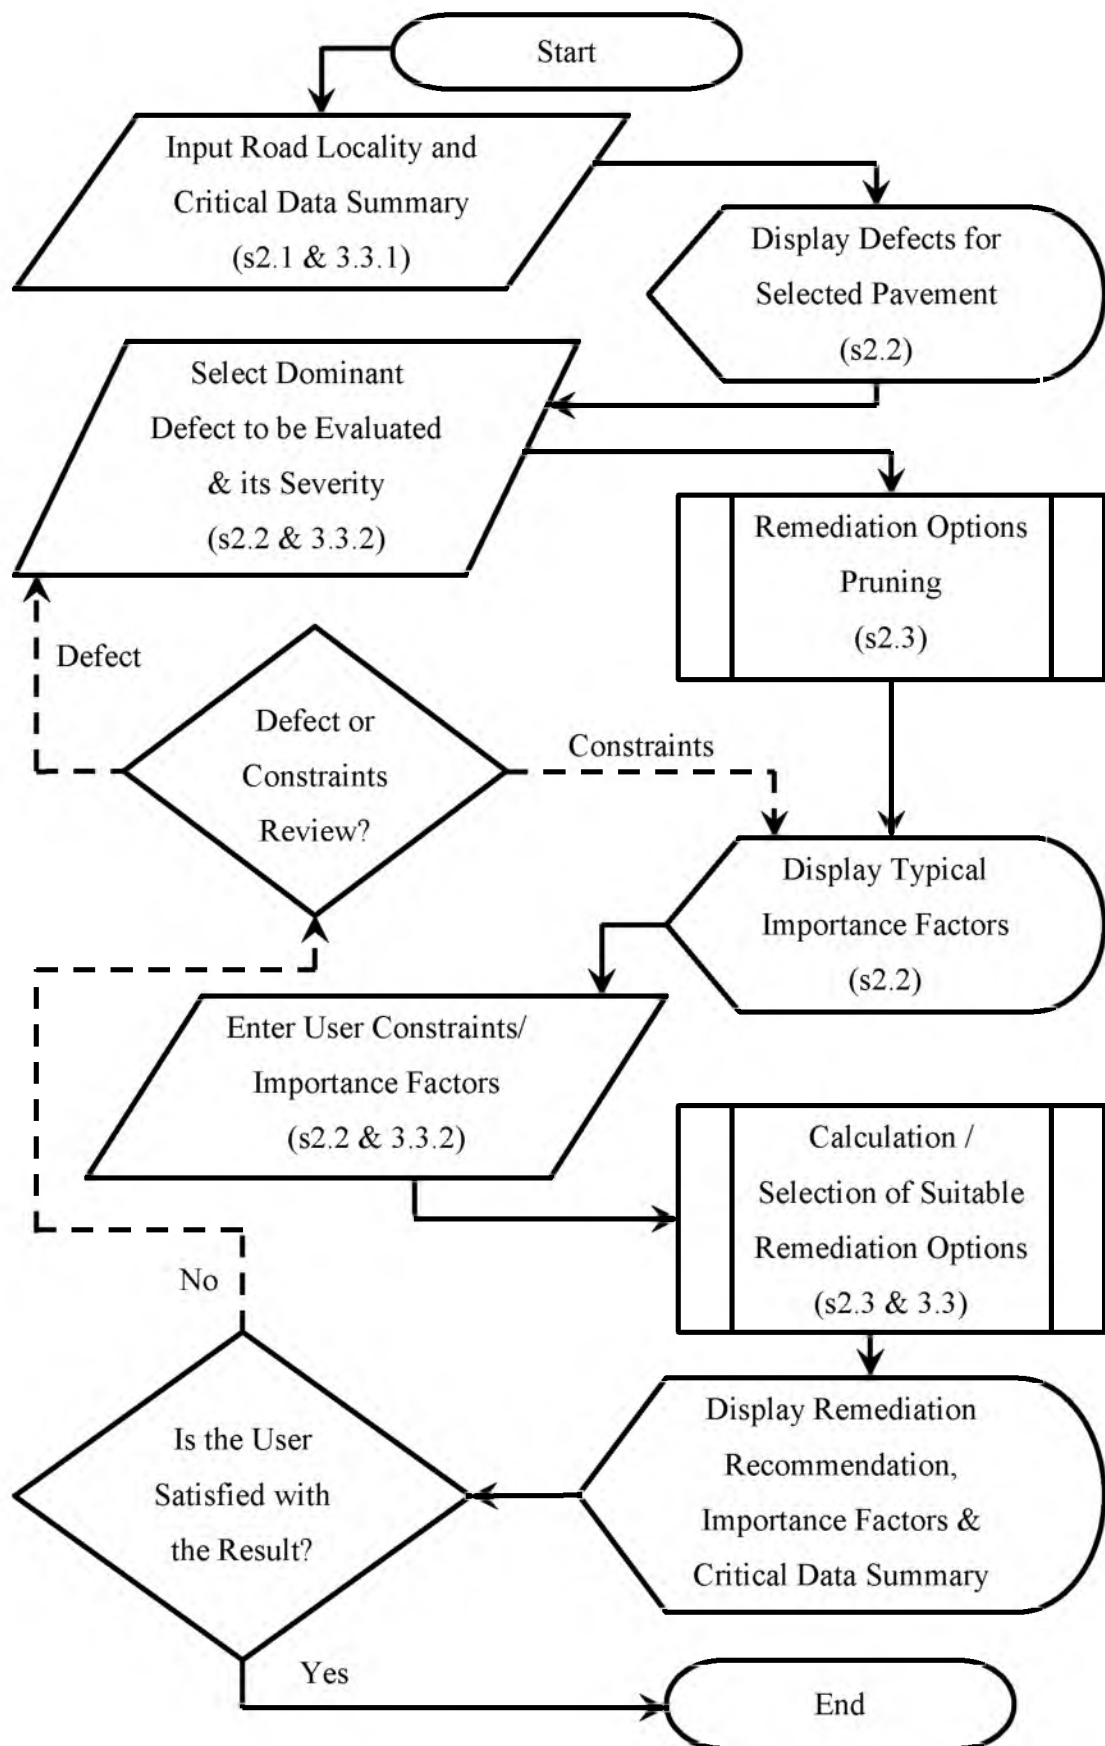
Figure 4.2 – Proposed “PaveMaint SELECT” DSS Software Framework

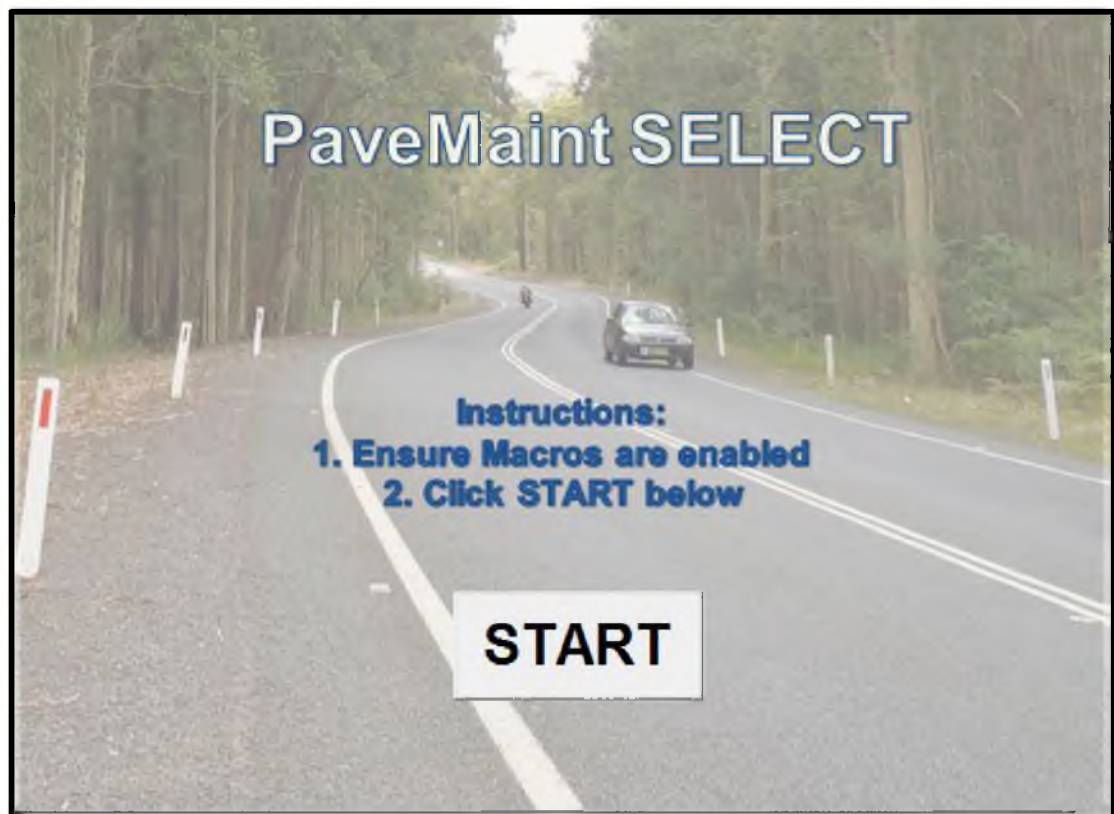
Figure 4.3 – PaveMaint SELECT Startup Screen

PaveMaint SELECT is a VBA program embedded in a macro-enabled Excel file named *PaveMaint SELECT v0.1.xlsm* (found in the Compact Disc provided with this thesis). Upon launching the spreadsheet the user is presented with a simple “Startup” screen shown in Figure 4.3 directing the user to follow simple instructions to launch the program.

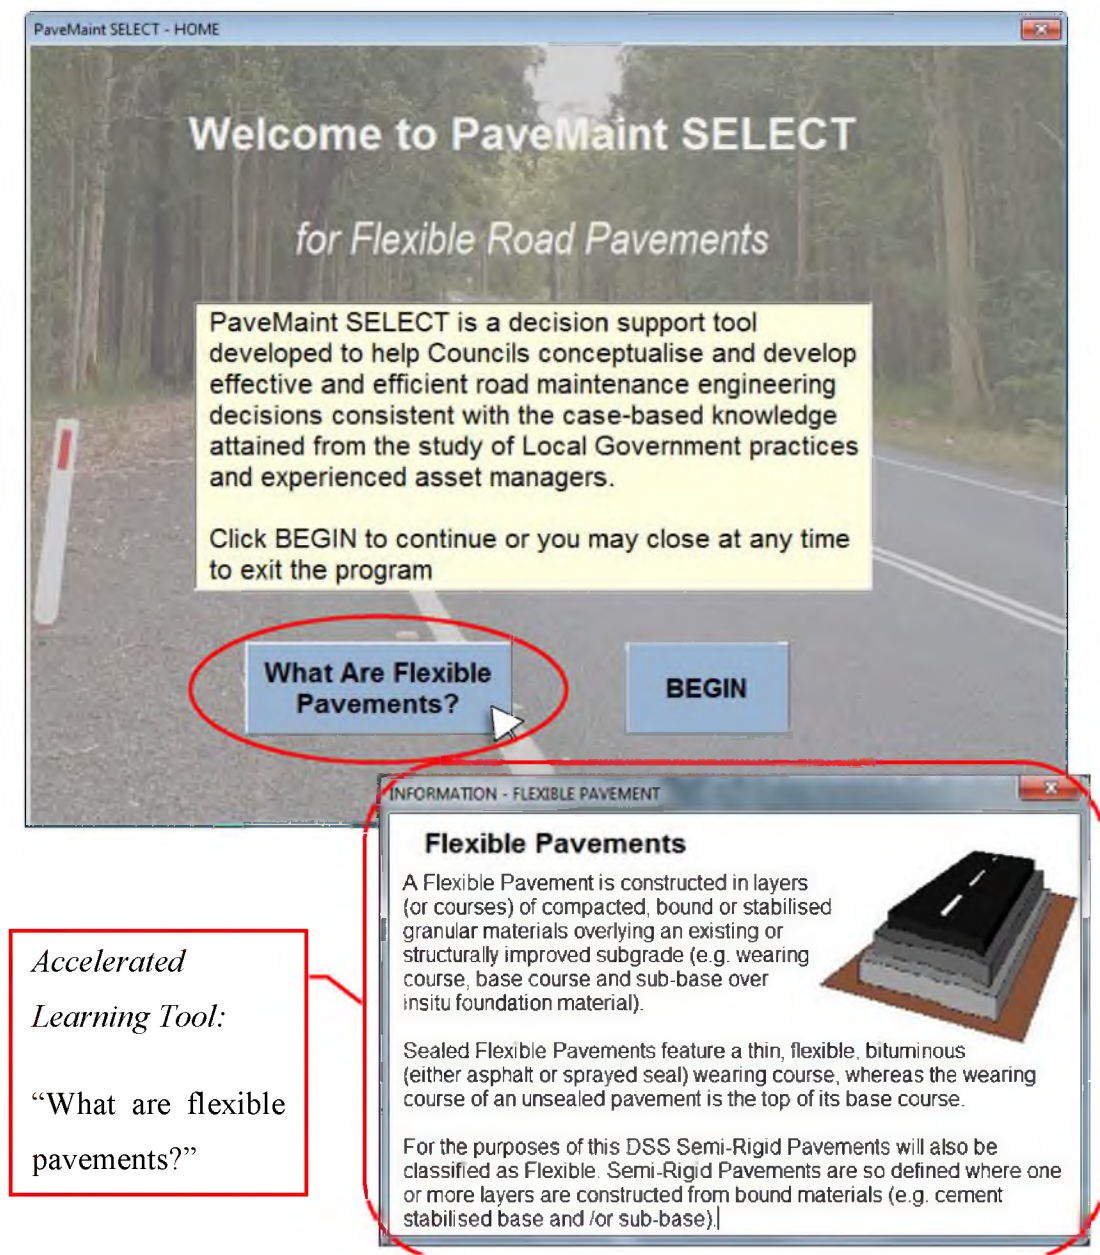
Figure 4.4 – Pavemaint SELECT Introduction Screen with *Accelerated Learning Tool*

Once the user has enabled macro functionality on the spreadsheet, by selecting “START” the VBA program launches and the user is shown an introduction screen with explanatory notes on the program along with an *ALT* on what a flexible pavement is and its context in this DSS. This process is illustrated in Figure 4.4 which demonstrates the screen output when the user selects the “What Are Flexible Pavements?” *ALT*.

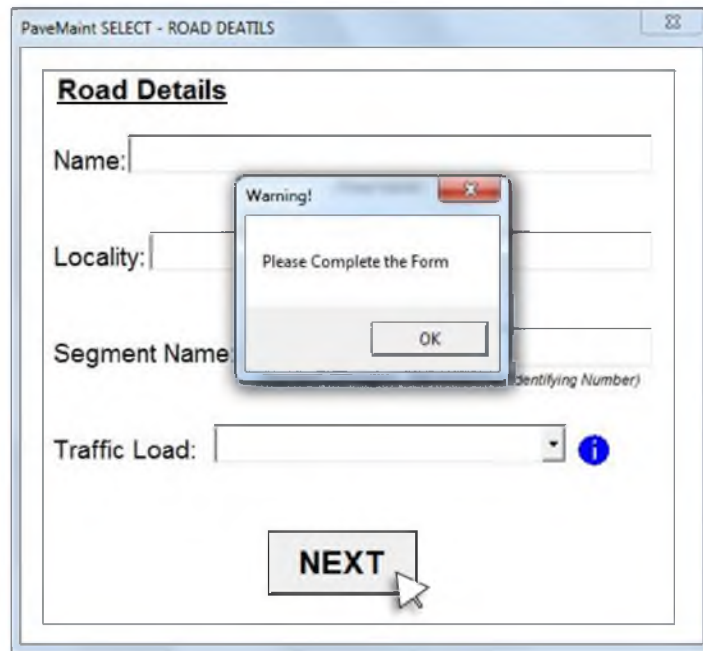
Figure 4.7 – Pavement SELECT Warning Screen for an Incomplete Form

To avoid errors in data entry, mainly insufficient or missing data, the VBA is programmed such that screens will not advance unless all fields of the preceding screen are complete.

An example of this behaviour is shown in Figure 4.7, where the user has clicked on the “Next” button of the “Road Details” screen before completing all the fields on the screen. Note: this behaviour is consistent for all screens throughout Pavement SELECT and detailed in Appendix B.

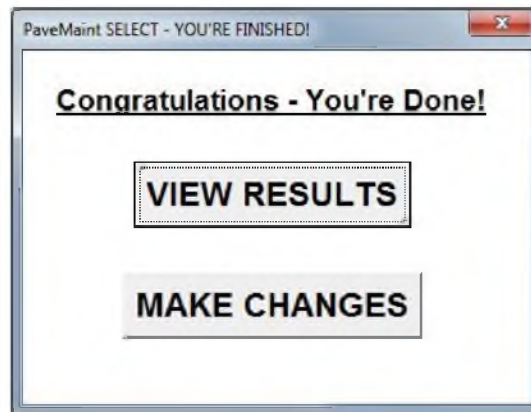
Figure 4.18 – Pavement SELECT End of Program / View or Edit Results Screen

The final screen of the programmed VBA portion of Pavemaint SELECT (as shown in Figure 4.18) is essentially an information screen that notifies the user that they have completed the input stages of the program and provides a final opportunity to go back and amend any of their selections, or to proceed and view the results of the evaluation. It is important to note that this is not necessarily the last opportunity the user will have to adjust their selections; it is simply the last opportunity the user will have to make changes within the current VBA environment for the dominant defect selected and further opportunity for refinement is provided within the "Solutions Sheet".

Should the user select "make changes", they will simply be directed back to the preceding screen where they will be able to review and adjust their selections; however, should the user select "view results" the VBA program interface will close and the user will be presented with the "Solutions Sheet" displayed in a worksheet

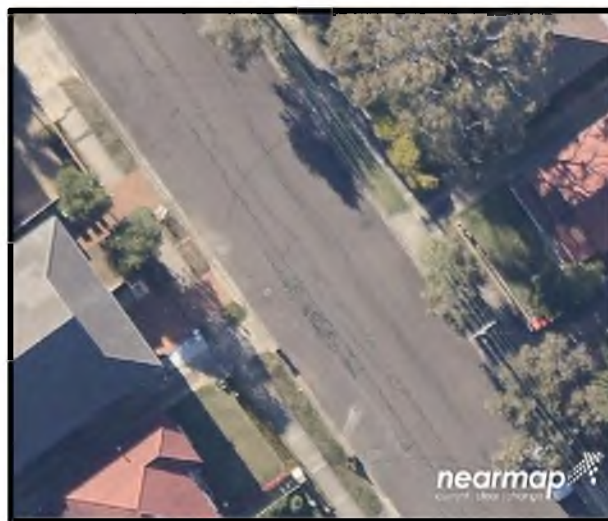
Figure 4.24 – Appearance of Crack Sealing Remediation from Satellite Imagery – Dora Street, Hurstville (NearMap 2014)

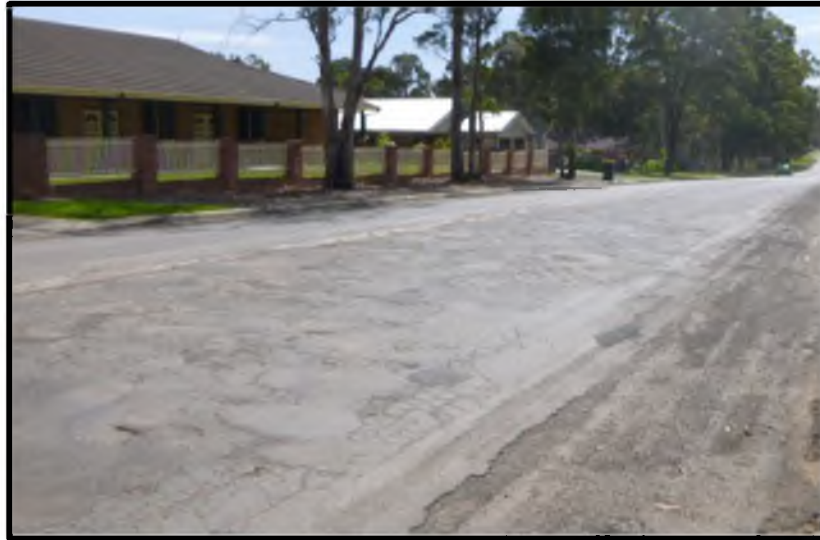
Figure 5.7 – Quinns Lane before Treatment Demonstrating Failed Crocodile Cracking with Patching Failure in a Poor to Unserviceable Condition

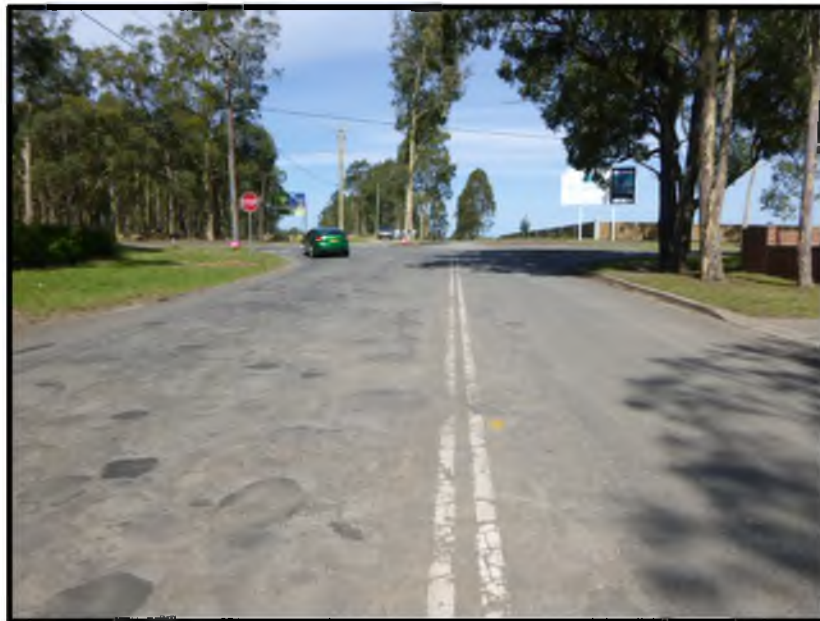
Figure 5.8 – Quinns Lane before Treatment Demonstrating Failed Crocodile Cracking with Patching in a Poor to Unserviceable Condition

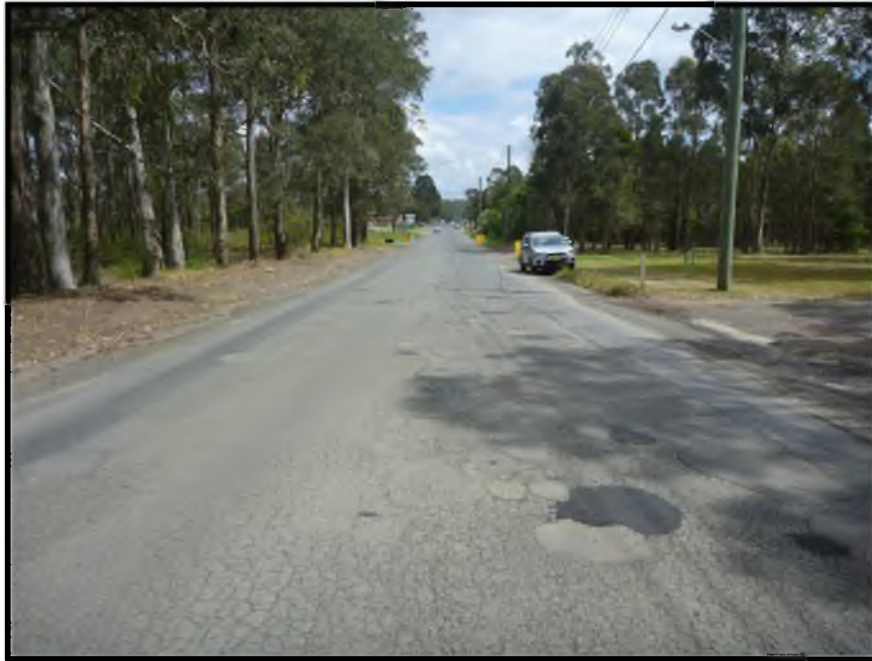
Figure 5.9 – Quinns Lane before Treatment Demonstrating Crocodile Cracking in a Poor Condition

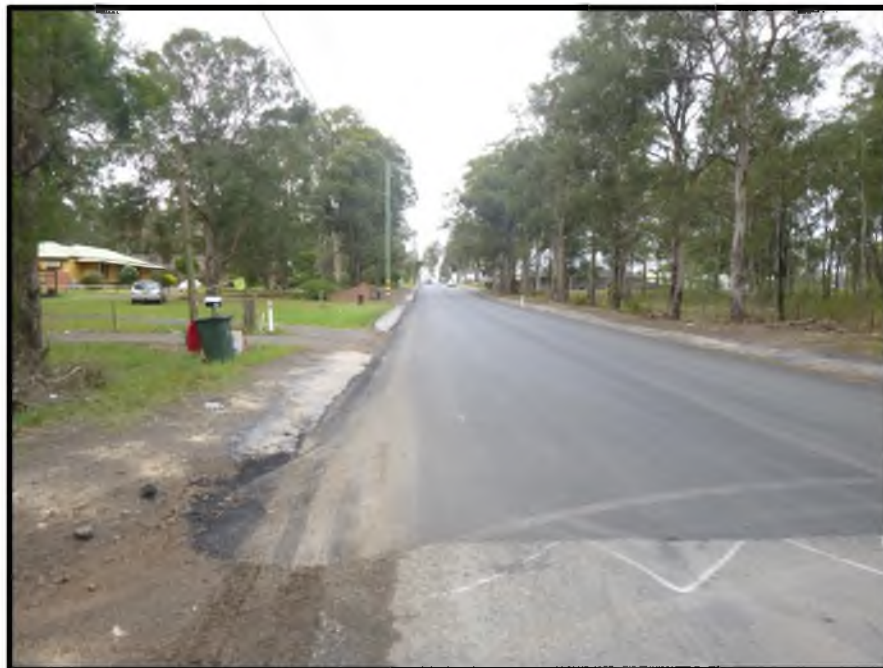
Figure 5.10 – Quinns Lane following Full Flexible Replacement Treatment

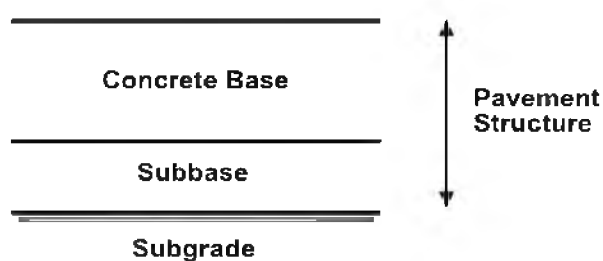
Figure A-1 – Typical Rigid Pavement Structure (Austroads 2009a)

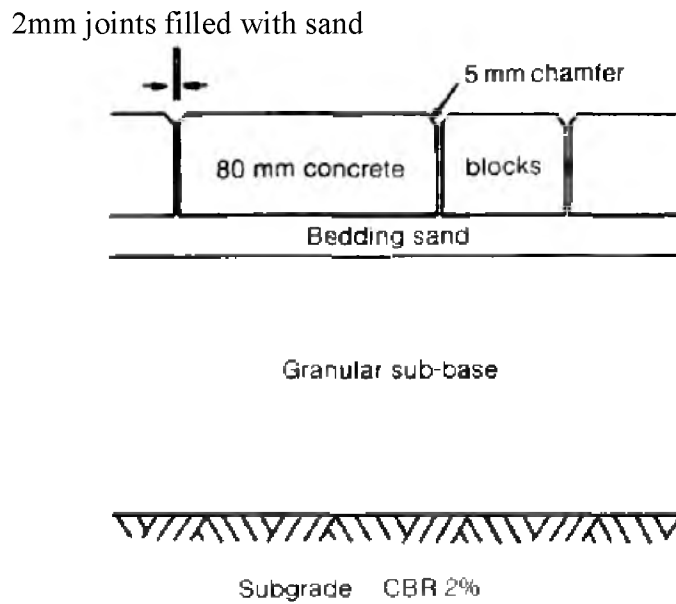
Figure A-2 – Typical Section of Segmental Block Pavement (Barber and Knapton 1979)

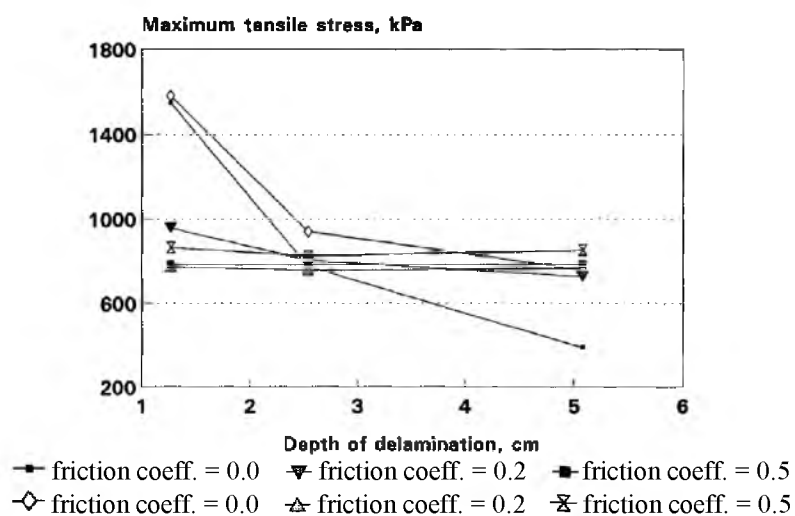
Figure A-3 – Concrete Spalling - Comparison of Maximum Tensile Stress with friction coefficients from a Finite-Element Analysis (Zollinger et al. 1994)
