Decision support system for the remediation of flexible road pavements in local government

**Decision Support System for the Remediation of Flexible Road
Pavements in Local Government**

**This thesis is presented as part of the requirement for the
Award of the Degree of Masters of Engineering (Research)**

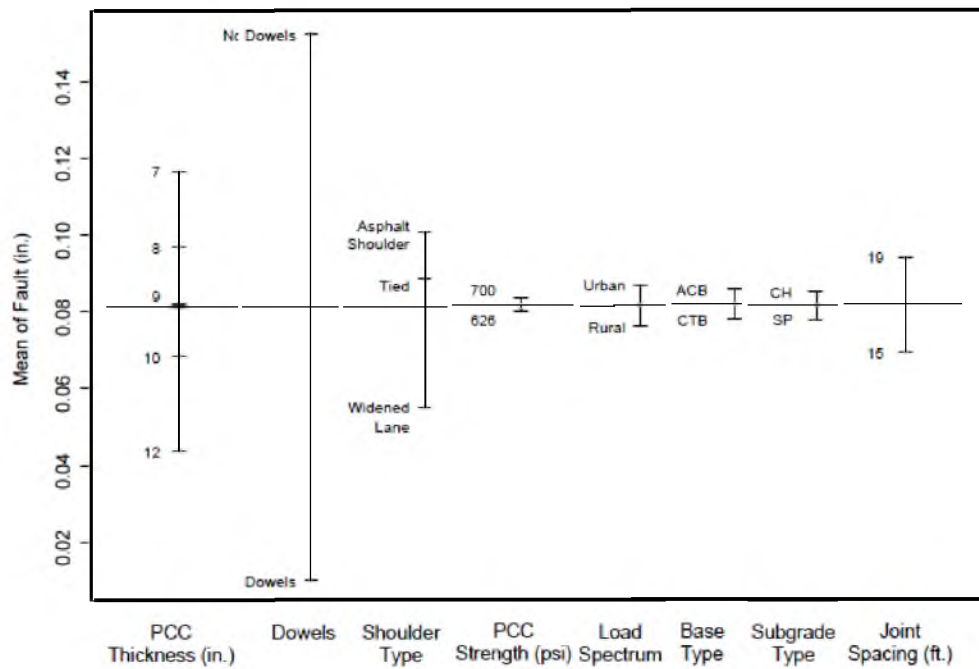
Figure A-4 – Relative effect of variables on faulting (Kannekanti and Harvey 2005)

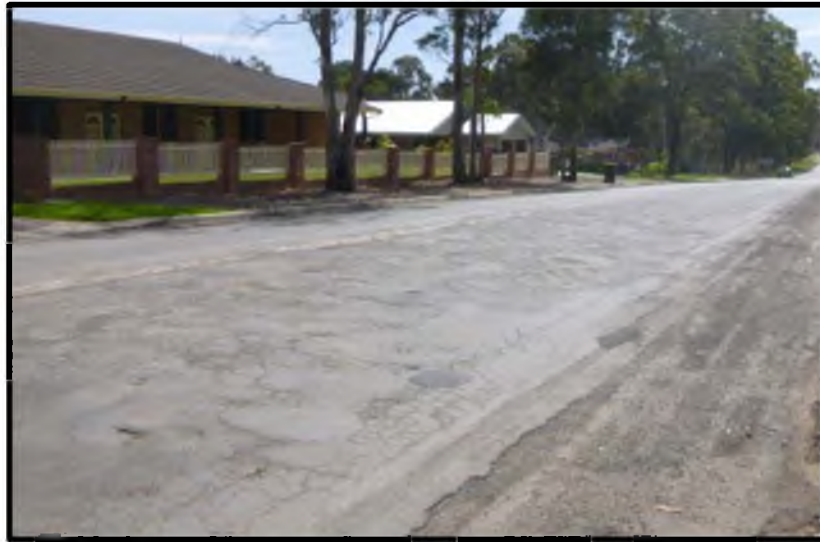
Figure C.9 – Quinns Lane before Treatment Demonstrating Failed Crocodile Cracking with Patching Failure in a Poor to Unserviceable Condition

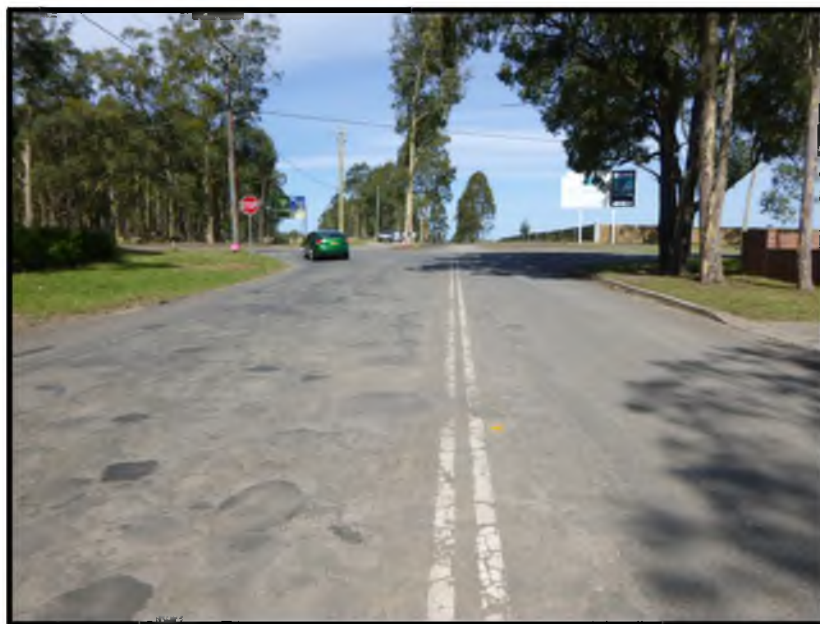
Figure C.10 – Quinns Lane before Treatment Demonstrating Failed Crocodile Cracking with Patching in a Poor to Unserviceable Condition

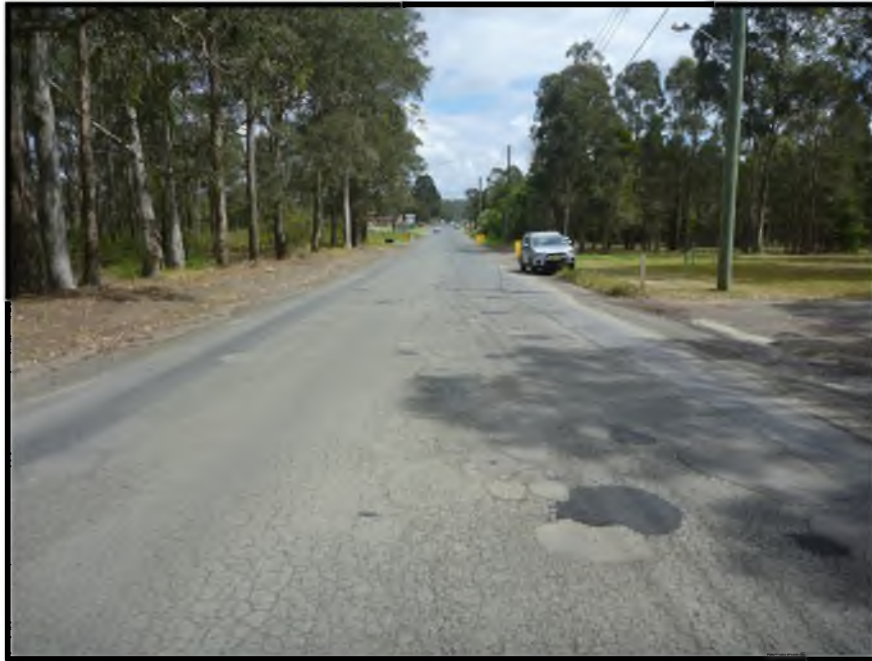
Figure C.11 – Quinns Lane before Treatment Demonstrating Crocodile Cracking in a Poor Condition

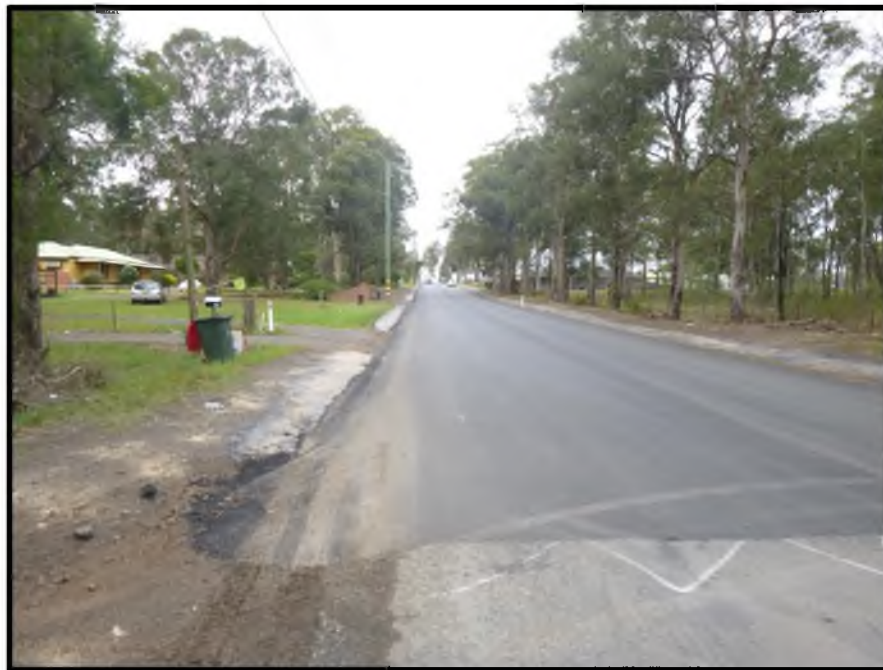
Figure C.12 – Quinns Lane following Full Flexible Replacement Treatment

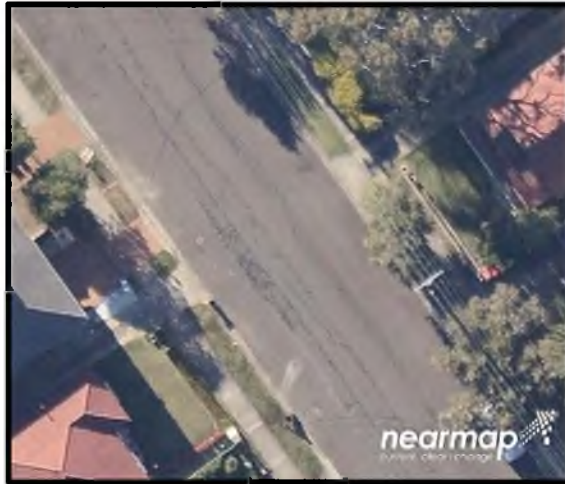
Figure C.34 – Satellite Imagery of Crack Sealing Repair of Dora Street, Hurstville (NearMap 2014)
