# Strengthening reinforced concrete T connections by steel straps

**ABSTRACT:** The aim of this paper is to present results of testing a full scale reinforced concrete T connection by static loading. The connection is a T connection representing a beam-column connection. The beam and column had a square cross section with a 300 mm dimension. The height of the column was 2.9 m and the clear beam length was 1.4 m. The connection was initially tested to failure. Galvanised steel straps were used to strengthen the connection. Epoxy resin was used to fix the steel straps to the concrete surface. The connection was tested after the rehabilitation. Results of testing the rehabilitated connection show that the yield and ultimate loads were 65 kN and 95 kN, respectively, compared with the original test results of 75 kN and 84 kN, respectively.

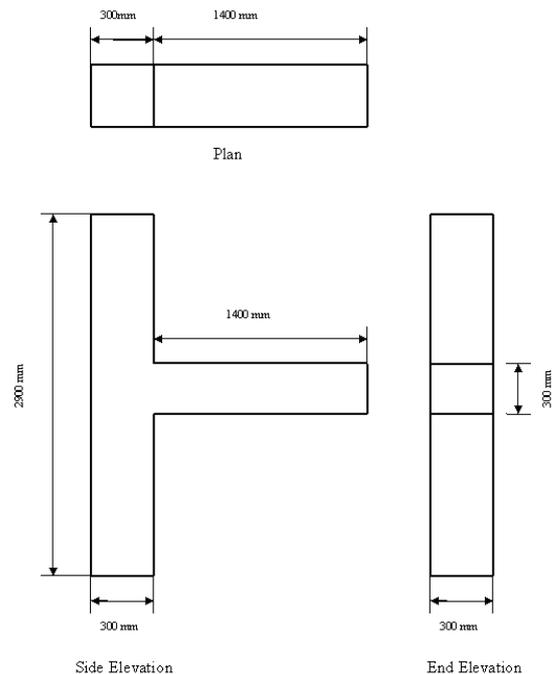
Figure 1. Dimensions of the beam-column connection.

In 2006, a helically reinforced T connection was tested to failure. The dimensions for the beam-column connection and the testing geometry are shown in Table 1 and Figure 1, respectively.

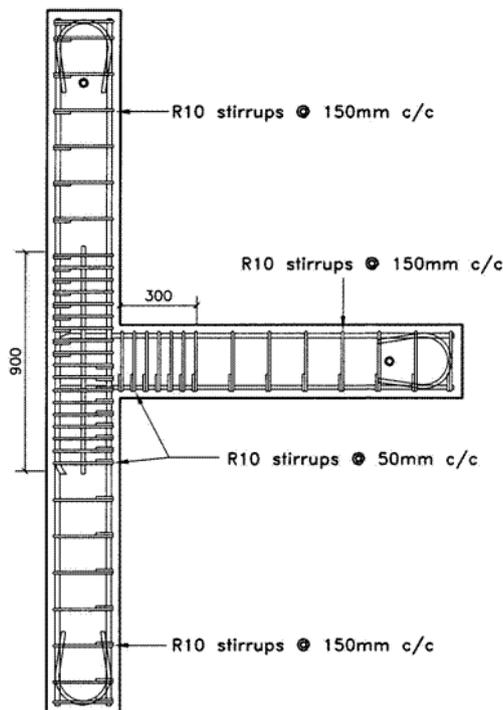
Figure 2. Reinforcement details.

The specimen was reinforced with N20 and N16 bars as shown in Table 2 and Figure 2.

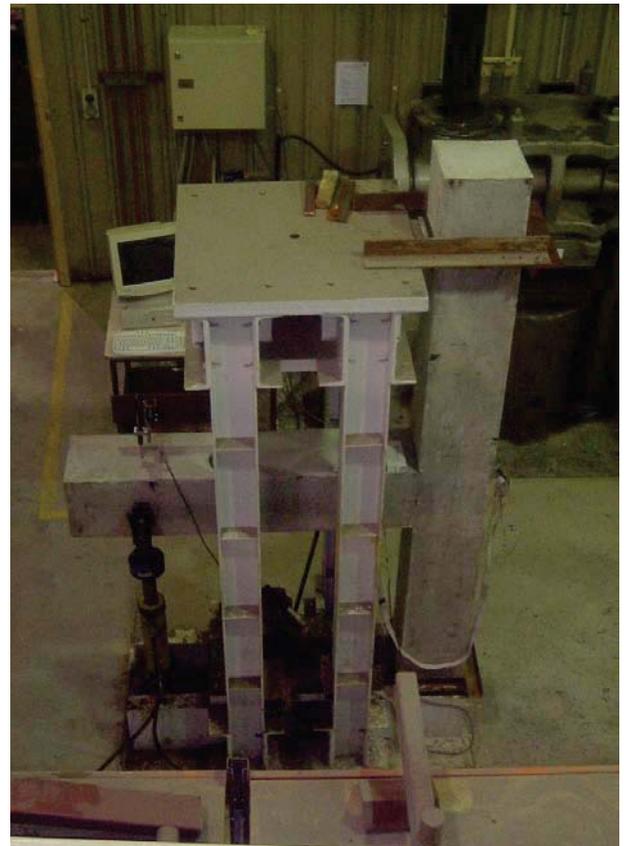
Figure 3. Testing frame.

The testing frame shown in Figure 3 was used to test the specimen both the initial specimen in 2006 and the rehabilitated specimen in 2007.

The hydraulic jack applied a downward vertical load onto the beam to create a large turning moment within the concrete connection. The load was applied at a distance of 1100 mm from the column beam interface while the column was held securely in place.

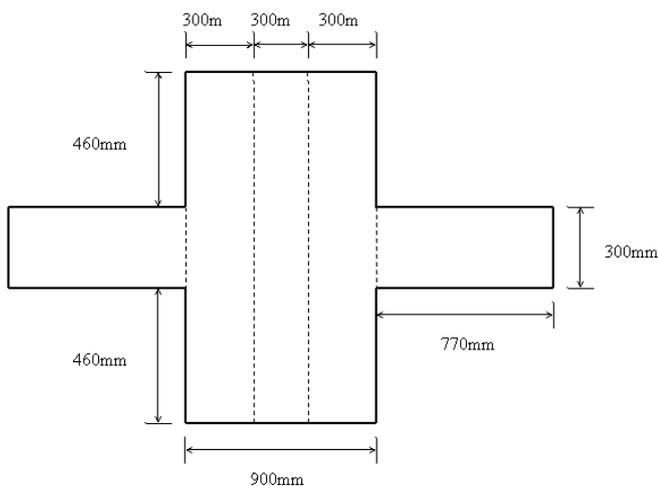
Figure 5. Dimensions of steel jacket.

A galvanised steel jacket was fabricated from galvanised steel. The steel jacket was measured, cut and bent to the required shape. The dimensions of the fabricated steel jacket are shown in Figure 4.

The dimensions of the steel jacket were marked onto the steel sheet, the sheet was then clamped with G-clamps onto a large working table and finally the steel sheet was cut using an electric cutter. Subsequently it was bent along the dotted lines to achieve its final form and was then fitted into the connection. The galvanised steel sheet was bent to the required shape using the bending machine. The steel jacket was then placed into the connection. Steel straps were used to hold the steel jacket in place and apply a confining pressure. The straps were spaced at 20 mm intervals. 22 steel straps and 19 steel straps were clamped onto the column and beam, respectively. A special band-it tool was used to apply a confining pressure to the steel straps and clamp them in place. The tool consists of a cutting handle, a grip lock and a turning handle.

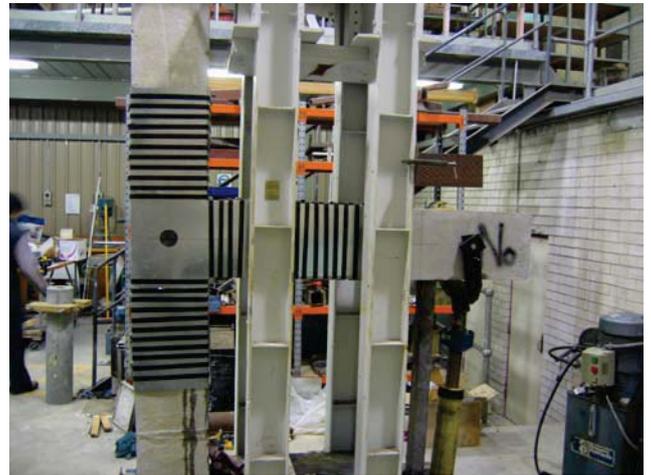
Figure 5. T-Connection completed with steel straps.

Figure 5 shows the completed strapping of the galvanised steel sheet onto the connection with the steel straps.

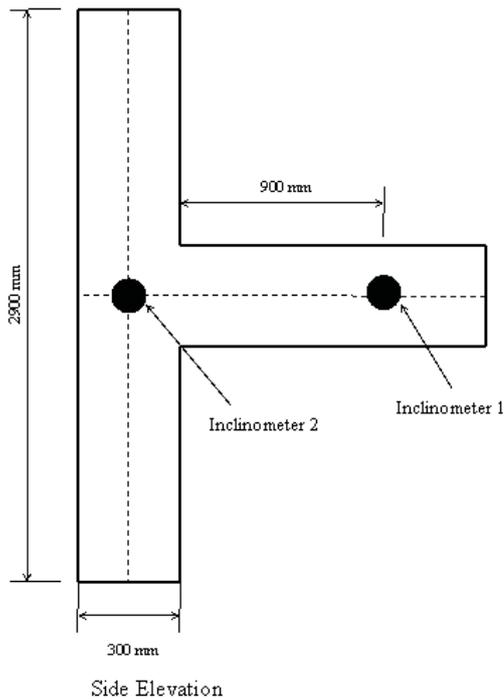
Figure 6. Position of Inclinometers.

An increasing single load was applied to simulate progressive collapse loading as done during testing the initial specimen. A hydraulic jack applied a downward vertical load onto the beam to create a turning moment within the connection. The load was applied at a distance of 1100 mm from the column-beam interface. The hydraulic jack applied an increasing point load until ultimate failure of the beam was reached. The loading rate was set to keep the deflection rate between 2.5 mm and 5 mm per minute and was determined by increasing or decreasing the pressure applied by the hydraulic pump to the hydraulic jack. An increasing single load was applied onto the beam with a 550 kN universal hydraulic jack from 0 kN to ultimate failure load. The deflections of the beam and the rotation measurements were taken throughout the testing period. The measurements were attached to a computer data logger to obtain a constant readout of the performance throughout the test. The applied load was measured via a 111.5 kN load cell which was connected on top of the hydraulic jack. The load cell was calibrated by technical staff before it was fixed on top of the hydraulic jack. A LVDT was placed to measure the beam deflection and was placed on the edge of the beam at a distance of 1100 mm from the column-beam interface. Two inclinometers were used to measure the rotation of the column and beam. The inclinometers logged the rotation in degrees for the whole test. One inclinometer was placed on the column and the other on the beam. The overall rotation of the joint is equal to the rotation of the beam minus

the rotation of the column. The position of the inclinometers is shown in Figure 6.
