# Rehabilitating destructed reinforced concrete T connections by steel straps

Hadi, M. N. (2011). Rehabilitating destructed reinforced concrete T connections by steel straps. *Construction and Building Materials*, 25 (2), 851-858. >

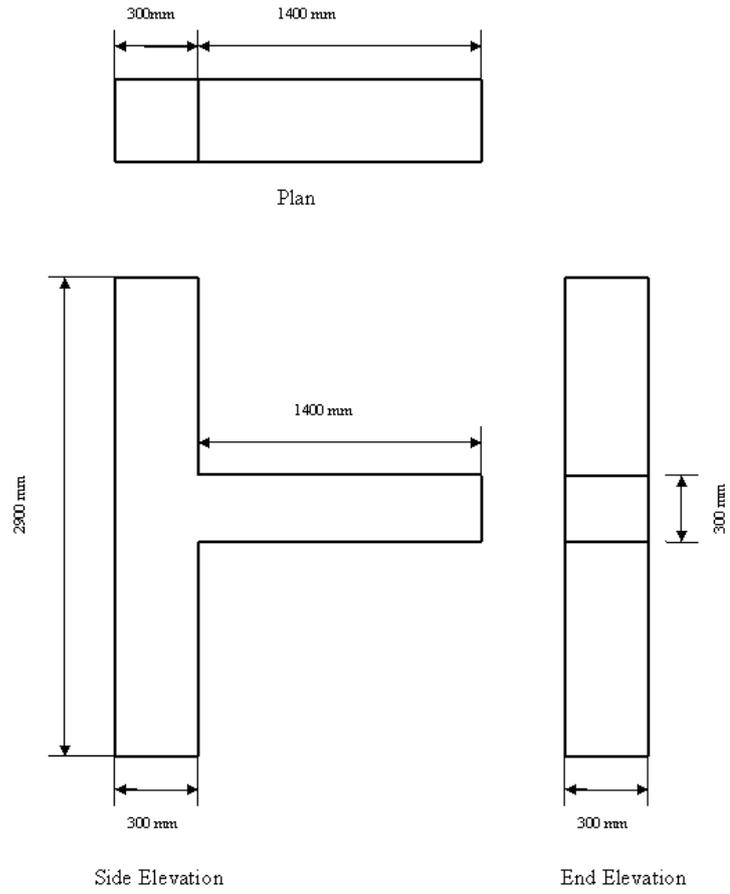
Figure 1. Dimensions of the beam-column connection.

In 2006, a reinforced T connection was tested to failure. The dimensions for the beam-column connection and the testing geometry are shown in Table 1 and Figure 1, respectively.

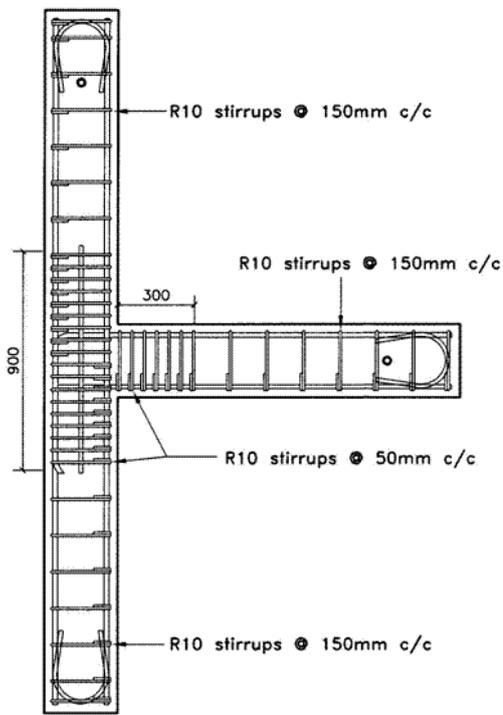
Beam Reinforcement

Column Reinforcement

Figure 2. Reinforcement details.

The connection specimen was reinforced with N20 (20 mm diameter deformed bars with 500 MPa nominal tensile strength and normal ductility) and N16 (16 mm diameter deformed bars with 500 MPa nominal tensile strength and normal ductility) bars as shown in Table 2 and Figure 2.

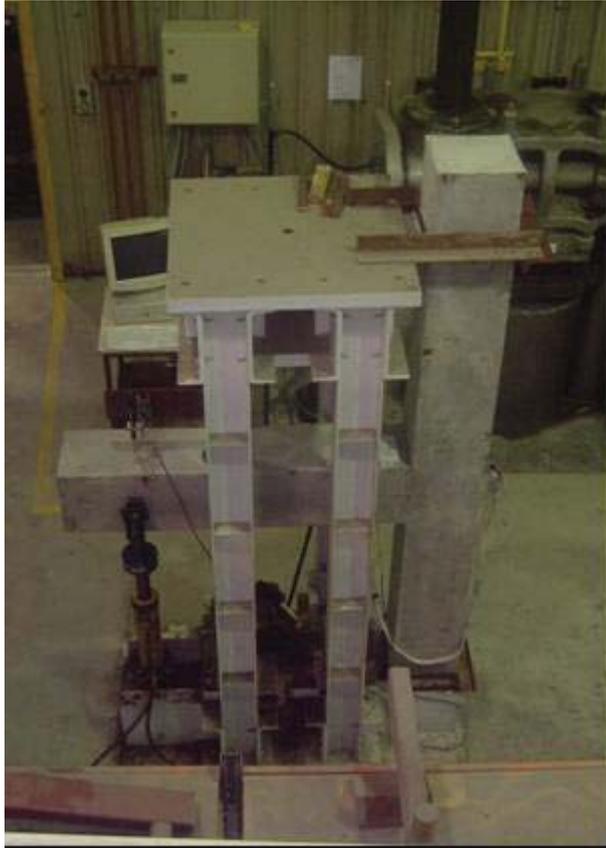
Figure 3. Testing frame.

The testing frame shown in Figure 3 was used to test the specimen both the initial specimen in 2006 and the rehabilitated specimen in 2007. The loading regime was chosen in line with the capabilities of the frame and the loading jack. An increasing single load was adopted.

The hydraulic jack applied a downward vertical load onto the beam to create a large turning moment within the concrete connection. The load was applied at a distance of 1100 mm from the column beam interface while the column was held securely in place.

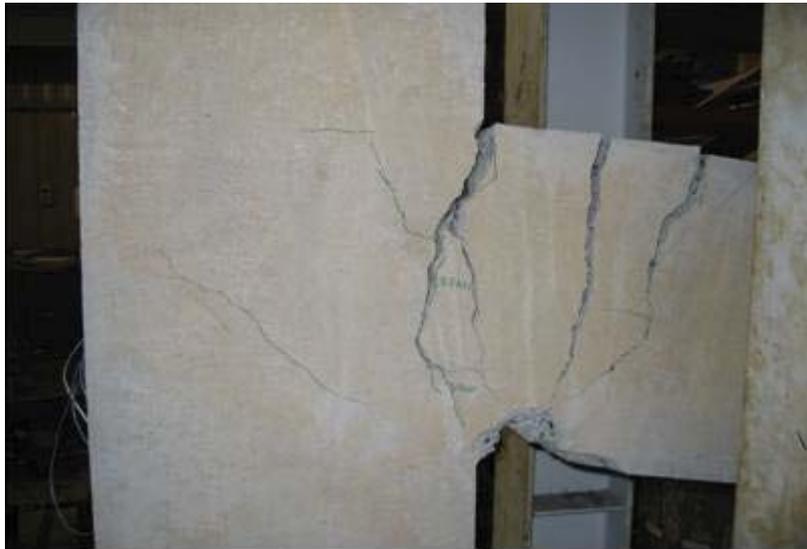
Figure 4 Cracks in damaged RC T-connection

The RC T-Connection with longitudinal reinforcement was tested in 2006 using a single increasing load to simulate progressive collapse. The load was applied downward at the edge of the beam through a hydraulic jack at a distance of 1100 mm from the beam-column interface. The damage caused to the connection due to the testing is depicted in Figure 4.

Three major tensile cracks formed and there was a major crushing of the concrete in the compression zone of the connection. Two of the major tensile cracks propagated right through the beam cross section while the other tensile crack did not. Some minor cracks formed on the surface of the beam and column.

As shown in Figure 4, there was a large spalling of concrete in the underside of the beam. For this particular region, injection of epoxy was not practical. Hence, a different grade of epoxy was used to patch it up. The Conbextra EP40 was used to fill the gap. The epoxy based resin and hardener were mixed in the ratio 1 to 4 respectively. Care was taken while handling the epoxy because of its corrosive nature. Safety goggles, mouth mask and rubber gloves were worn at all times when handling the epoxy.

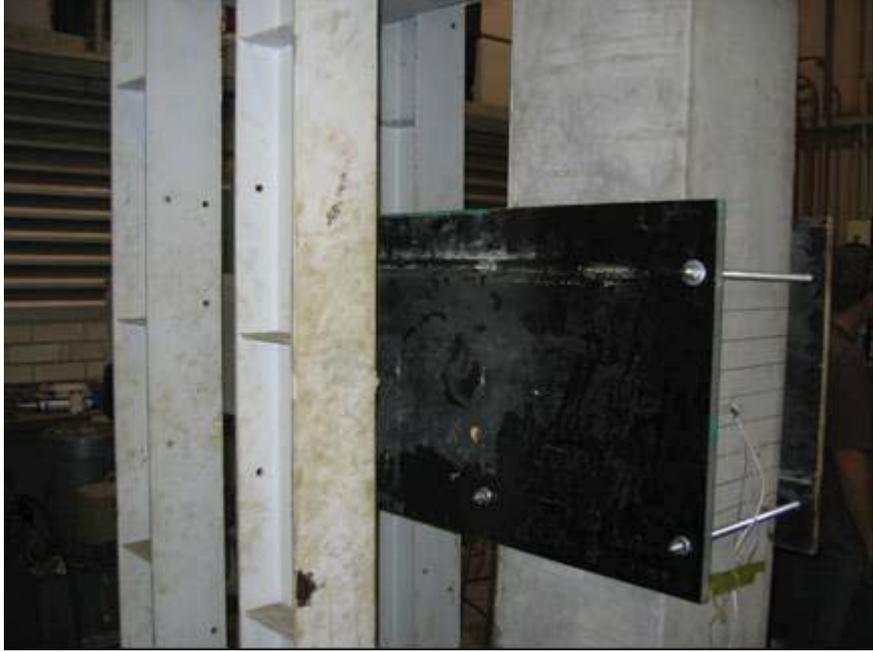
Figure 5 Installed Formwork

A designed to fit formwork was constructed to prevent the leakage of epoxy on the underside and the sides of the gap. The formwork was made of plywood and screwed using threaded rods and bolts to hold it together. The formwork was installed after the beam was aligned to its horizontal position as shown in Figure 5.

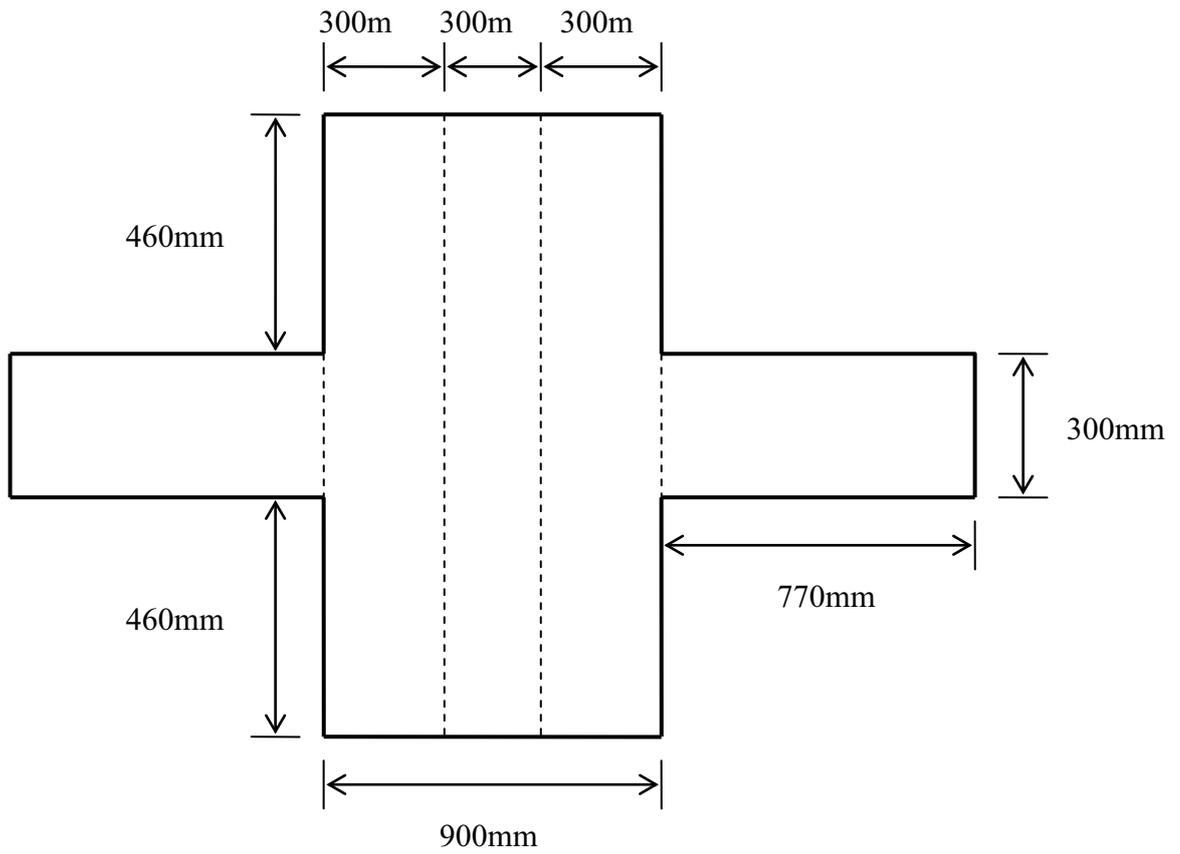
Figure 6 Dimensions of the steel jacket

A galvanised steel jacket was fabricated from galvanised steel. The steel jacket was measured, cut and bent to the required shape. The dimensions of the fabricated steel jacket are shown in Figure 6.

The dimensions of the steel jacket were marked onto the steel sheet, the sheet was then clamped with G-clamps onto a large working table and finally the steel sheet was cut. The steel sheet was cut to the required dimensions. Subsequently it was bent along the dotted

lines (Figure 6) to achieve its final form and was then fitted into the connection. The galvanised steel sheet was bent to the required shape.

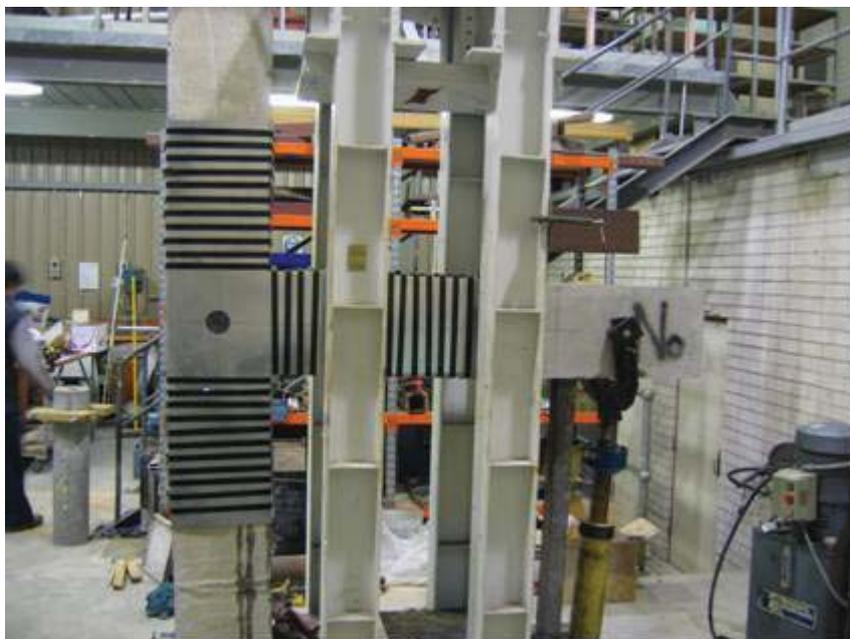
Figure 7 T-Connection completed with steel straps

Figure 7 shows the completed strapping of the galvanised steel sheet onto the connection with the steel straps.

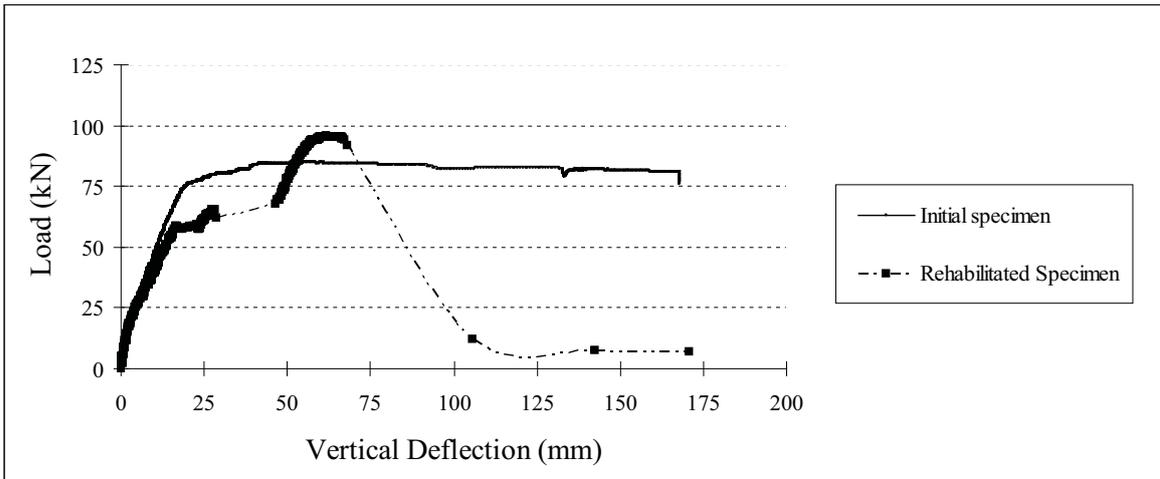
Figure 8 Load-deflection Curves of the Initial and the Rehabilitated Specimen

Figure 8 shows the load-deflection curves of the initial and rehabilitated specimen. Likewise Figure 9 shows bending moment-rotation of the initial and rehabilitated specimen.

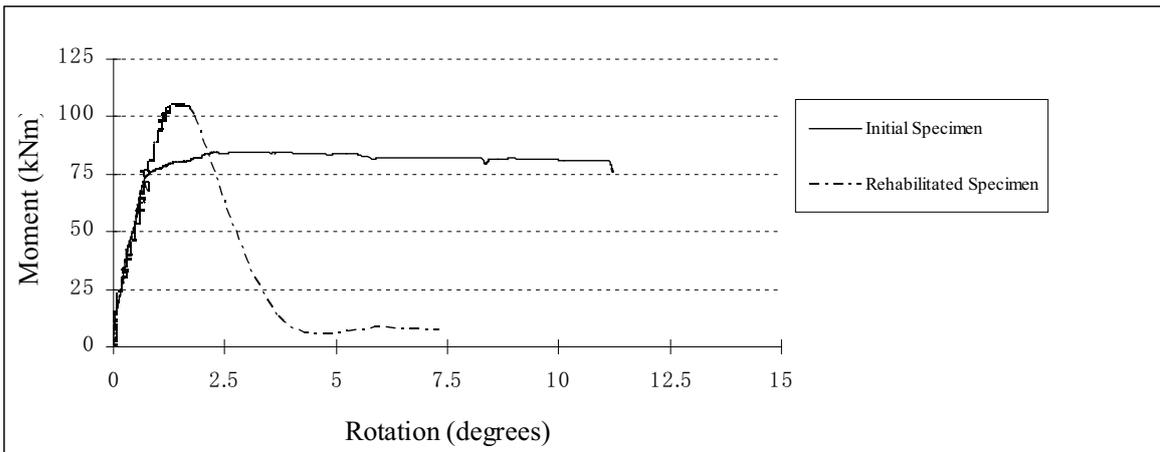
Figure 9 Bending Moment-Rotation Curves of the Initial and the Rehabilitated Specimen

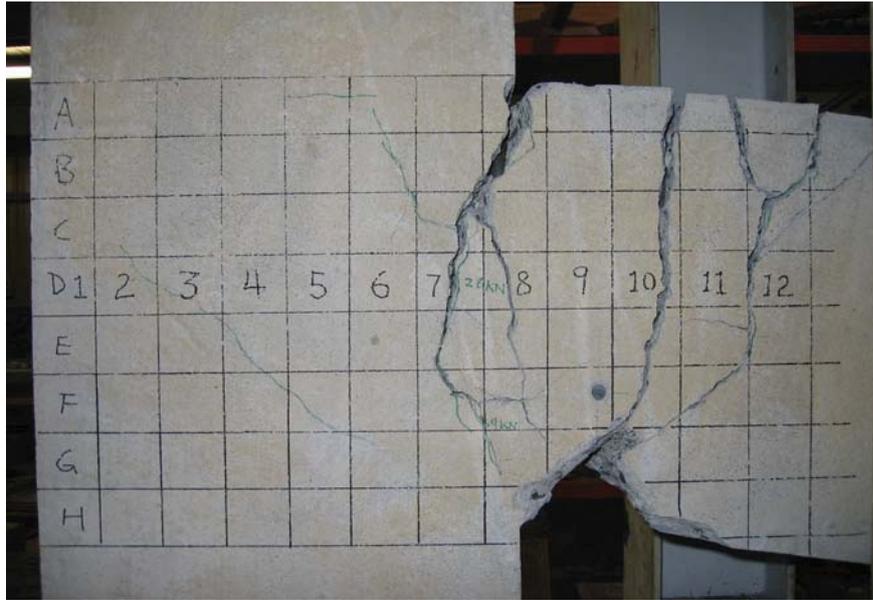
Figure 10 Tensile cracks and concrete crushing before rehabilitation

The initial specimen had a crack pattern as depicted in Figure 10. It shows three major tensile cracks on the beam and crushing of concrete in the compression zone. Tiny cracks were also observed on the concrete surface of the column and beam near the joint.

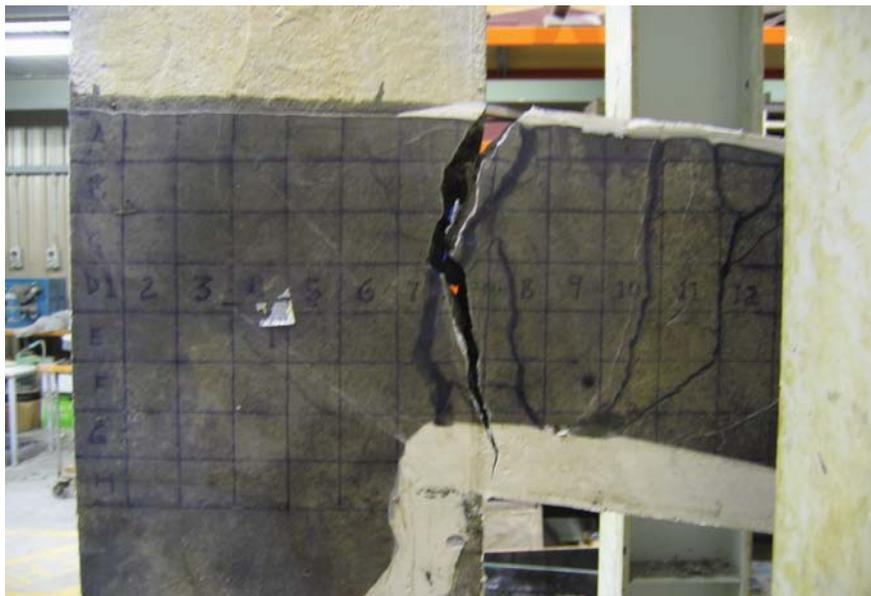
Figure 11 A single major tensile crack in rehabilitated specimen

Figure 11 shows a single major tensile crack in the rehabilitated specimen after testing. There was also no crushing of epoxy in the compression zone of the beam. The epoxy applied to fill the cracks in the tensile cracks is very viscous and transparent. As such the initial crack lines are vividly visible. Therefore, these cracks should not be mistaken for new cracks forming in the epoxy repaired region.

It can also be seen from Figure 11 that the new major tensile crack is propagating into the epoxy in the compression zone. However, at this point, the beam reached ultimate failure and visual inspection showed that the two primary tensile reinforcement bars had fully ruptured.

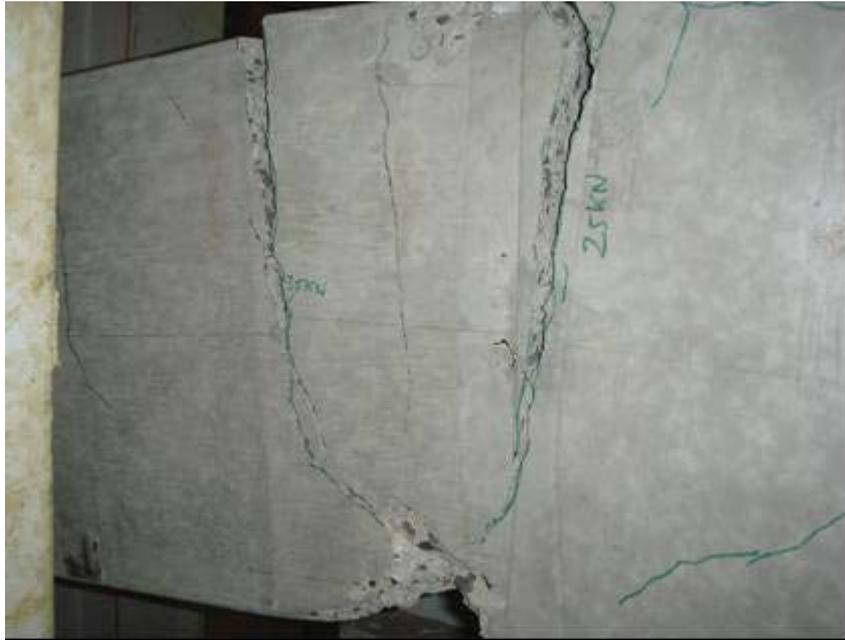
Figure 12 Concrete crushing and tensile cracks in original specimen

The external reinforcement using galvanised steel and steel straps provided confinement to the concrete and epoxy. Figure 12 shows the extent of the damage on the original specimen after the test. Concrete crushing was observed in the compression zone of the connection. Three major tensile cracks and tiny surface cracks formed as well.

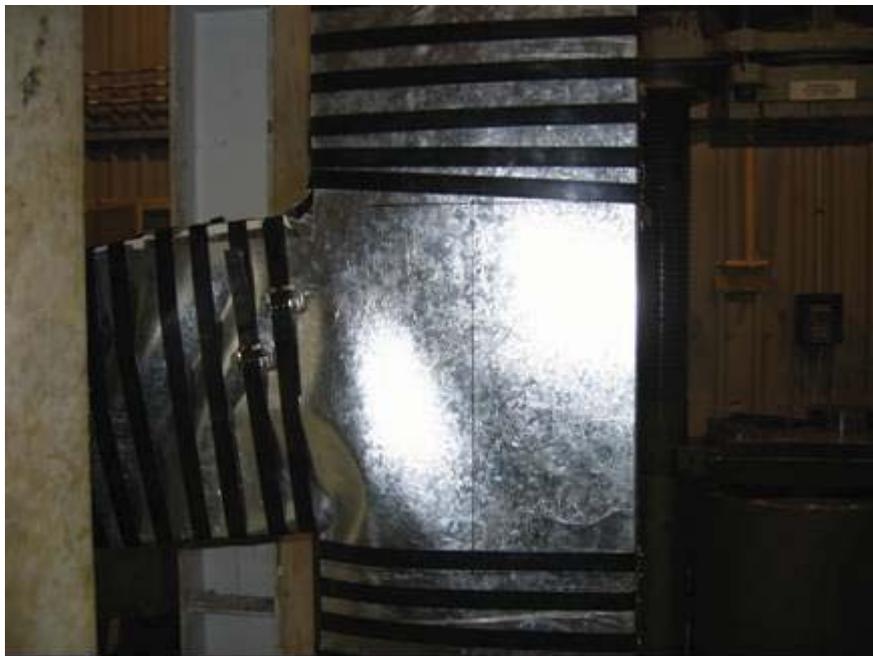
Figure 13 Buckling of galvanised steel

It was observed that the galvanised steel buckled during the testing as shown in Figure 13. This buckling was due to the tensile forces acting in the tensile zone of the beam and the compressive forces acting in the compression zone.

It can be seen in Figure 13 that the steel straps near the beam-column interface moved slightly outwards from their original positions. This movement was due to the tensile force acting on the galvanised steel in the tensile zone. It is evident that the galvanised steel and steel straps added strength to the connection together with the epoxy adhesive. More importantly, most of the added strength in the specimen comes from the epoxy as there was no reopening of the cracks in the repaired region. However, it is difficult to gauge exactly how much strength was added by the galvanised steel and the steel straps.

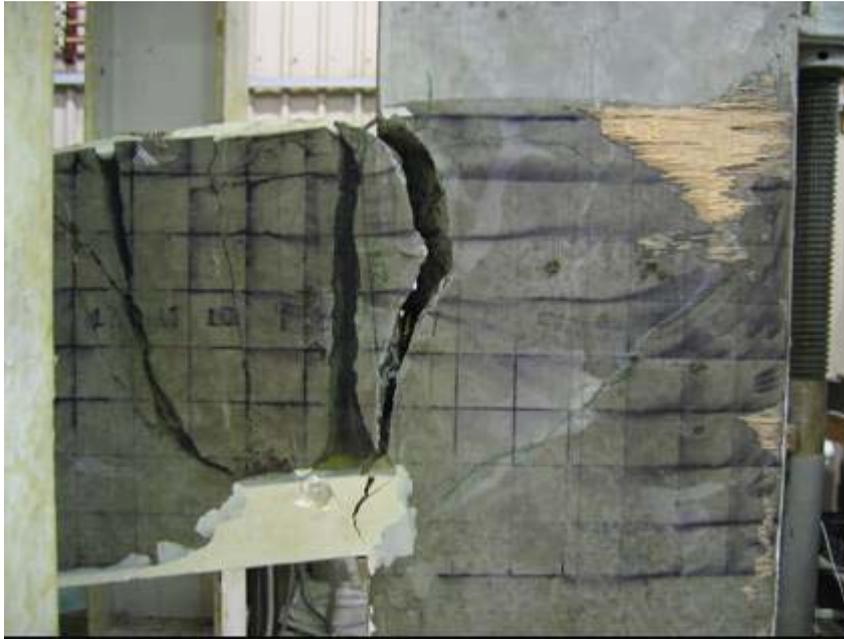
Figure 14 Rehabilitated specimen after testing

Figure 14 depicts the damage of the rehabilitated specimen after it was tested. A major tensile crack formed and slowly propagated into the compression zone. The tensile crack was ripped off the column due to the rupturing of the two primary reinforcement bars.
