Advanced microstructural characterisation of insulated rail joints

Advanced Microstructural Characterisation of Insulated Rail Joints

Master of Philosophy

School of Mechanical, Materials and Mechatronics Engineering

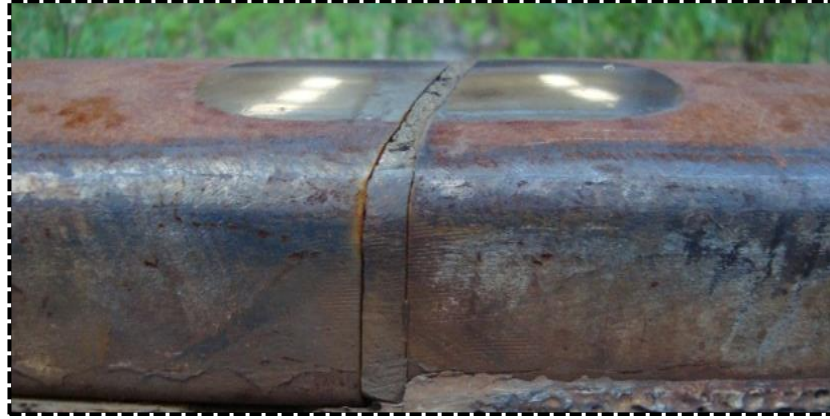
Figure 2-4 Surface coated IRJ with martensitic stainless steel

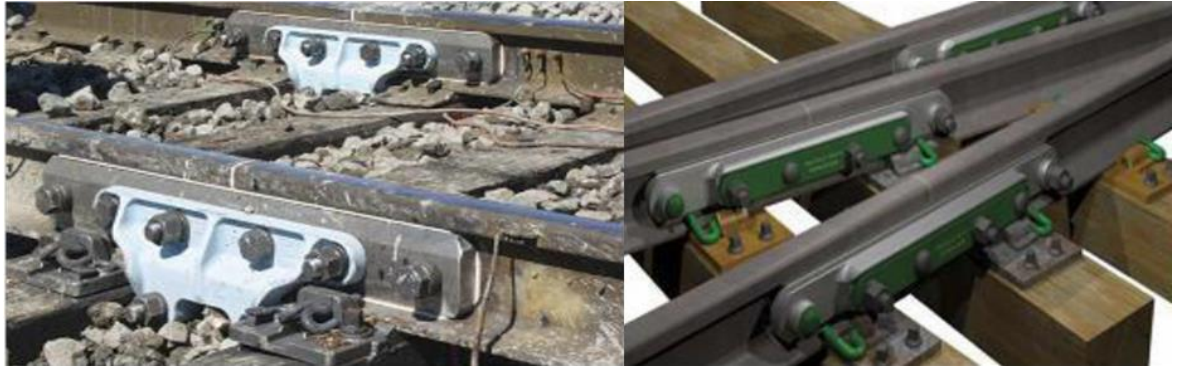
Figure 3-13 “Hercules” series insulated rail joints from NorFast Inc

A new IRJ type described as the “Hercules”, has been recently introduced in Canada by NorFast. It has been demonstrated to have heavy-haul railway applications due to the longer service life of this type of joint. Also, of benefit is the high-speed installation, high signal reliability, and improved economics of field installation (Australian Rail Track Corporation, 2010). Compared with TTCI designs, the “Hercules” IRJs is claimed to cope with higher wheel loads without the requirement of glued bonds, and can be field-assembled without field welding. In addition, it is claimed that the field assembly process can be performed with straightforward and versatile properties on either tangent track or at turnouts/corners, Figure 3-13 (Australian Rail Track Corporation, 2010).

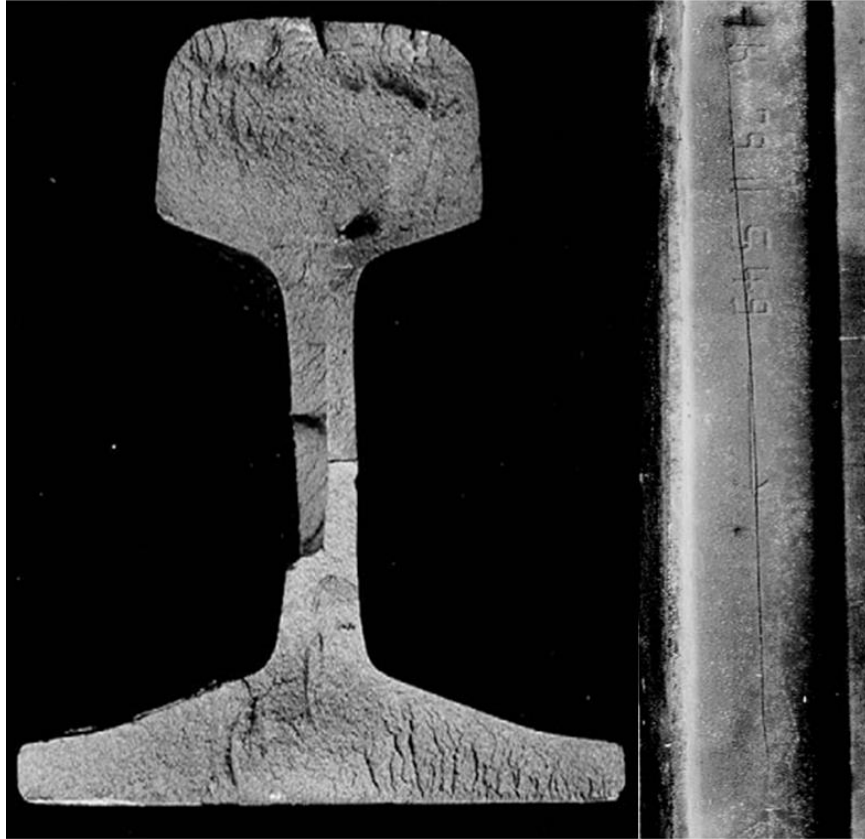
Figure 3-27 Longitudinal vertical web crack "piping, Horizontal web crack

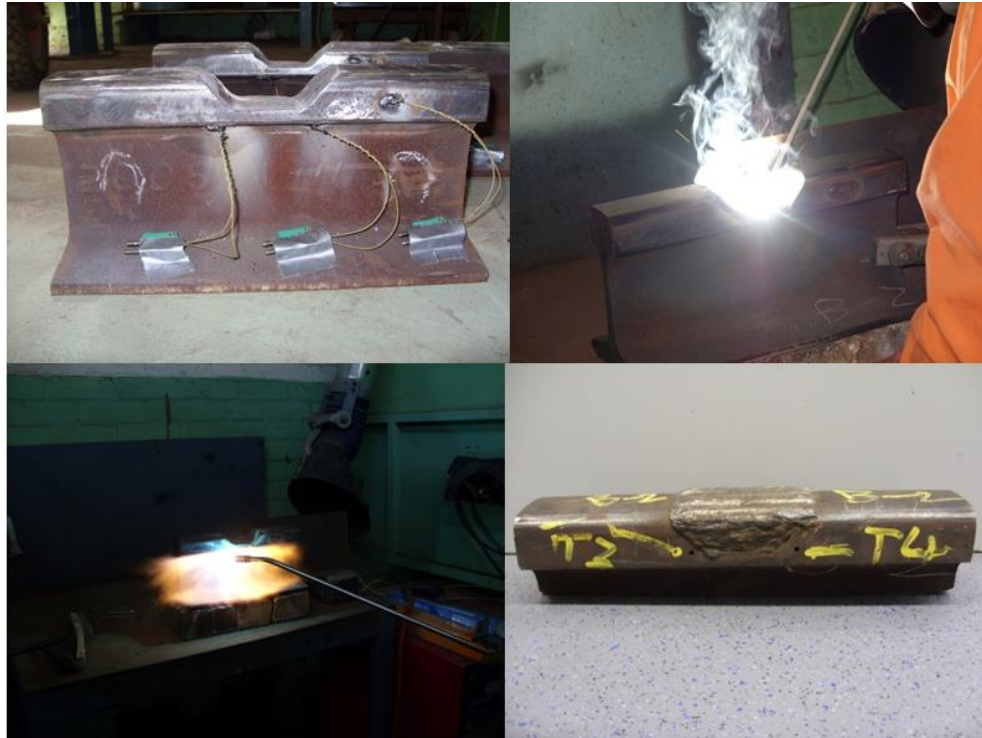
Figure 4-1 Preliminary trial welding of Maraging steel on the rail head in the shape of bathtub dimension

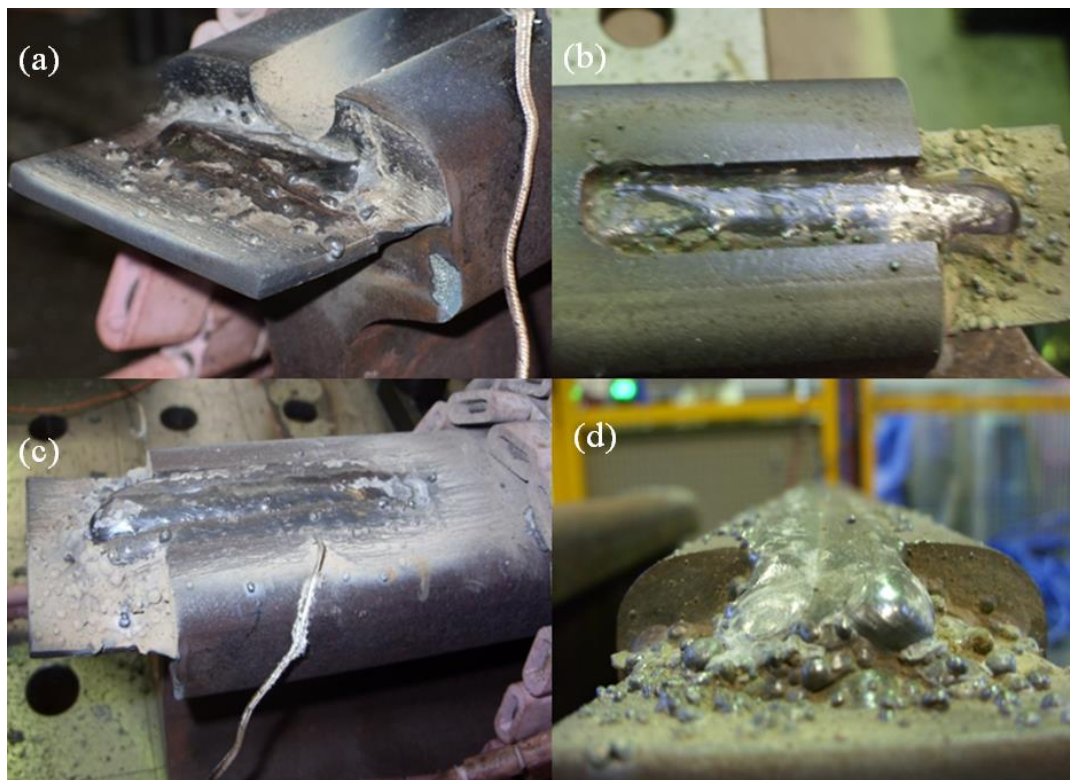
Figure 4-4 (a) Run-on plate (b) weld run (c & d) Completion of weld

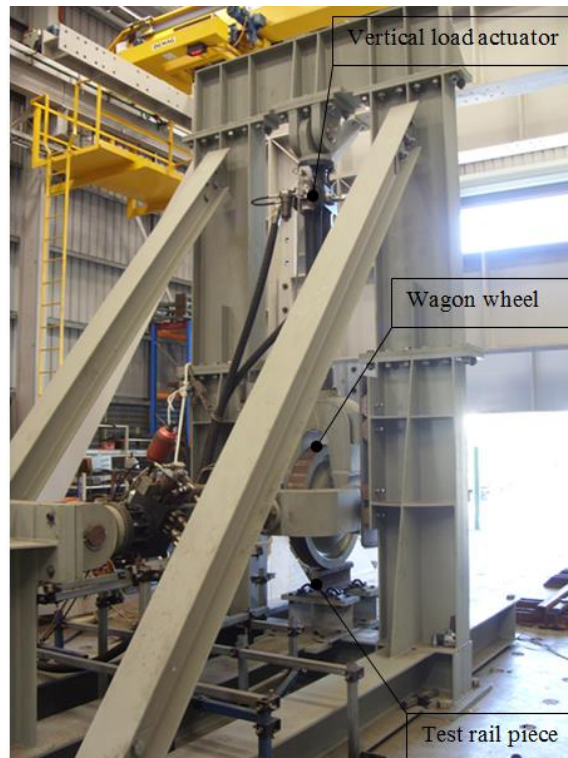
Figure 4-8 Full-scale wheel-on-rail track rail rig set-up
