Roadside rest area wastewater treatment system: Performance evaluation and improvement

Roadside rest area wastewater treatment system: performance evaluation and improvement

Abstract: The performance of a decentralised sewage treatment plant located at a rest area servicing a major freeway was investigated. Long term monitoring and rigorous analyses undertaken in this study revealed several unique and challenging issues associated with such scarcely studied systems. Data collected over a six month period showed that the raw wastewater strength was well above typical household wastewater characteristics, with the average BOD₅, COD, TOC, TN and TP values of 880, 4900, 350, 238 and 8 mg/L, respectively. The system performance was considerably lower than that expected of a typical wastewater treatment unit. Several shortcomings in design (e.g., inefficient aeration device and return activated sludge system) and inconsistencies in maintenance practice were identified and some remedial measures were proposed and tested. Of particular interest were the increase of the dissolved oxygen (DO) concentration (from 0.5 to 4 mg/L) and the simultaneous significant improvement of COD and TOC rem

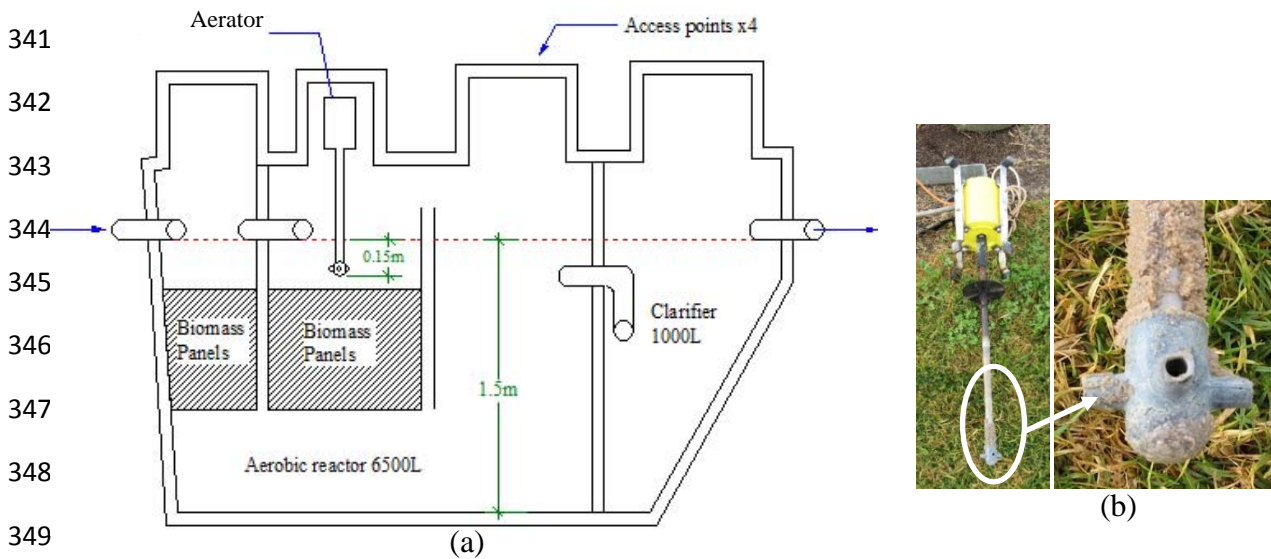
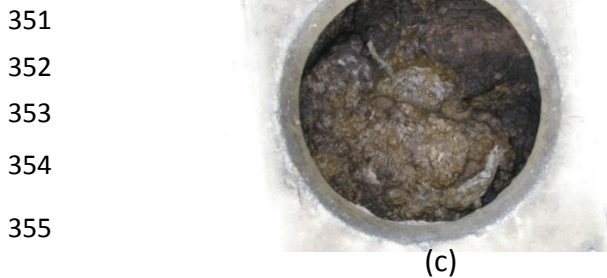
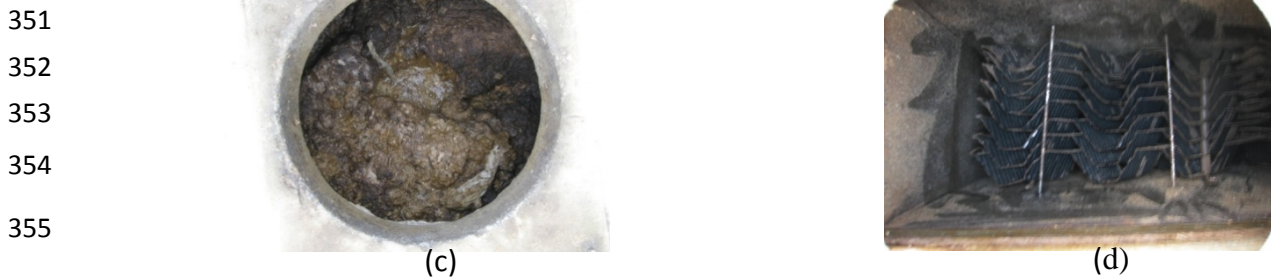
357 **Figure 2:** Identification of reasons for plant underperformance

174 In order to find out the reason of inefficient DO distribution, a closer inspection of the aerator was
175 required (Figure 2). The manufacturer used a rotating aeration device which supplied air from
176 atmosphere through the vent and injected it into the tank while circulating the entire contents. It
177 was instantly conceivable that as the tank is baffled (Figure 2a), the mixing in one section would
178 not translate to effective aeration in the adjacent section. There were also some concerns with the
179 location of the aerator. The aerator was positioned at the top of the tank and injected air into the
180 upper 0.15 m surface above the biomass panels. Ideally the air would need to be diffused below
181 these panels.

358 (a) Configuration of the aerator in the aerobic tank, (b) Closer look at the aerator, (c) Biomass
359 panels heavily clogged with anaerobic biomass, (d) Biomass panel after servicing.

183 The MLSS is an indicator on the amount of activated sludge in the chamber. Depending on the
184 configuration i.e. suspended growth or hybrid system, the MLSS in AWTS should be in the range
185 2000–6000 mg/L [19]. Maintaining the correct MLSS ensures that the food to micro-organism
186 (F/M) ratio is in the right balance [1]. Table 2 shows that the MLSS in the aerobic reactor was
187 very low. Accordingly it created a high F/M ratio and effectively reduced the BOD₅ and nutrient
188 removal efficiencies. In a combined suspended and attached growth reactor the biomass attached
189 on the support too needs to be taken into account. The aerobic reactor in this study housed 177 m²
190 of biomass panels (Figure 2 c,d). During a planned servicing of the aerobic reactor the biomass
191 panels appeared heavily clogged (Figure 2 c). Apparently insufficient mixing led to the
192 accumulation of anaerobic bacteria on the panels, and accordingly removal performance was

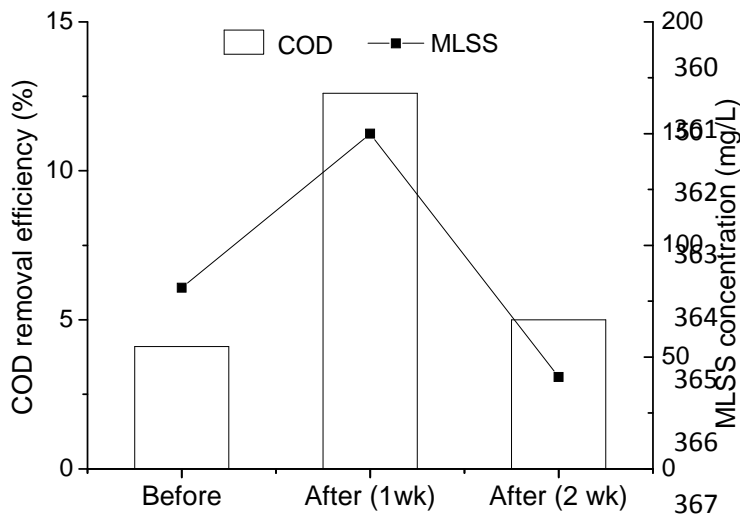
220 The initial results clearly showed that the only tank showing any signs of removal efficiency was
221 the anaerobic tank (Table 2). To try and kick start the system, activated sludge (MLSS~ 2000
222 mg/L) was collected from the Wollongong sewage treatment plant and seeded into the aerobic
223 reactor. Figure 3a shows the COD removal efficiency and MLSS concentration in the aerobic tank
224 before and different intervals after seeding. A temporary marginal improvement in removal
225 performance was observed after the seeding. This indicated the importance of maintaining
226 adequate level of MLSS concentration in the reactor. However, the plummeting removal rate and
227 MLSS concentration over time underscored that without improving the DO level, accumulation of
228 aerobic bacteria on the biomass panels would not be possible, and washout of suspended sludge
229 would be inevitable. This confirmed that the DO and MLSS problems were interrelated.

(a) Effect of seeding of aerobic reactor without improving DO level
 (b) Homogenous DO level maintained after installation of the air blower.

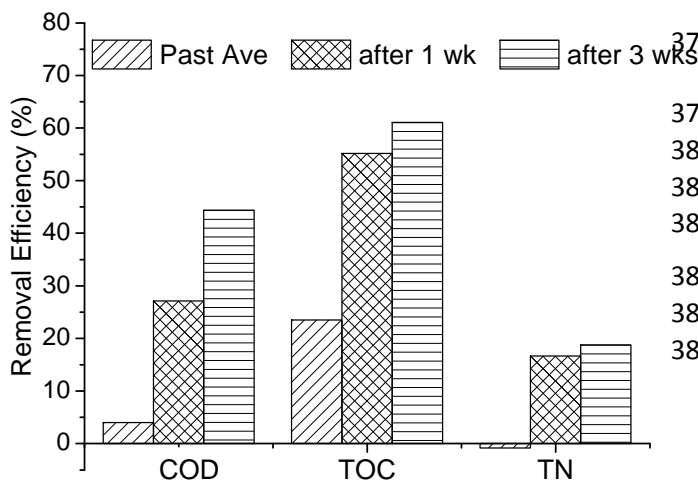
231 Martin [20] previously reported improved removal performance in a package aerobic treatment
232 system by installing a blower which can supply 100L/min of air. Accordingly a diffuser was
233 installed at the bottom of the aerobic tank and was connected to a blower (6/24 min on/off,
234 100L/min). Figure 3b shows the DO profile over the reactor depth before and after the installation.
235 A homogenous and markedly improved DO concentration could be sustained due to the change of
236 the aeration system. It is worth noting that the DO level did not drop below 2 mg/L level even
237 during the off period of the blower. Figure 3c shows the stable improvement in COD, TOC and
238 TN removal in the aerobic tank due to the improvement of the DO level. The removal efficiency
239 of COD, TOC and TN improved from 4 %, 24 % and negligible level to 44 %, 61% and 19 %, respectively.

(c) Performance of the aerobic reactor before and after the installation of the blower.

240 respectively. It should be noted that despite the improved performance, the MLSS in the reactor
241 did not improve significantly. However, visual observation confirmed that a steady level of
242 biomass was attached onto the panels. With 177 m² of biomass media and an assumed average
243 biomass density of 100 g/m² in line with the literature reports [21], the total amount of attached
244 biomass can be estimated as 17700 g, which, if considered distributed over the whole volume of
245 the reactor (6500 L), is equivalent to an MLSS of 2700 mg/L. This is a reasonable concentration
246 in line with the observed removal performance. Apparently due to the efficient aeration the panels
247 maintained an active mass of aerobic bacteria which gave rise to the observed improved removal
248 performance.
