Fluvial geomorphology of the Nambucca river catchment: late quaternary change, post-settlement channel degradation and proposals for rehabilitation

**FLUVIAL GEOMORPHOLOGY OF THE NAMBUCCA RIVER CATCHMENT:
LATE QUATERNARY CHANGE, POST-SETTLEMENT CHANNEL
DEGRADATION AND PROPOSALS FOR REHABILITATION**

DOCTOR OF PHILOSOPHY

School of Geosciences

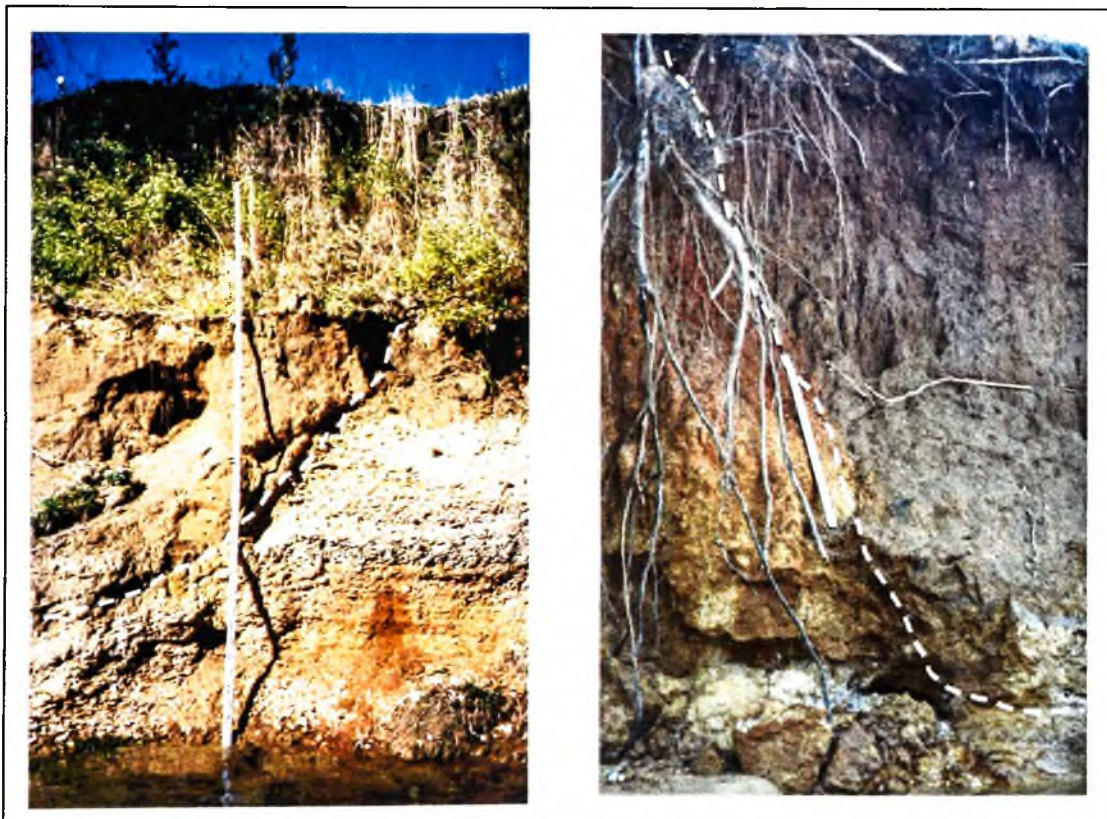
Figure 7.2: Cut and fill sections on North Arm (Site N4) and Deep Creek (Site D3)

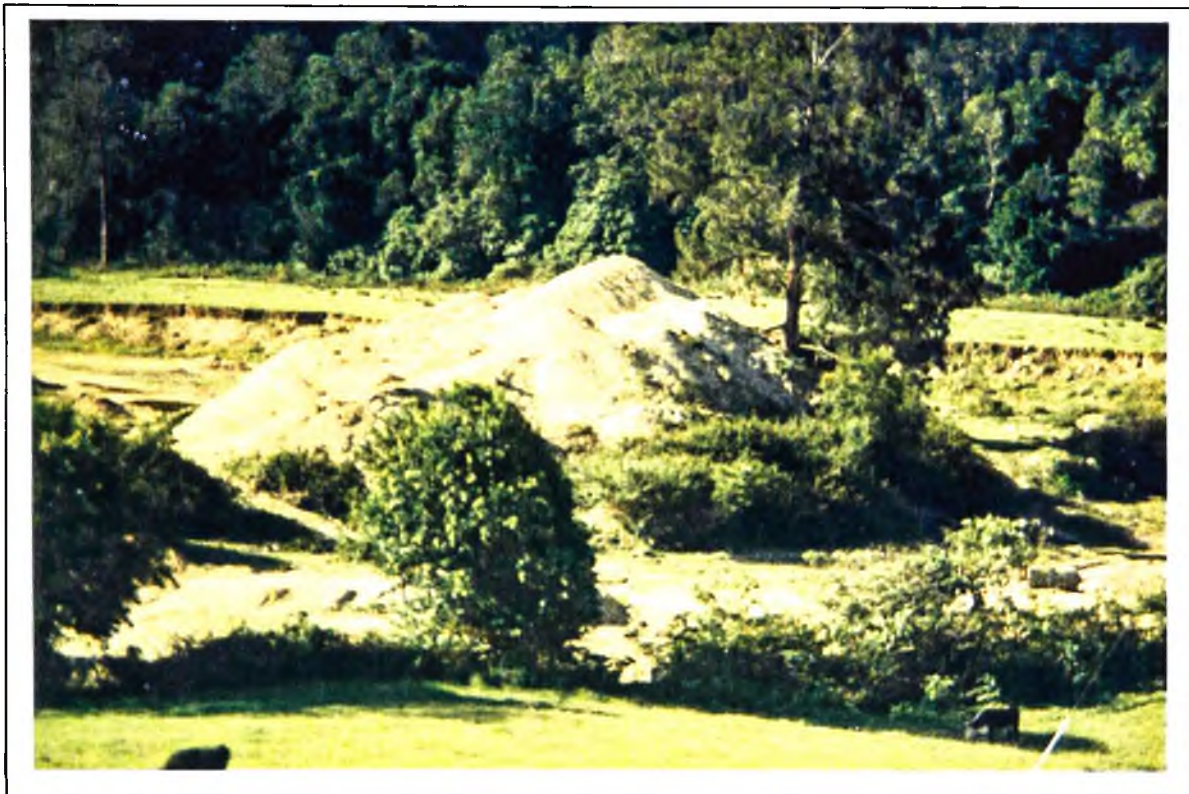
Figure 7.5: An example of illegal gravel extraction from North Arm in the late 1980's

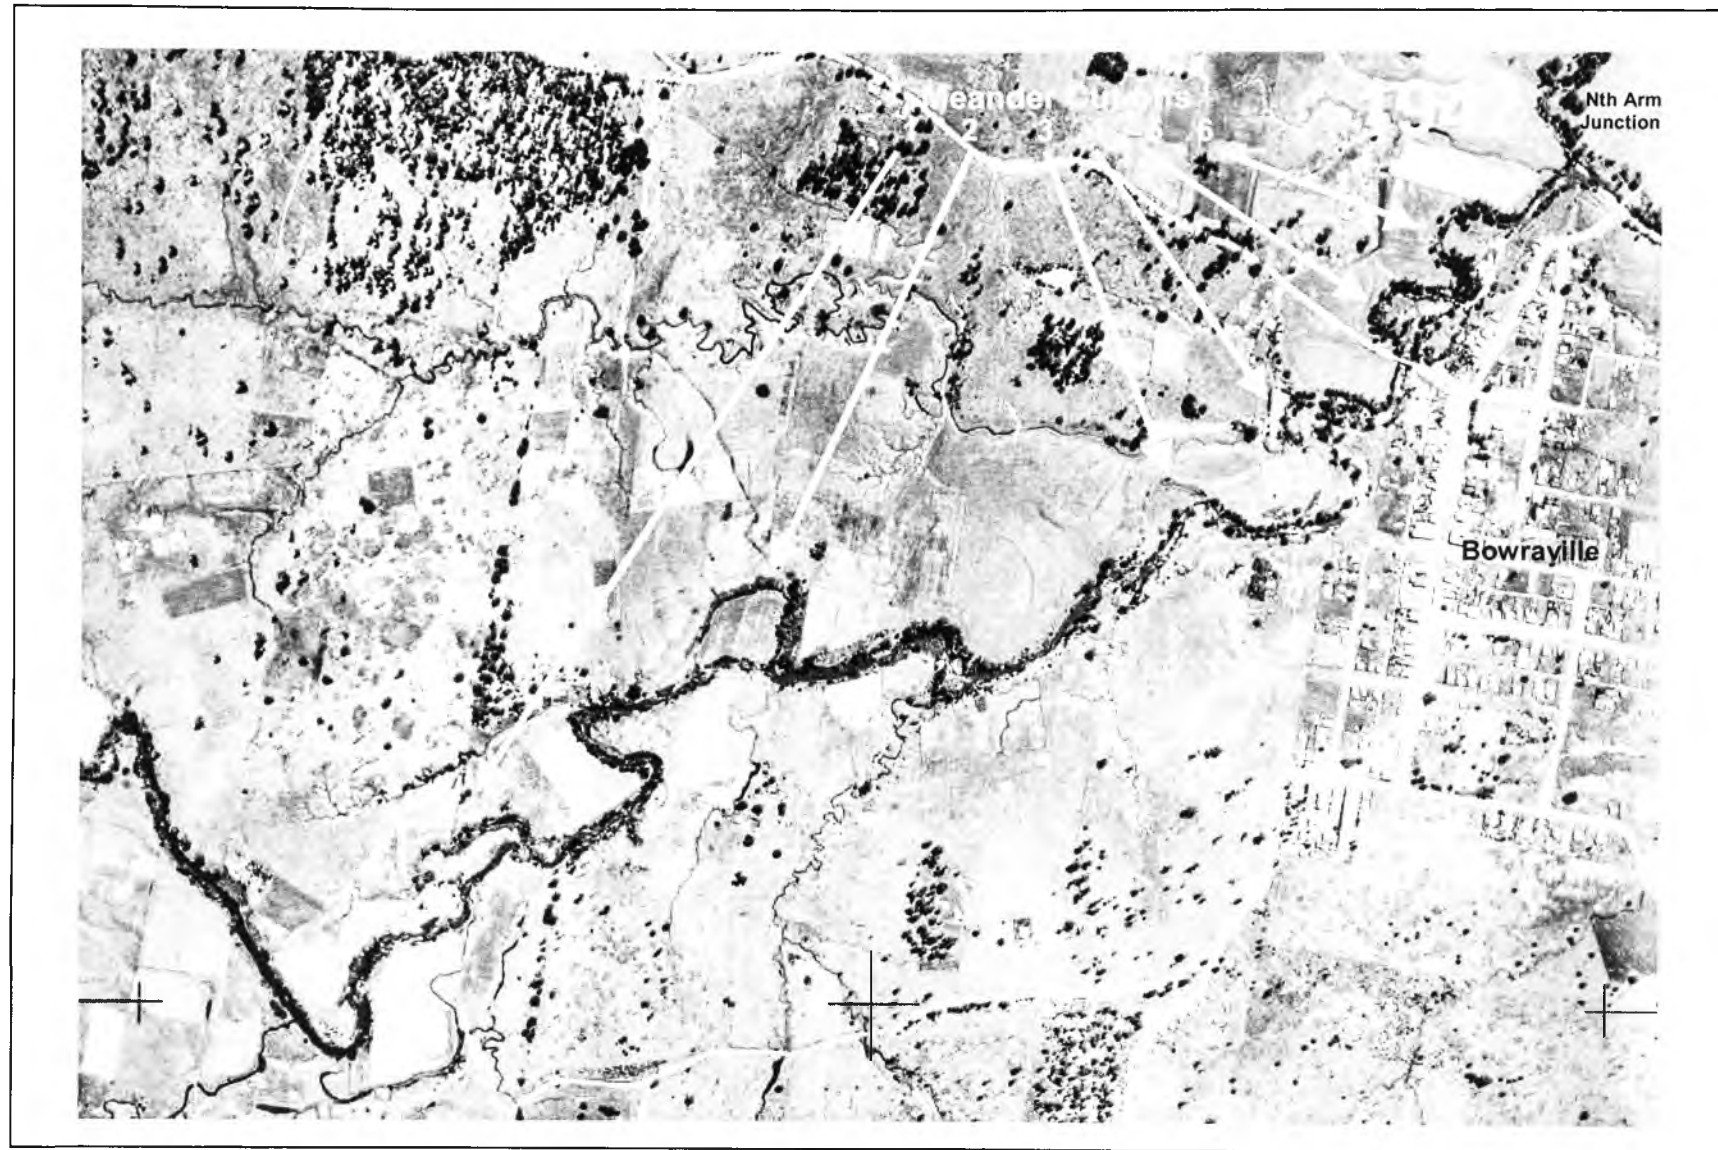
Figure 8.2: Meander cut-offs evident on lower South Arm in 1942

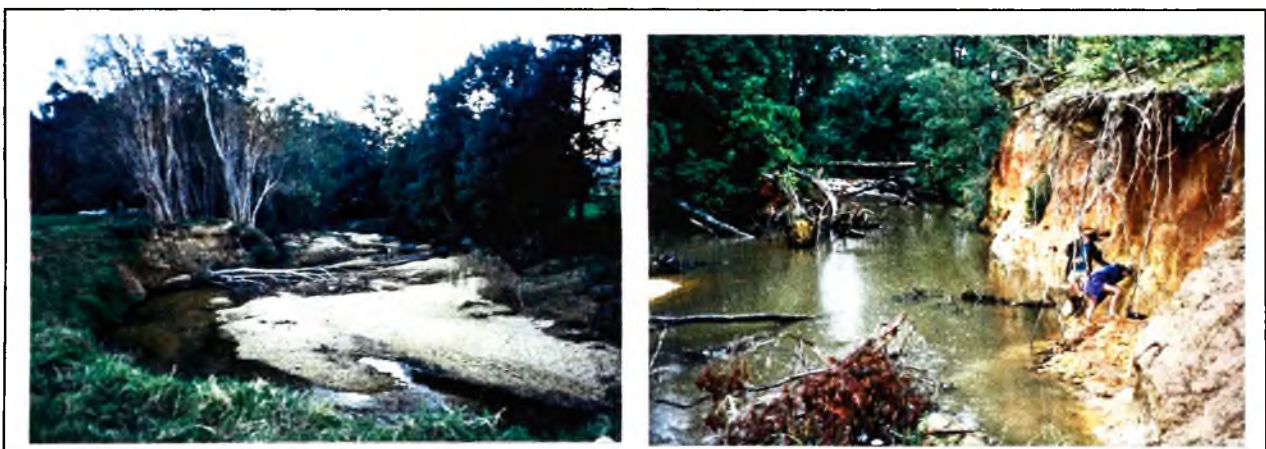
Figure 8.6: Exposed banks and tree collapse at the lower ends of North Arm (left) and Deep Creek (right)

Channel expansion and the collapse of riparian vegetation into the channel commonly occurs following bed degradation. Under these conditions, large trees collapsing with the banks may *appear* to be causing bank erosion. This is a process currently occurring along lower North Arm about 300 m upstream of N7, where camphor laurels are falling into the channel, and at D3 on Deep Creek (Figure 8.6). However, in most cases bank erosion has almost certainly proceeded irrespective of whether this vegetation was present or not. Indeed, for areas where vegetative cover is of sufficient density (and where the incision is not too deep), the overall rate of bank erosion will probably be slowed by the presence of the vegetation. An example of this situation is given by Cohen (1997) for Jones Creek in East Gippsland, Victoria, where a fully forested system is experiencing similar channel instability to that in the Nambucca catchment. In Jones Creek the instability is associated with bed lowering on the Genoa River, into which Jones Creek flows. This study has illustrated that even the largest trees can be undercut and collapse into the channel once incision extends in depth below the root zone.

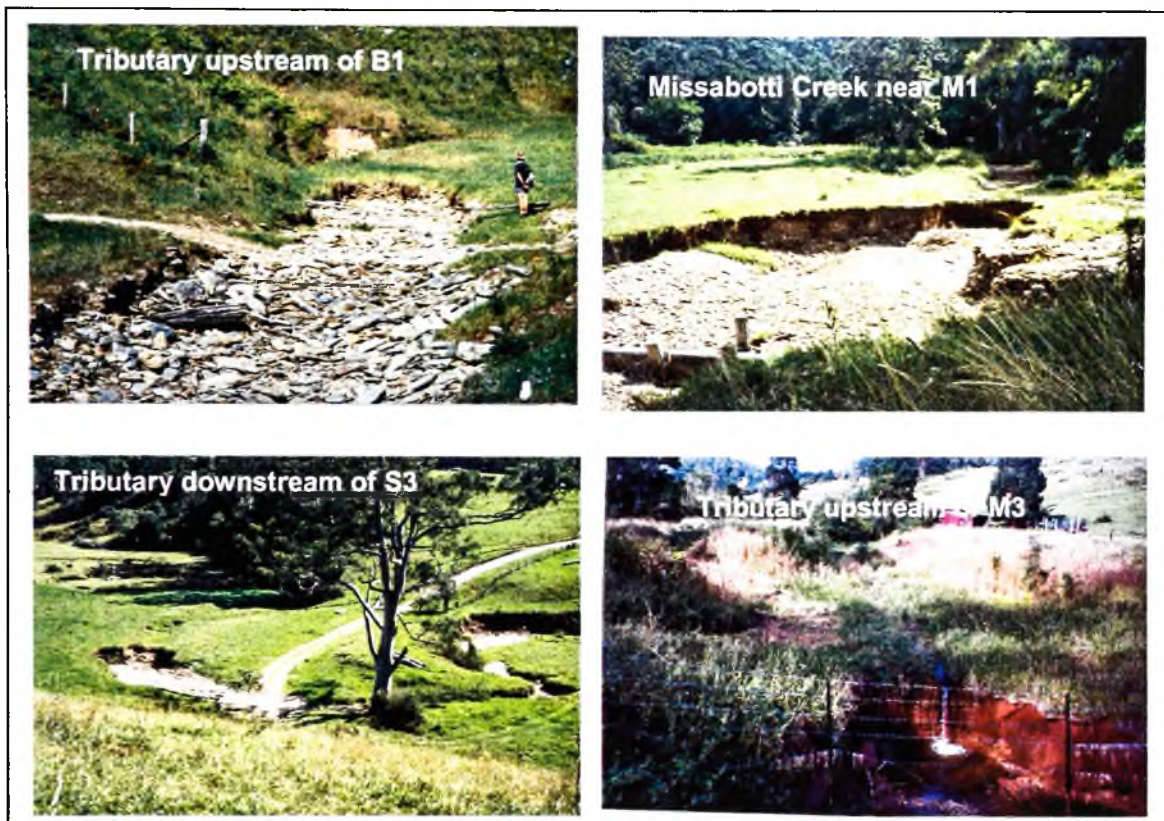
Figure 8.7: Severe nickpoint retreat on tributaries of the Nambucca catchment

channel and gully expansion immediately above confluence with the main channel. Kennaile Creek shows a sharp steepening of its gradient where it enters Missabotti Creek, and there is evidence that the bed of the former is also lowering. Other examples of perched and incising tributaries occur on Buckra Bendinni Creek and South Arm (downstream of S3; Figure 8.7). In the latter case, this renewed activity has caused a meander cut-off on the main tributary.

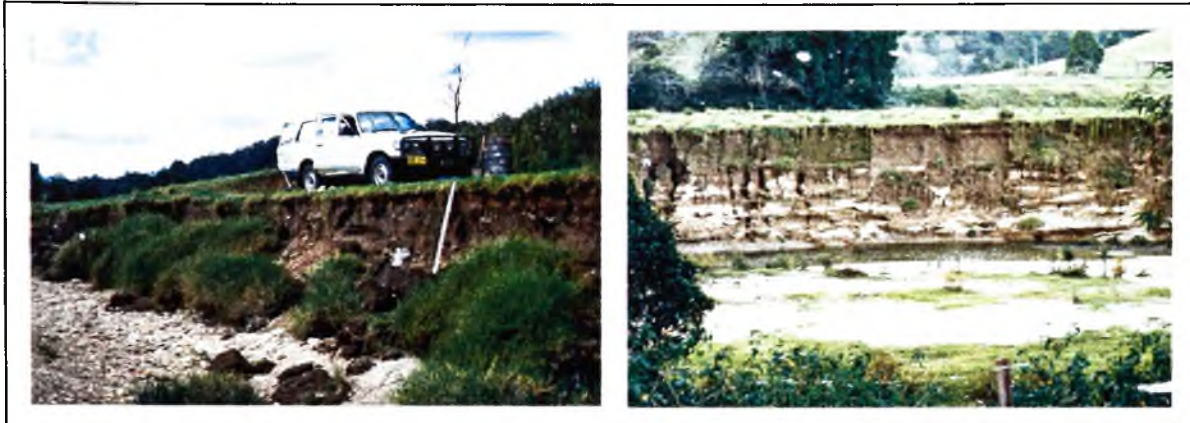
Figure 8.8: Bank slumping (M1 – left) and bank collapse (T5 – right) in the Nambucca catchment

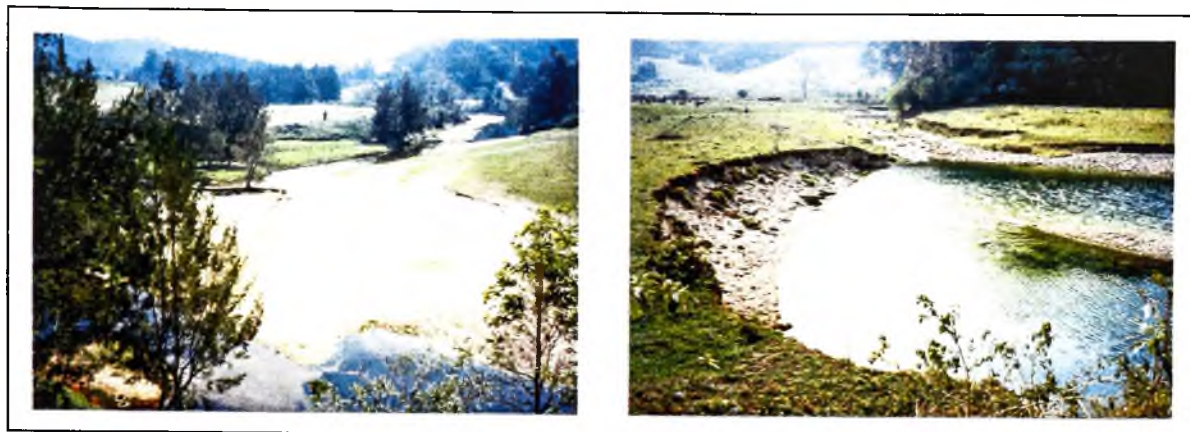
Figure 8.10: Overwidened pools in bedrock valley side areas on Taylors Arm (left) and Buckra Bendinni Creek (right)

The pre-European channels meandered through the floodplain material much more than the current system which is dominated by straight reaches flowing in a straight line from one valley side to another, eliminating the meandering that was evident in the past. Apart from localised bed degradation, the velocities on the downstream side of the straight reach has caused serious erosion and overwidening. Examples of this exist on Buckra Bendinni Creek and Taylors Arm (Figure 8.10).

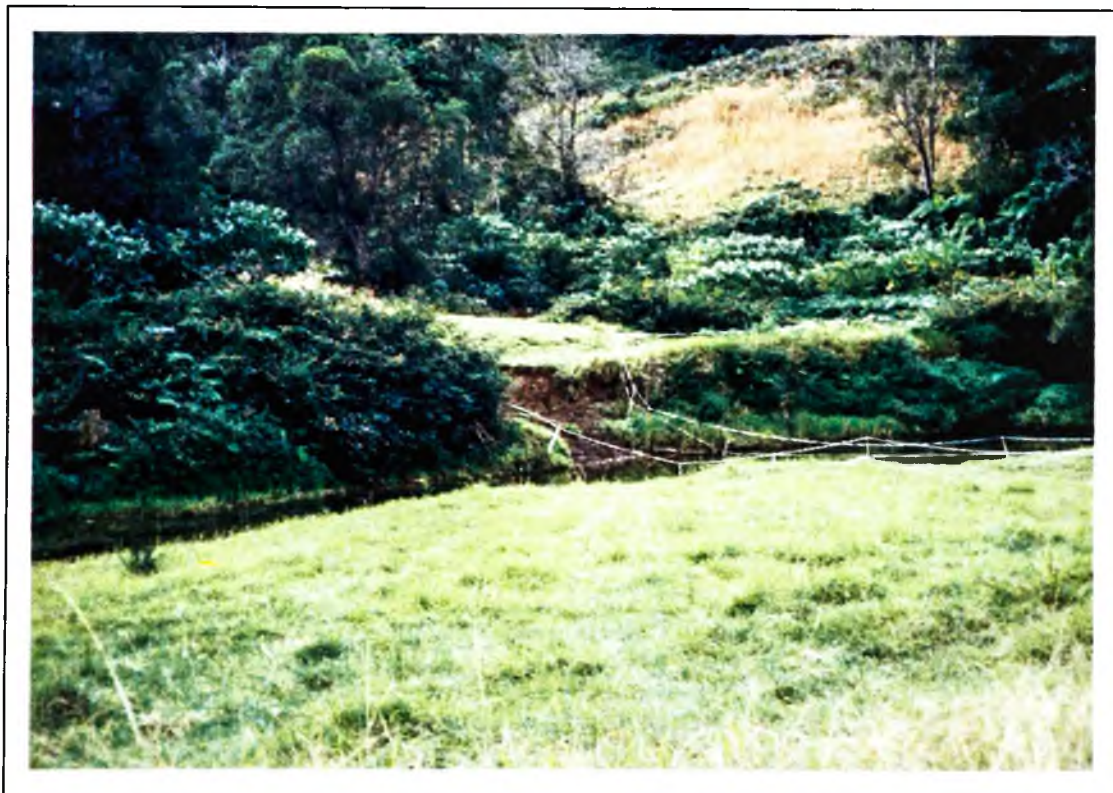
Figure 8.13: Cattle trampling at a stock access point at North Arm Site 2

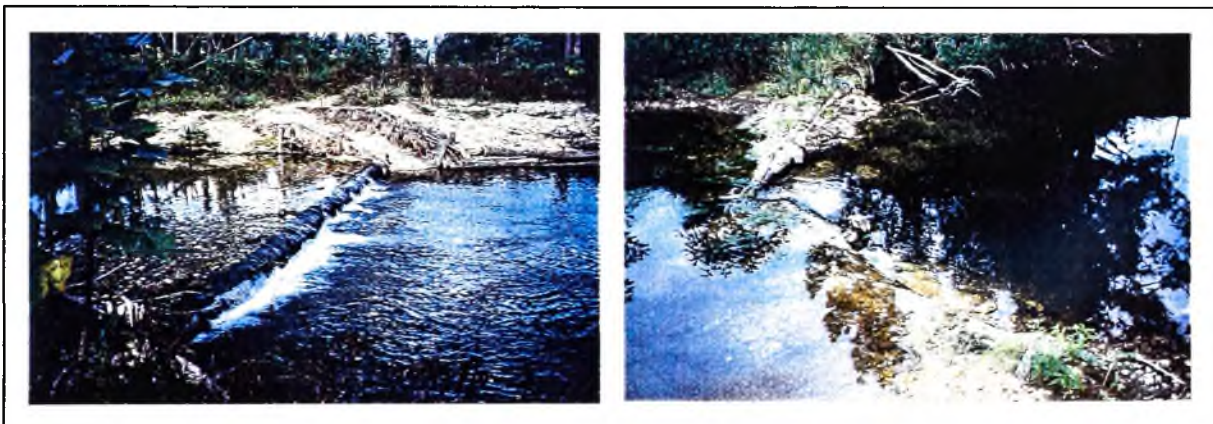
Figure 8.14: Versions of log sills; straight sill on Taylors Arm (left) and a v-notch log sill on Missabotti Creek(right)

A major problem with log sills is that they can be outflanked by the flow. Figure 8.14 shows a straight log sill working on Taylors Arm. The success of this sill is, in part, due to the protection given by a 'splash log' placed on the downstream side of the main log, and to the placement of brush groynes along the banks at the outer ends of the log. These brush groynes help to prevent the sill being outflanked by scouring in times of flood. Continual maintenance of the sills and brush groynes by property owners greatly contributes to their success. Figure 8.14 also shows a v-notch sill on Missabotti Creek where a pool has been successfully scoured on the downstream side. This sill has not been outflanked due to the fact that the logs have been embedded into a cohesive and vegetated bank of soil in contrasts to those where the banks consist of unconsolidated gravel. The narrowness of the channel here, and the decreased chance of outflanking, have helped the sill to remain intact. A possible risk with the use of *geotextile* is that when it is not constantly submerged it can breakdown, risking undercutting of the log structure.

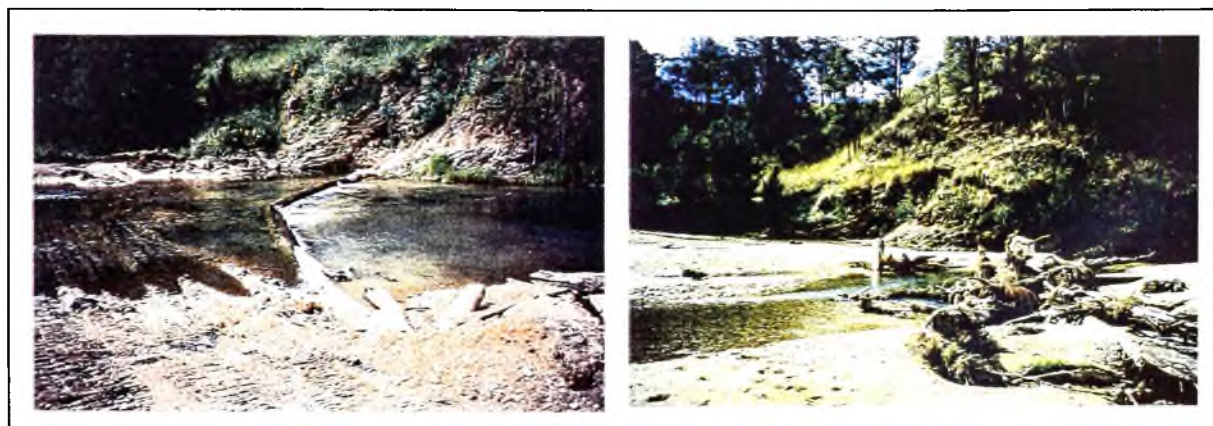
Figure 8.15: A v-notch log sill after construction at Site N3 on North Arm in February 1996 (left) and after the May flood in 1996 (right)

Figure 8.15 shows the fate of a V-notch log sill that has been outflanked. This reach was over steepened due to a meander cut-off in the 1980's. Figure 8.15 shows a comparison of the sill just after completion in February 1996 and shortly after the May 1996 flood. The sill was placed against bedrock on the left side of the channel but was only buried under gravel on the right side. The May flood caused the structure to be undercut and outflanked on the right side of the channel. The newly created channel, with a design width of 15 m, was unable to cope with the storm event and the floodwaters outflanked the log sills, also removing the groynes that were designed to prevent this from happening.

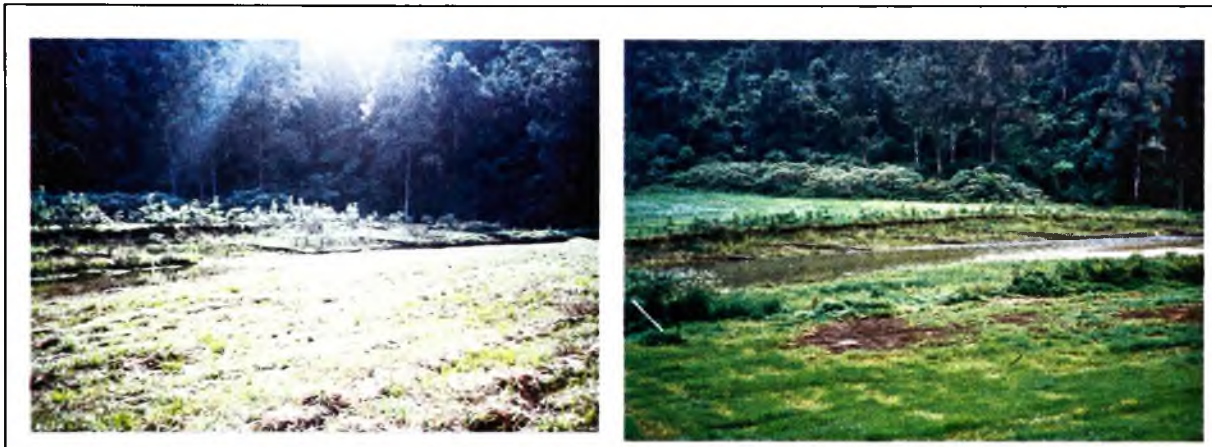
Figure 8.16: Brush groynes at 'Operation Sue' on North Arm in 1997 (left) and 1999 (right)

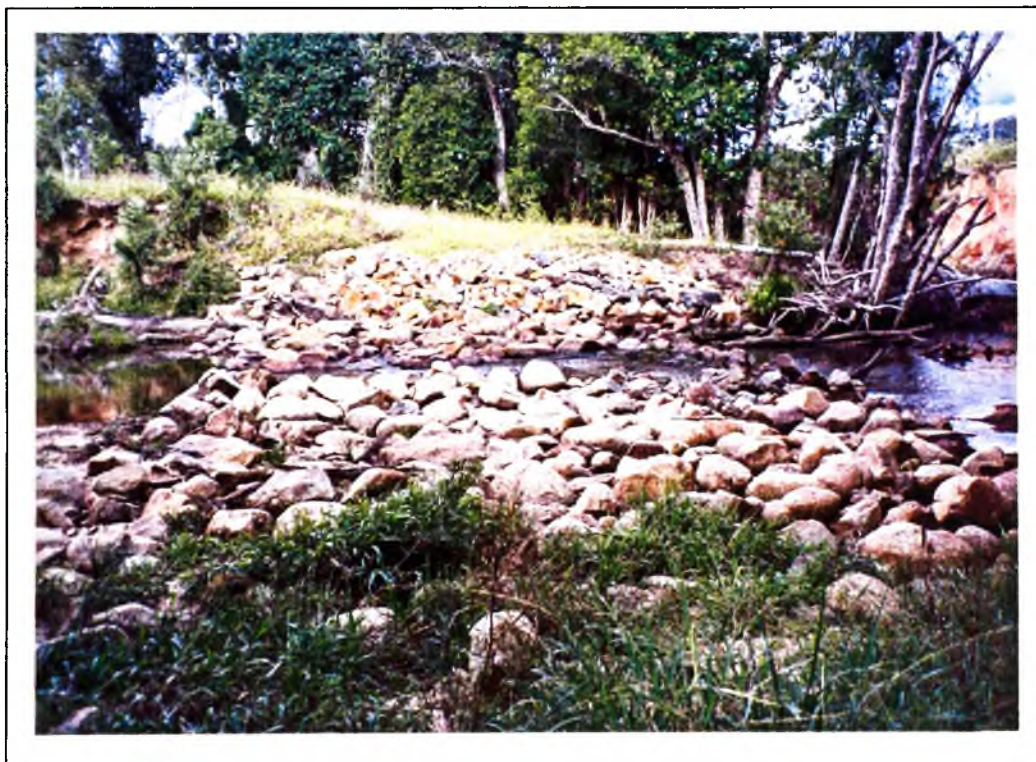
Figure 8.20: Rock ramp on Deep Creek (D3)

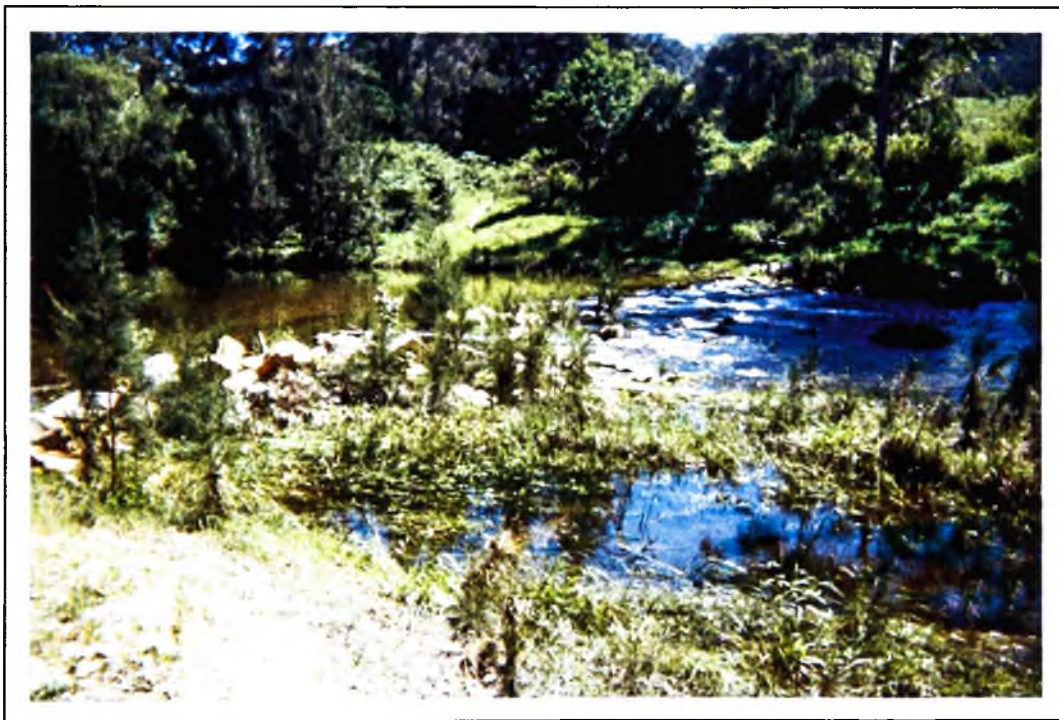
Figure 8.22: Rock ramp on North Arm Site N3 in 1999, three years after construction

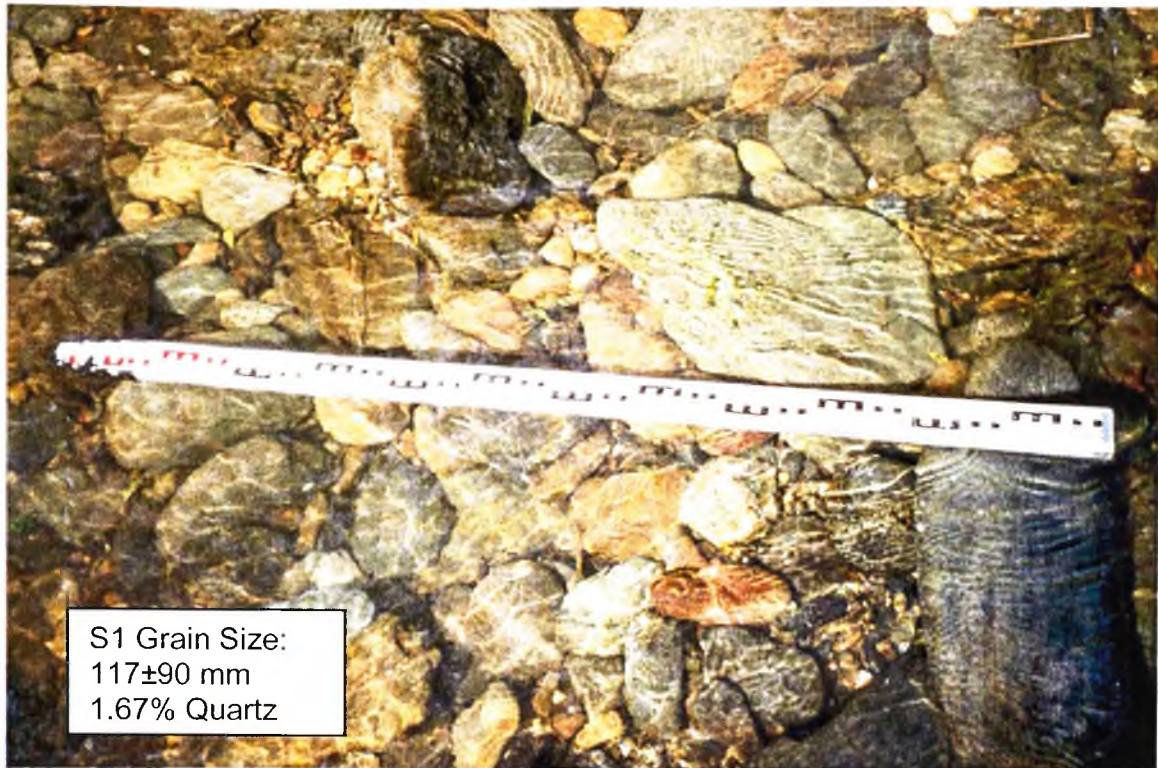
Difference in bedload size for the upper and lower reaches of the Nambucca catchment. The bed material in the above photograph is from South Arm Site 1, whilst the photograph below is at South Arm Site 5.
