Coal Operators' Conference

Non destructive integrity testing of rock reinforcement elements in Australian mines

NON DESTRUCTIVE INTEGRITY TESTING OF ROCK REINFORCEMENT ELEMENTS IN AUSTRALIAN MINES

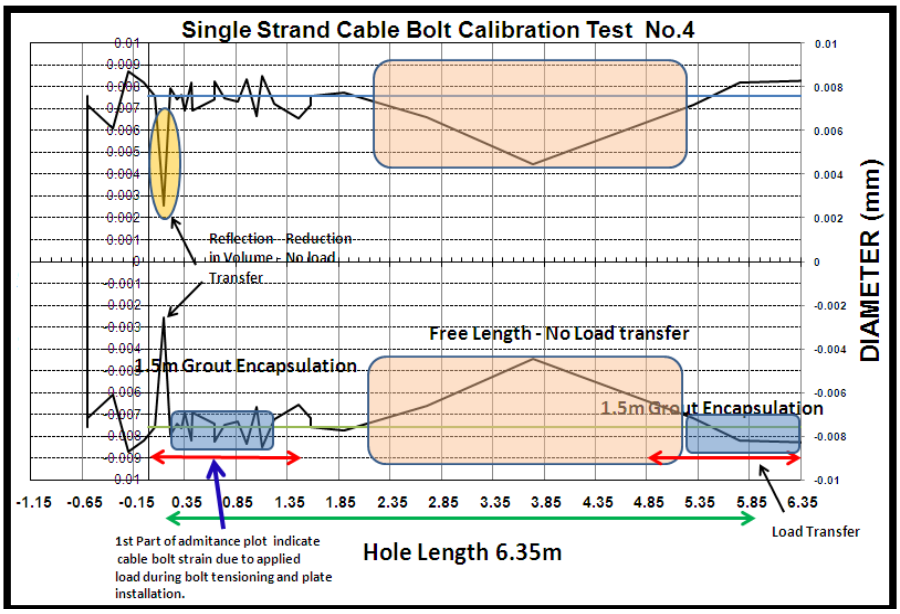
Table 6 - Two dimensional graph showing structural stiffness of rock reinforcement element with diameter used as a guide

The two opposing curved black lines on the graph represent structural stiffness through good embedment or load transfer. The top (blue) and bottom (green) horizontal lines in the graph collectively represent the element's full diameter. The structural stiffness presented in the two dimensional plot together with the element's diameter are used to indicate whether any disturbance (i.e. bolt necking, bolt volume reduction through corrosion, bolt shearing (Hartman, 2003) and/or ineffective grout or resin embedment) or reflection point can be detected during testing. The graph is an example of disturbance (reflection) where grouting was deliberately placed towards the toe end of the bolt as part of a calibration program at the Sunrise Dam Mine (WA). The graph clearly shows good load transfer or embedment towards the toe end of the bolt.

Both Figure 6 and 7 above are prime examples of poor grouting. Figure 6 is an example of a calibration bolt with known grouting embedment at the toe and collar. Figure 7 is a two-dimensional graph of a *"full column grouted"* twin strand cable bolt tested at the Fosterville Gold Mine showing clear signs of a defect (i.e. grout deficiency) between 3 m and 4 m. In addition, this graph also shows that the cable bolt length to be 6 m instead of 8 m.

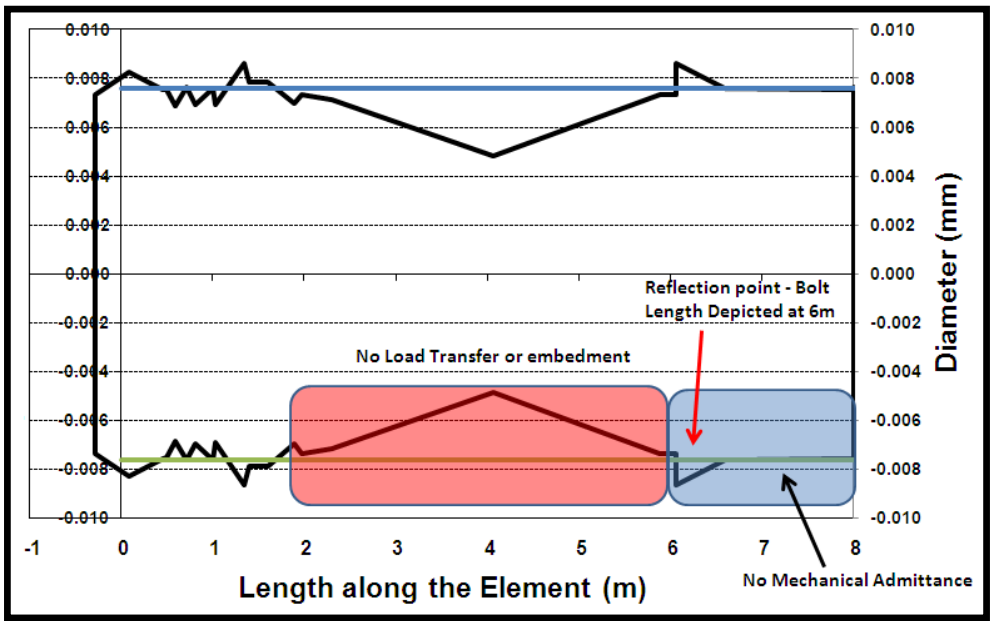
Table 7 - Two dimensional graph showing confirmation of twin stand cable bolt 6m length following initial 8m input parameter

The above graph clearly shows bolt length to be around 6 m following test input parameter set to 8 m. The bolt length was later confirmed by the mine to be a 6 m twin strand cable bolt.

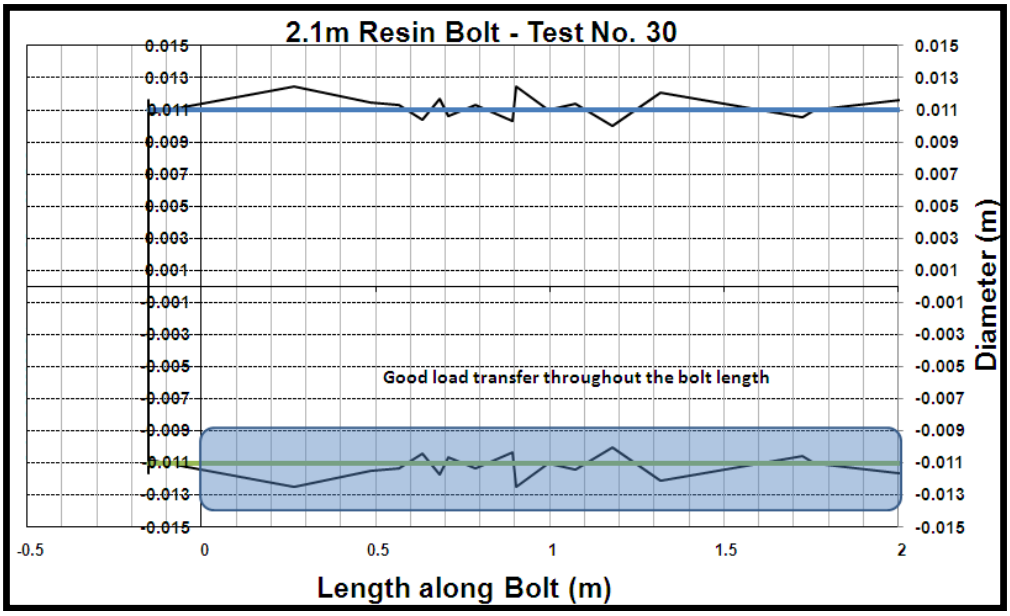
Table 8 - Two dimensional graph showing good embedment achieved along the length of the 2.1 m resin anchor installation

Test completed at Mandalong Coal Mine shows that the resin installation practices at Mandalong appear to be of good quality when interpreting the two dimensional graphs (see Figure 8 below) and calculated load. Figure 8 indicates good embedment (structural stiffness) along the length of the resin bolt.

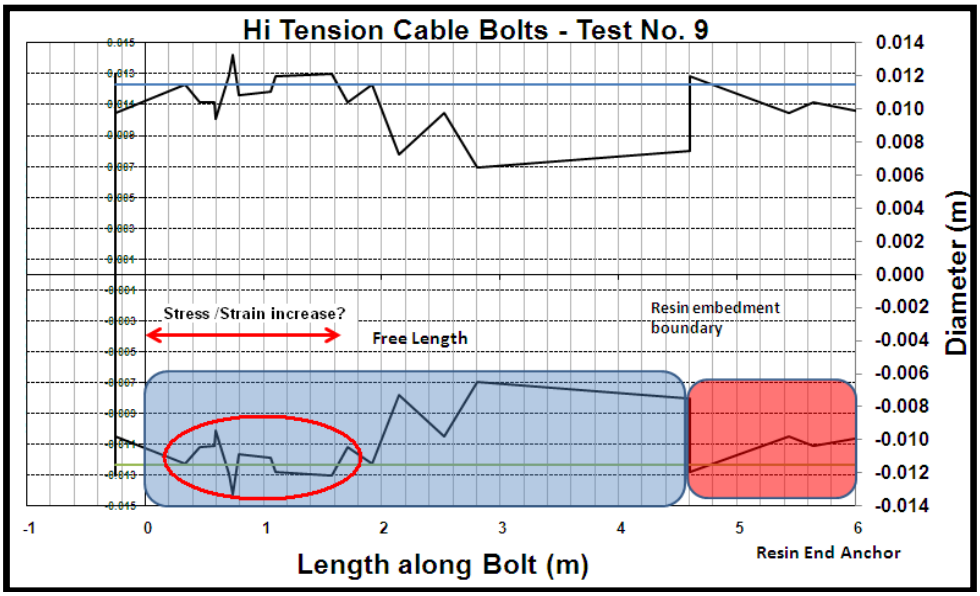
Table 9 - Two dimensional graph showing confirmation of end anchor resin embedment and possible stress / strain increase in close proximity of hole collar

The Hi-Tens cable bolts are installed using a 1 200 mm long slow set resin which is inserted into the hole using a conduit to push it right to the back of the hole. The Hi-Tens tendon is inserted into the hole until it reaches the base of the resin. The bolt is spun through the resin for about 30 seconds to activate the quick set resin. The plate, barrel and wedge are installed with a tensioner to 20 tonnes. Tests conducted on the Hi-Tens tendon showed an interesting two dimensional graph where the resin installation is limited to the toe area of the bolt / hole as per design. A free anchor length of around 4.2m is maintained with the 2D plot showing either signs of stress increase or noise close to the collar. We have reason to believe that it could be related to an increase in stiffness / strain in the bolt as this was previously noticed when testing cable bolts at the Sunrise Dam Gold Mine and other mines. This phenomena relates to the first part of the two dimensional graph (see below Figure 9 – Hi Tension tendon – Test No. 9 – Mandalong Coal).
